DOCUMENT CHANGE NOTICE (DCN)

DOCUMENT No. (DOC-REV-GP. ID)	TITLE	NEW REV.
D961416-A	Large Core Optic Component Carrier Cover	B
D961449-A	Core Optic Component Carrier Top Plate	B
D961467-A	Core Optic Component Carrier Metrology Interface Top Plate	B

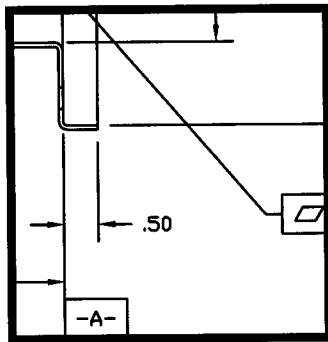
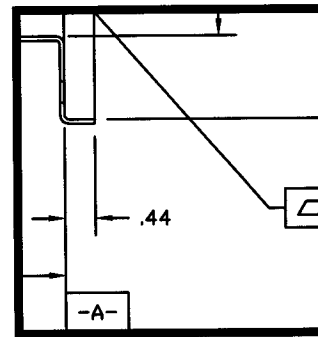
D961416: Changed size of lip at base of cover in zone 3A as shown, to eliminate interference with handle plates D961451 on top assemblies D961460 & D961461:

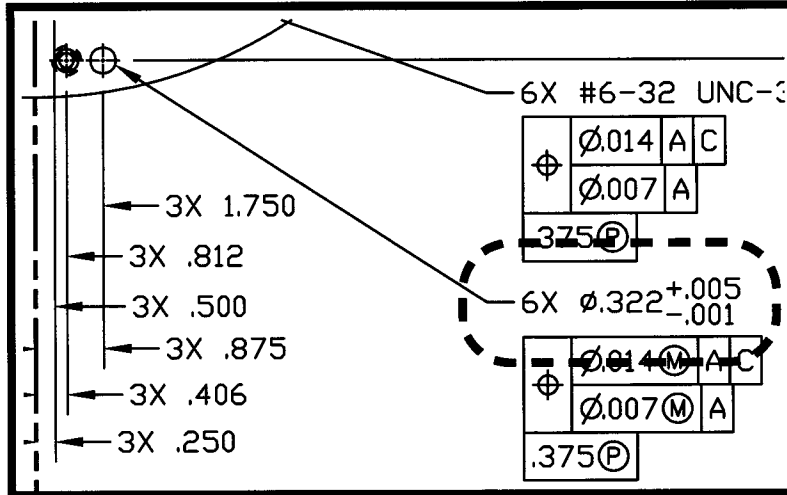
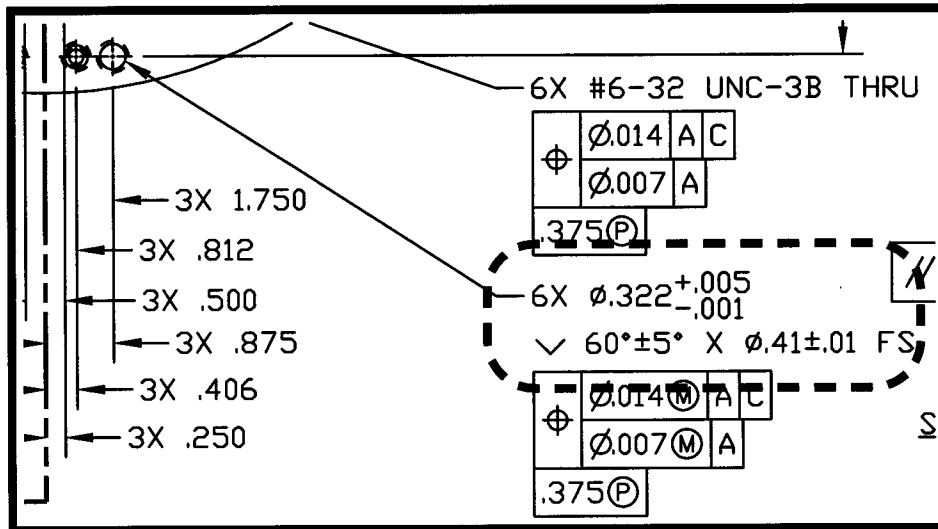
D961449:

Added countersinks to bottom side of plate on six clearance holes as shown:

REASON FOR CHANGE: Alleviate “wedging” of captive screw retaining rings D970001, between top of standoffs and bottom side of top plate D961449 on top assemblies D961460 & D961461. This problem caused the retaining rings to ride down the captive screw threads when backing out the captive screws to remove the top plate.

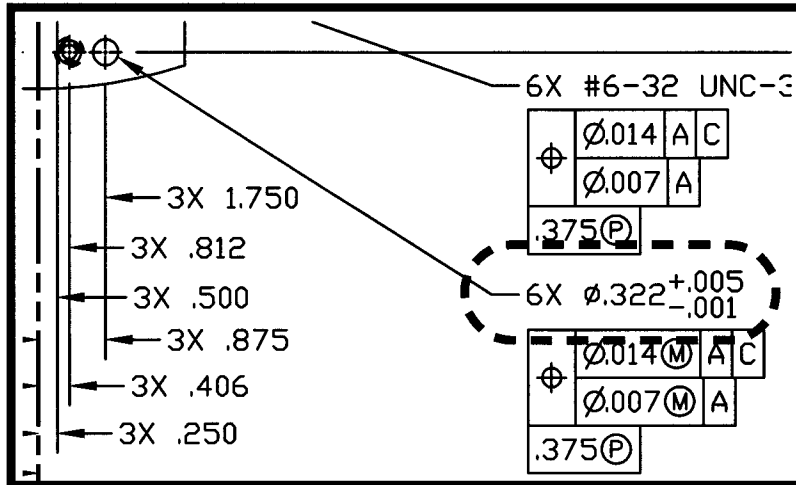
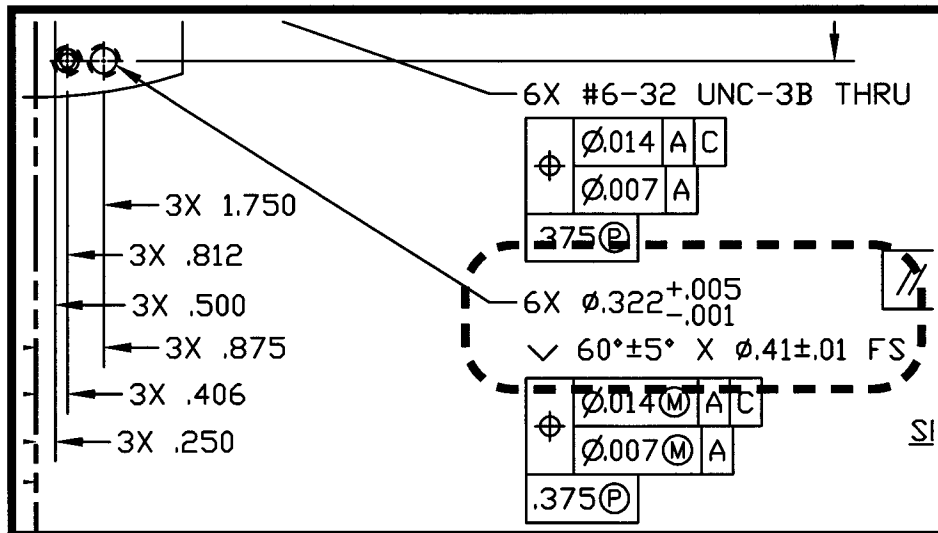
D961467:

Added countersinks to bottom side of plate on six clearance holes as shown:

REASON FOR CHANGE: Alleviate “wedging” of captive screw retaining rings D970001, between top of standoffs and bottom side of top plate D961467 on top assemblies D961460 & D961461. This problem caused the retaining rings to ride down the captive screw threads when backing out the captive screws to remove the top plate.
