G960122-

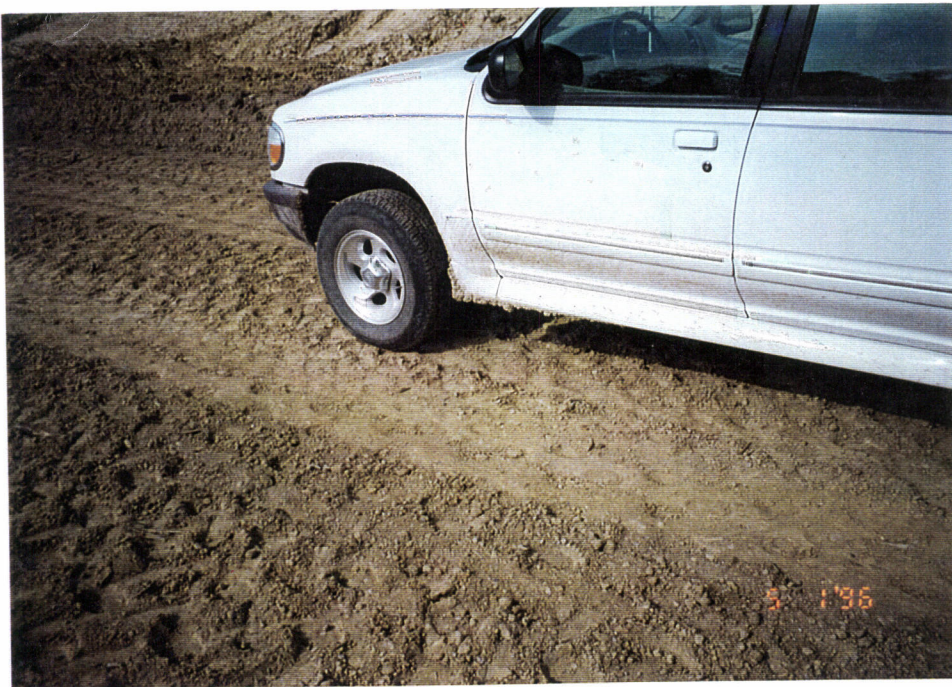
G960122-01-O-P

1. Southwest arm at station 73+00 showing small imprint that the tire is making on compacted soil.

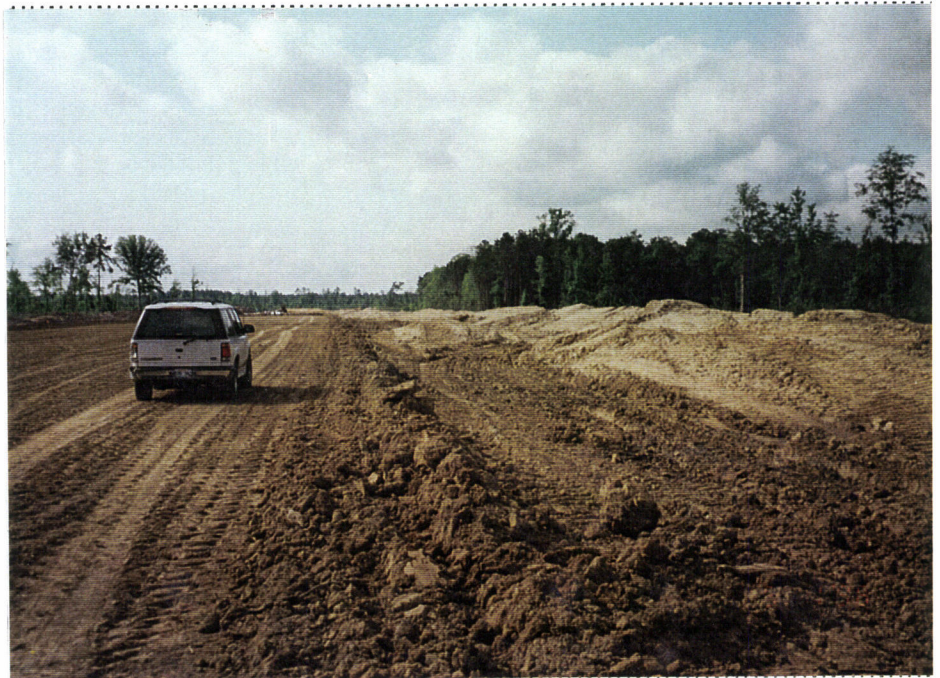
G960122-02-O-P

2. Southwest arm at station 73+00 looking SW at culvert 92+60, at pipeline location.

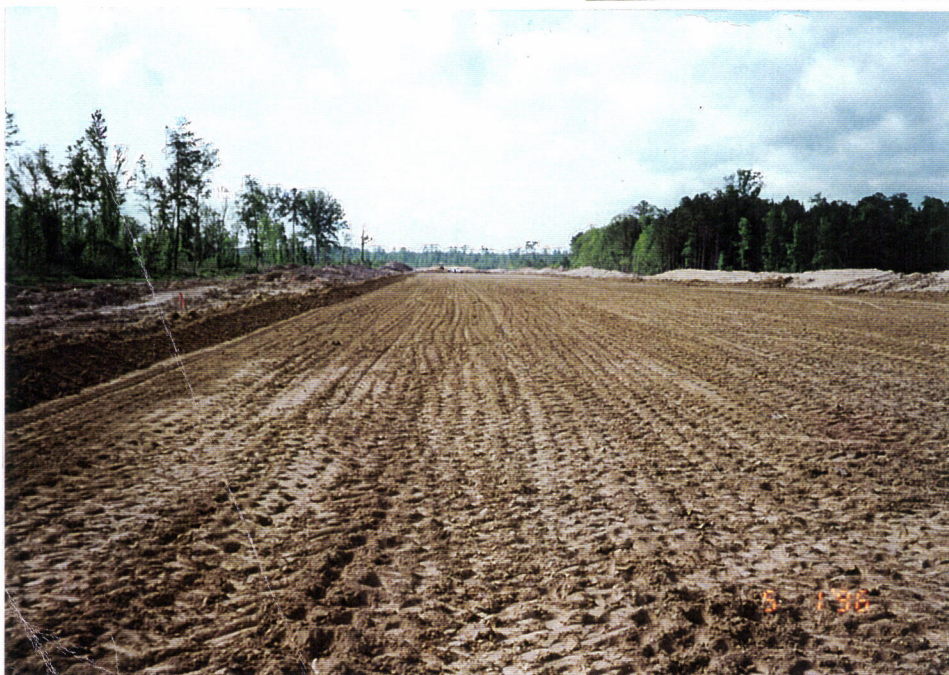
G960122-03-O-P

3. Southwest arm at station 73+00 showing the quality of soil after compaction is done.

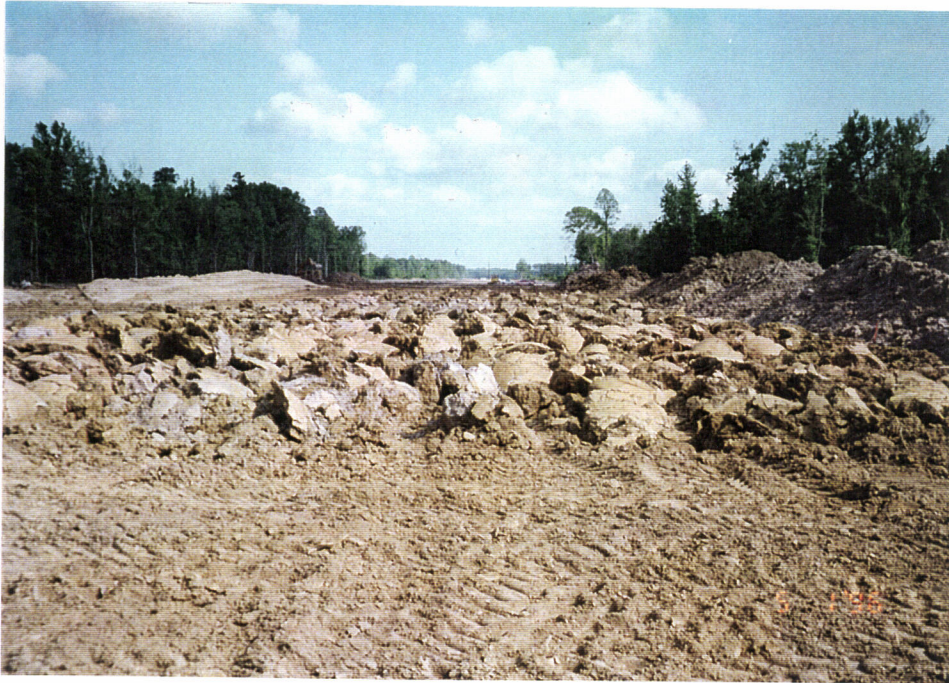
G960122-04-O-P

4. Southeast arm #1 at station 97+00 showing berm material after being plowed up with grader to remove moisture.

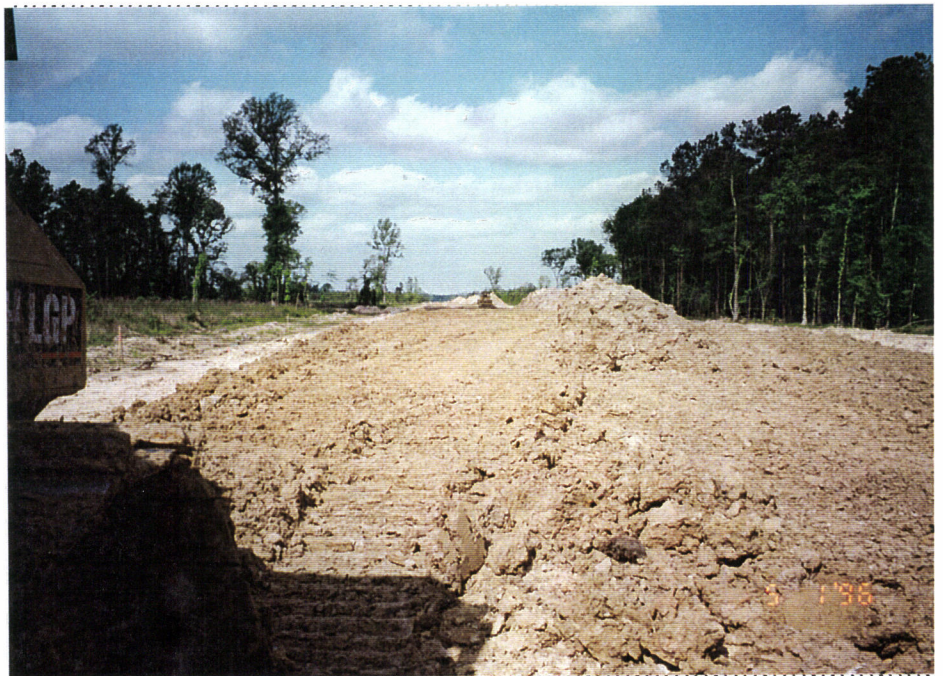
G960122-05-O-P

5. Southwest arm at station 79+00 showing excavated material being spread to create a lift of berm.

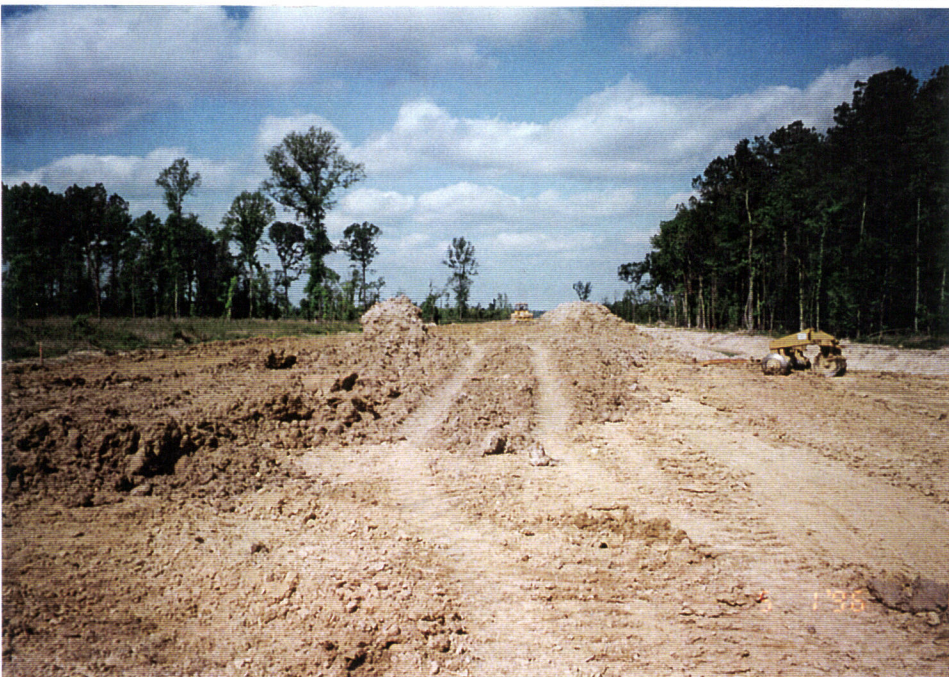
G960122-06-O-P

6. Southwest arm at station 79+00 showing construction of a lift of berm.

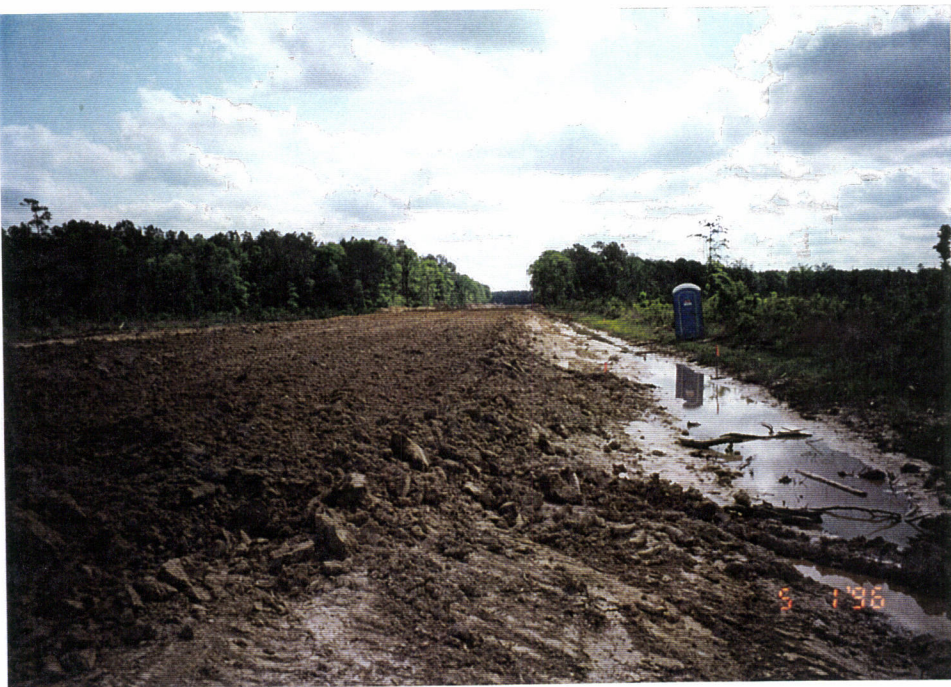
G960122-07-O-PV

7. Southwest arm at station 41+00 looking NE showing the height of berm about half the finished height.

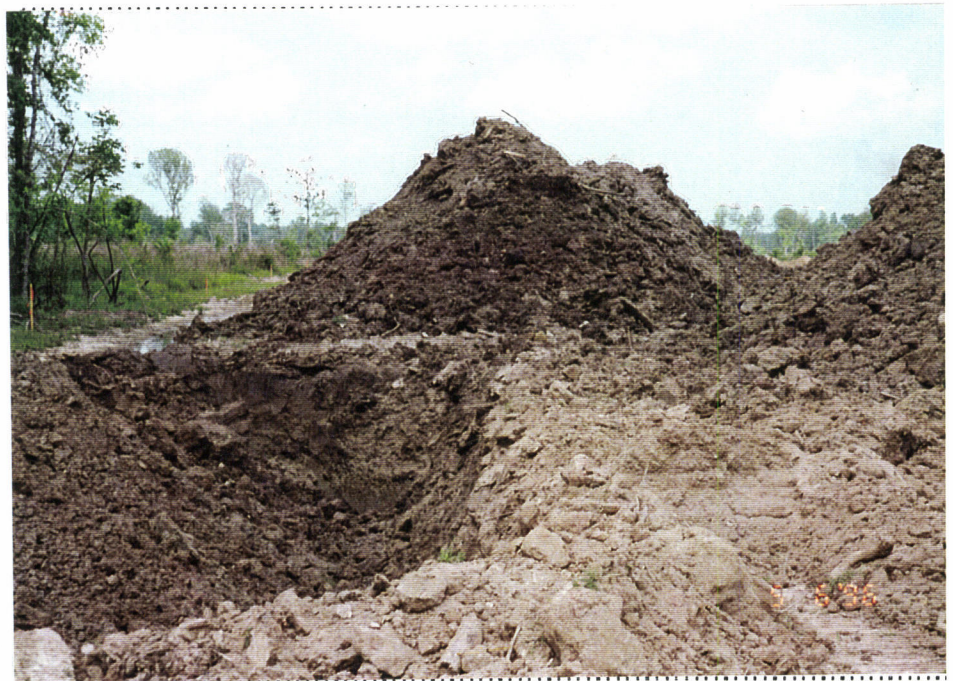
G960122-08-O-P

8. Southwest arm #2 at station 43+00 showing organic material being excavated so acceptable soil may be installed.

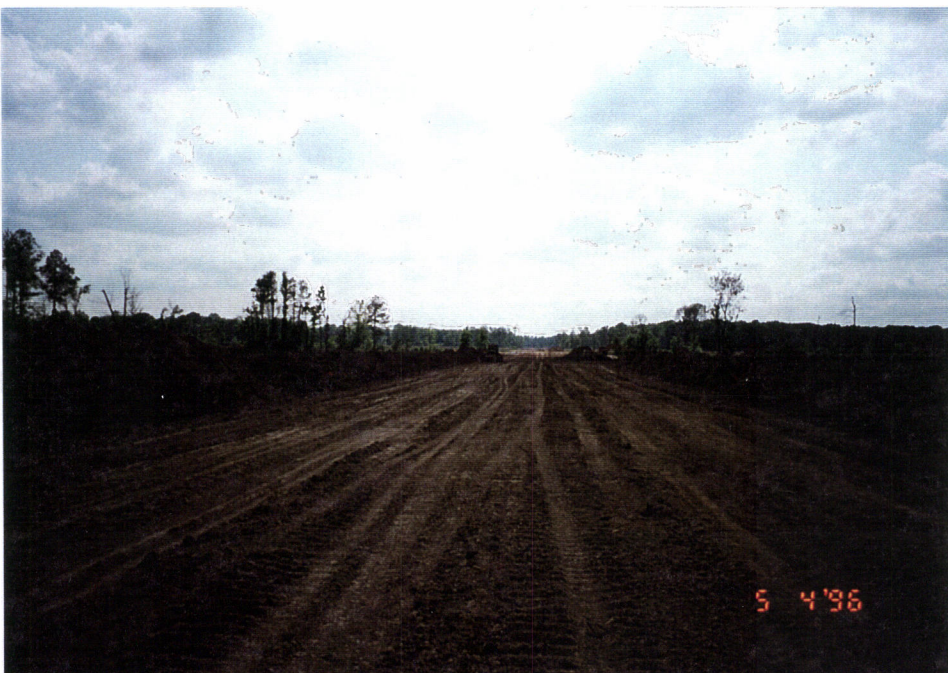
G960122-09-O-P

9. Southwest arm showing berm construction at station 98+00.

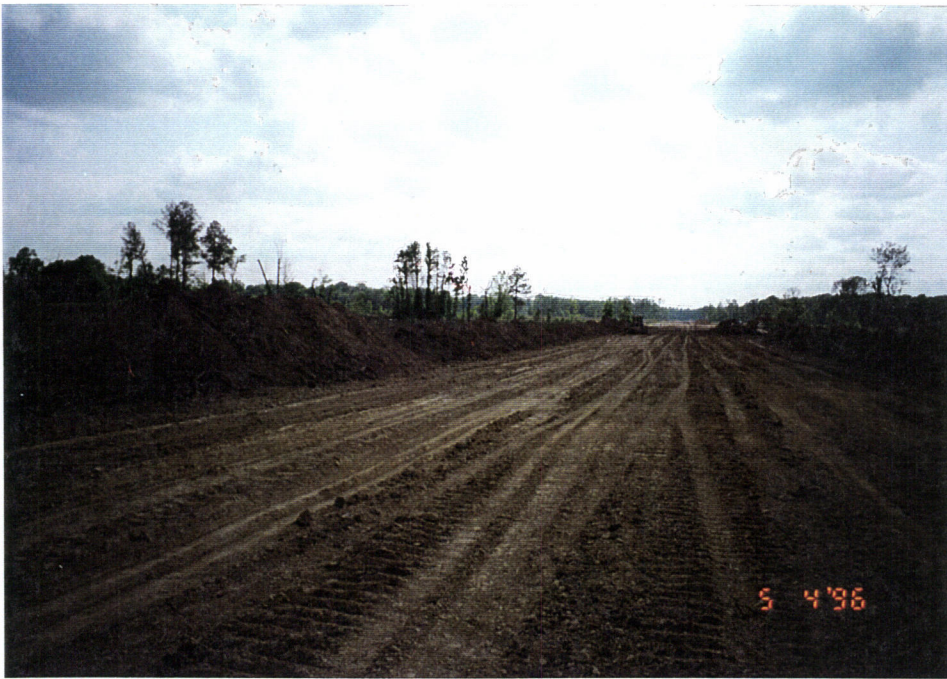
G960122-10-O-P

10. Southwest arm #2 at station 98+00 showing the extent of organic material (left side of photo).

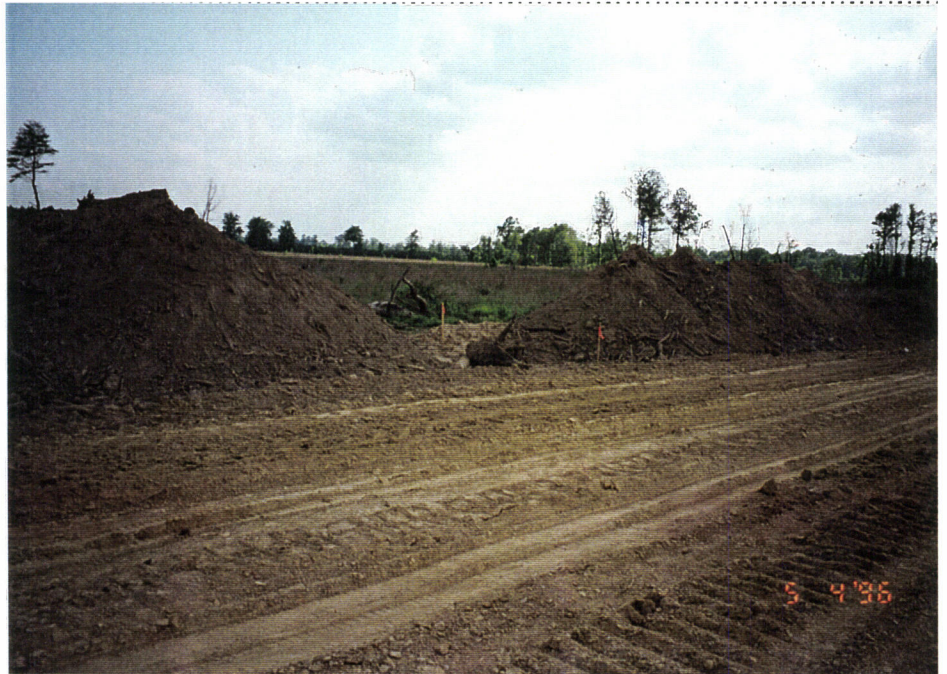
G960122-11-O-P

11. Southwest arm #2 at station 98+00 showing the organic material.

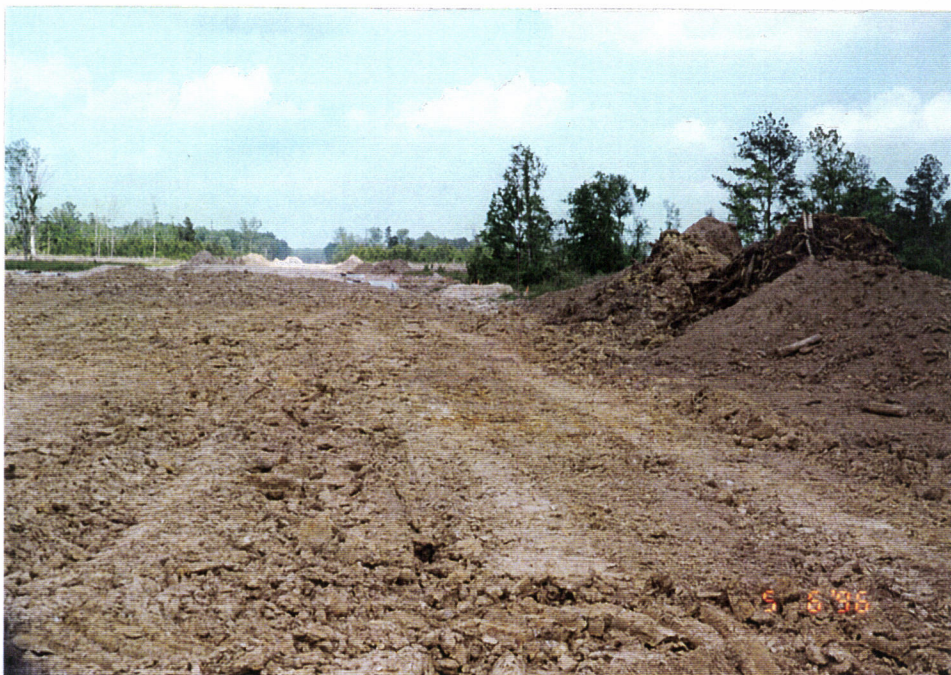
G960122-12-O-P

12. Southwest arm at station 82+00 looking NE at pipeline crossing in background. Note: organic material on right.

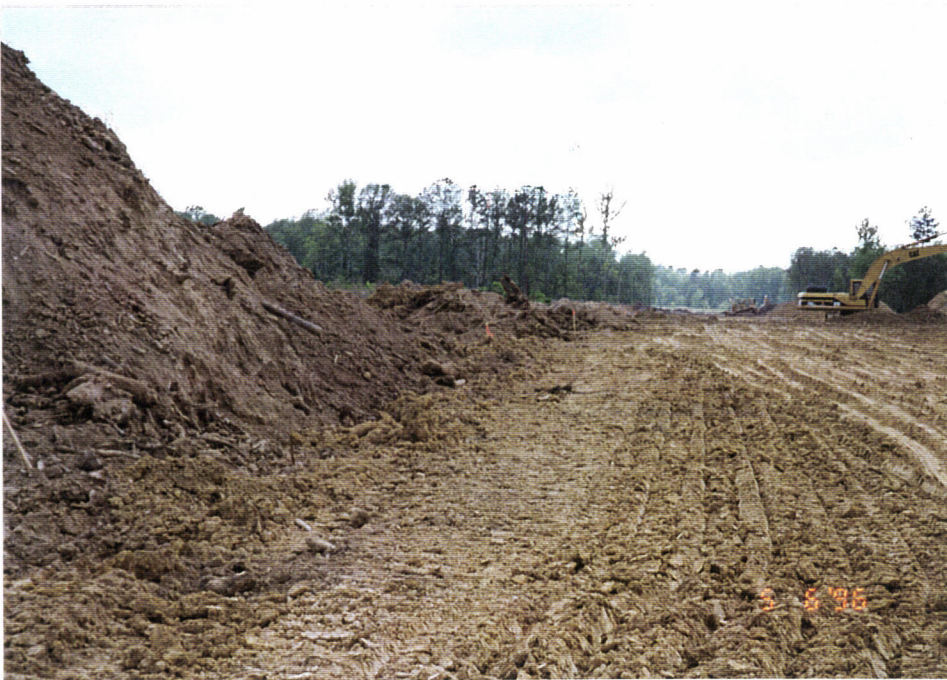
G960122- 13 -O-P

13. Southwest arm at station 80+00 looking NW at the extent of organic material on left.

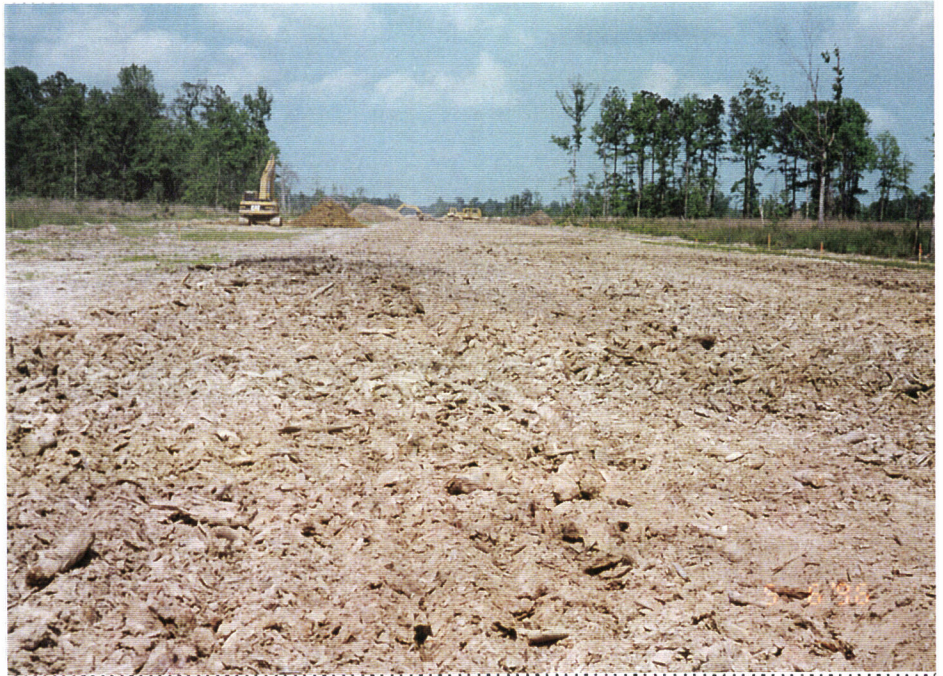
G960122- 14 -O-P

14. Southwest arm at station 121+00 looking NE at base preparation showing exposing organic material to be removed.

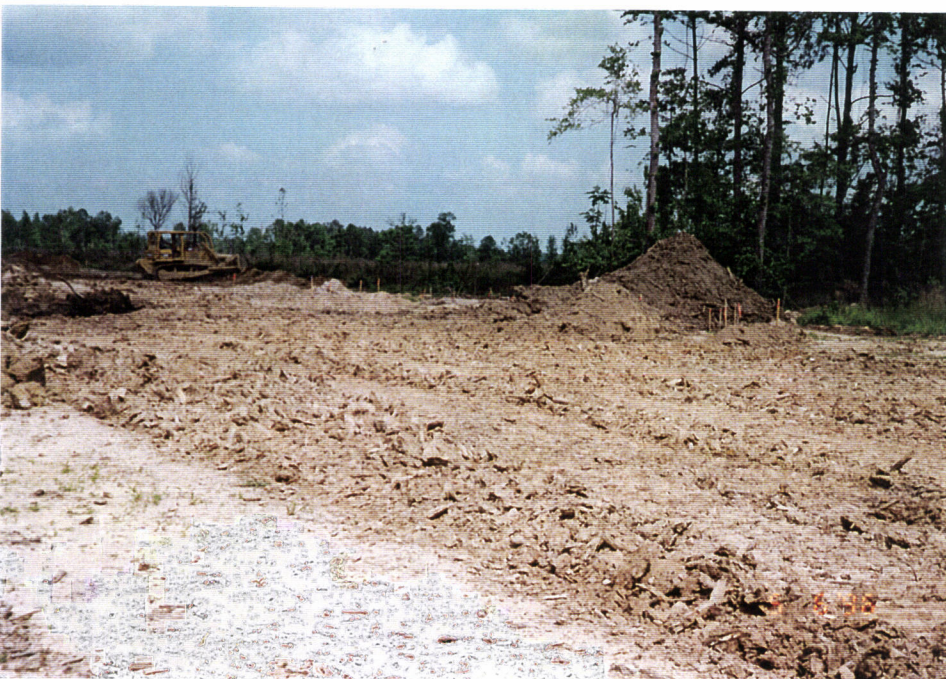
G960122- 15 -O-P

15. Southwest arm at station 121+00 showing removing organic material to facilitate berm base construction.

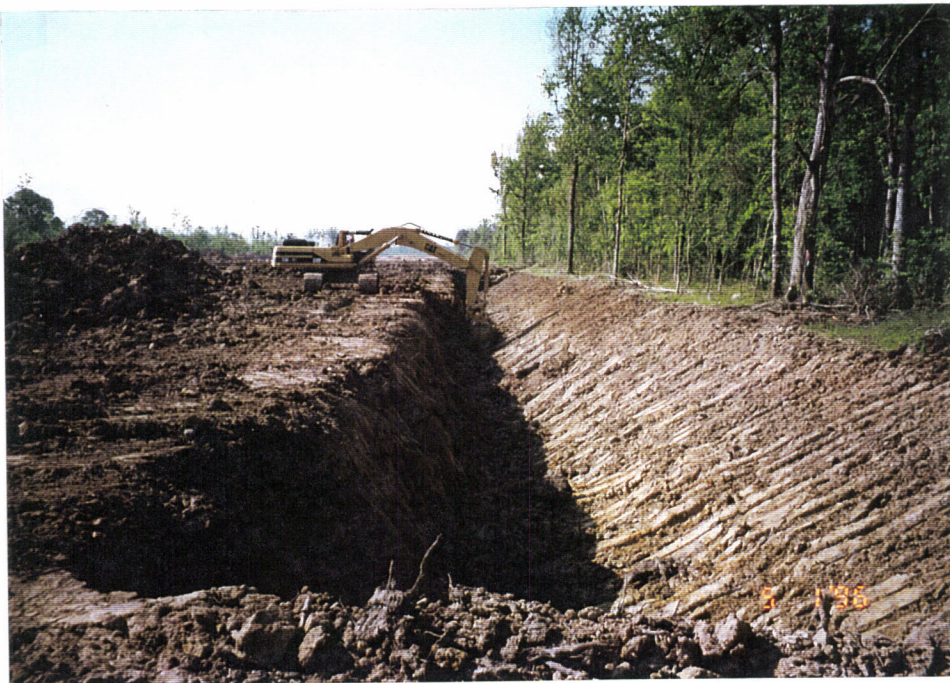
G960122- 16 -O-PV

16. Southwest arm at station 11+00 excavating good material from trench for berm construction.

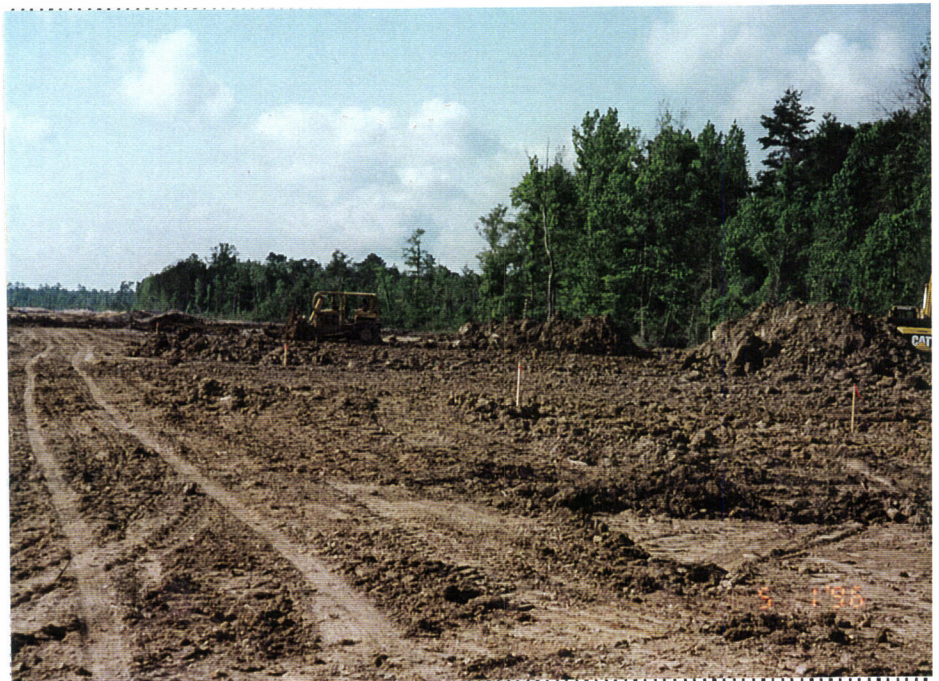
G960122-17 -O-P

17. Southwest arm #2 at station 19+00 building berm with excavated material.

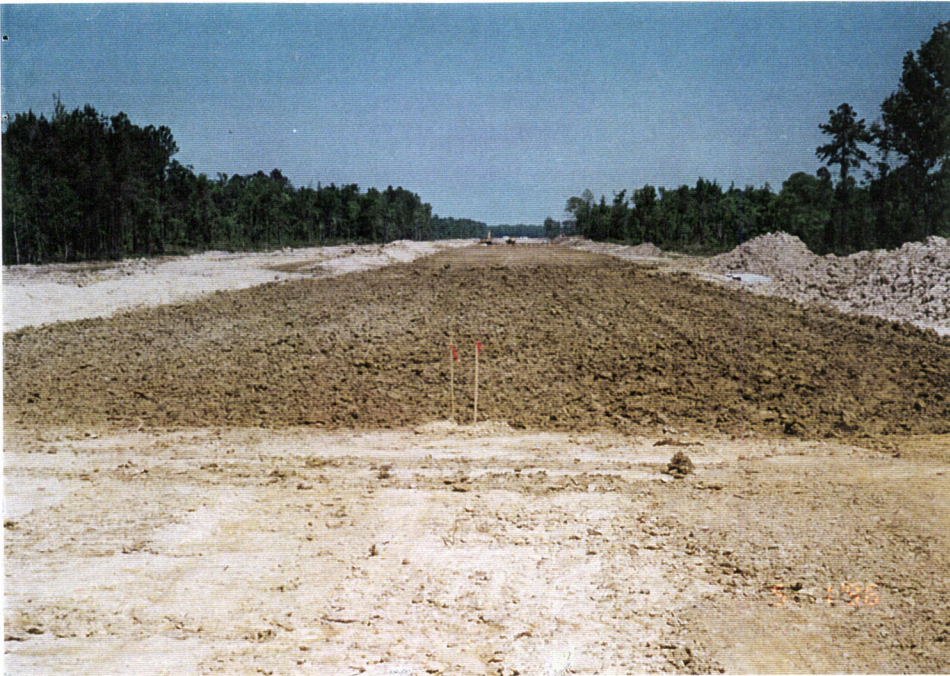
G960122-19-O-P

19. Southwest arm at station 27+00 showing disked material on berm drying out for compaction.

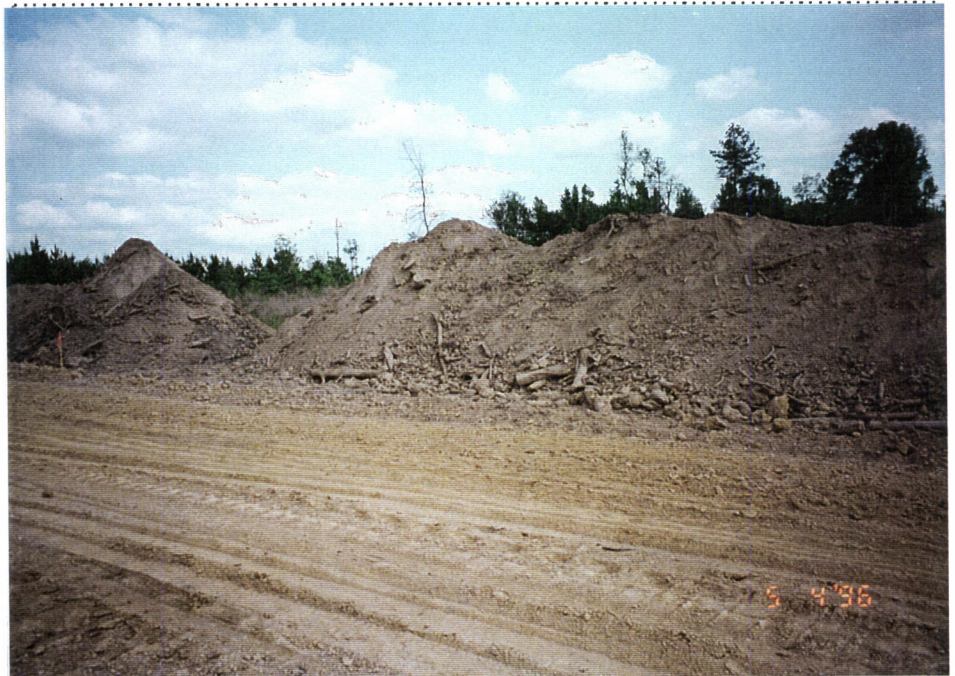
G960122-20-O-P

20. Southeast arm at station 97+00 showing organic material removed and acceptable material installed in its place.

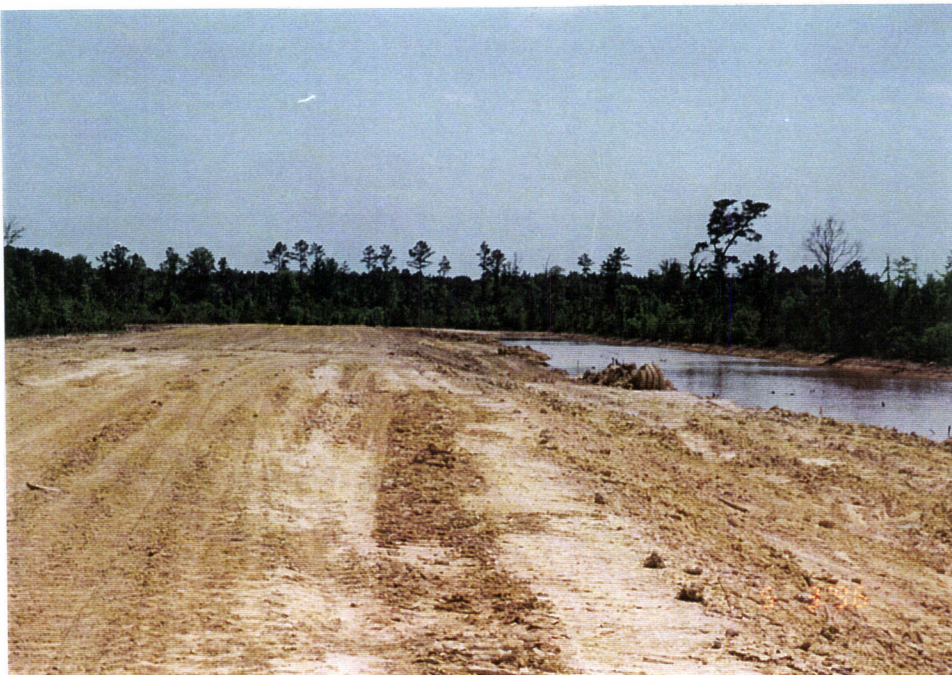
G960122-21-O-P

21. Southeast arm at station 100+00 looking SE at berm approximately one foot below finish grade.

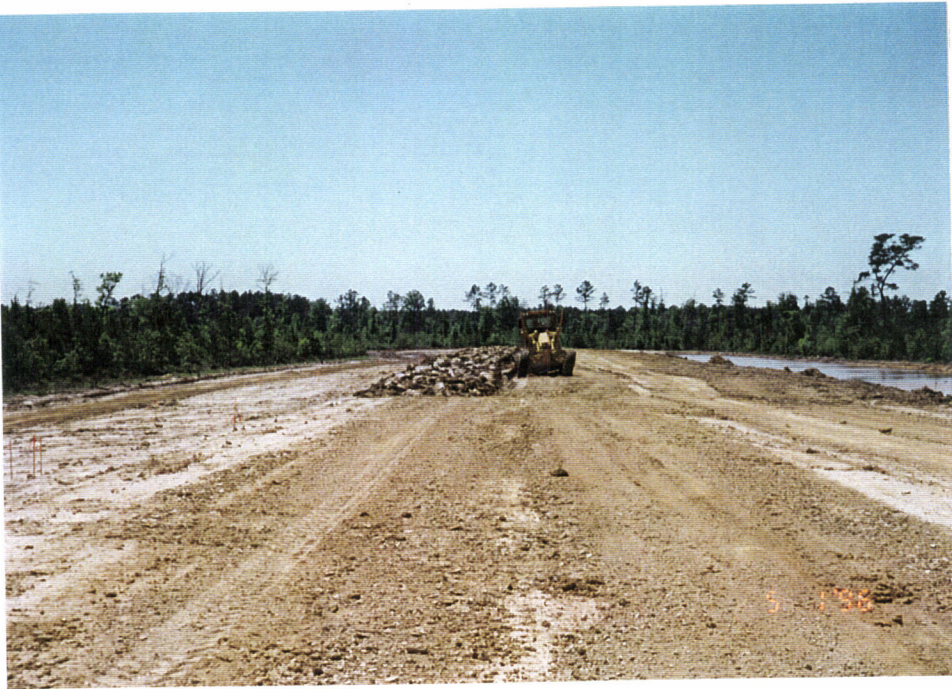
G960122-22-O-P

22. Southeast arm at station 116+00 plowing a low area after rain to dry out soil base for compaction.

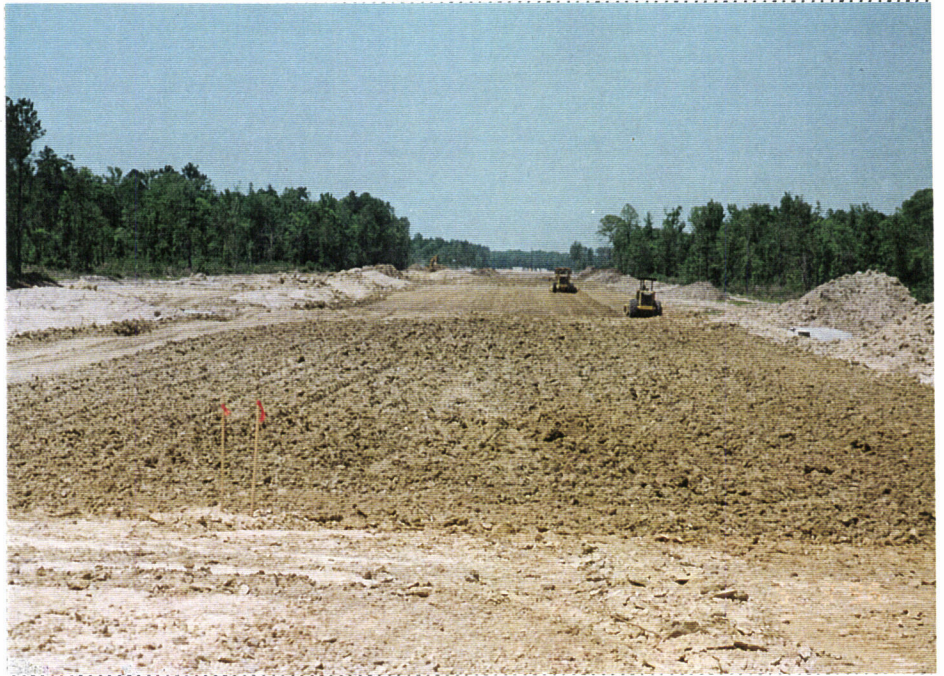
G960122-23-O-P

23. Southeast arm at station 87+00 showing disked material in foreground and compaction in the background.

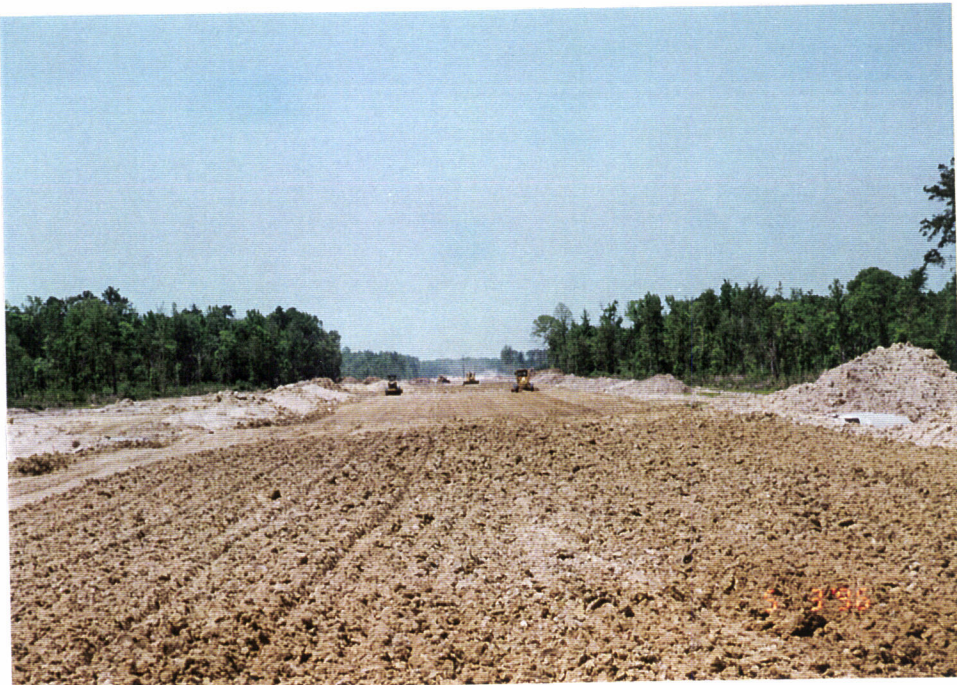
G960122-24-O-PV

24. Southeast arm at station 86+00 showing berm building operation and clear skies.
