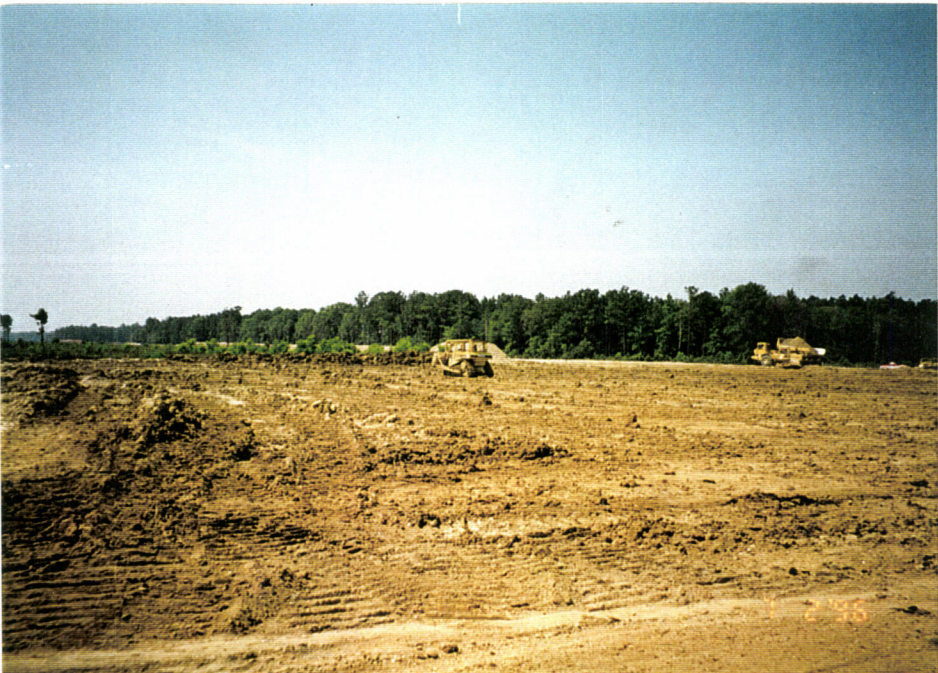
G960154- 01 - O-P

1. Wet material being removed from Southeast side of Corner Station.

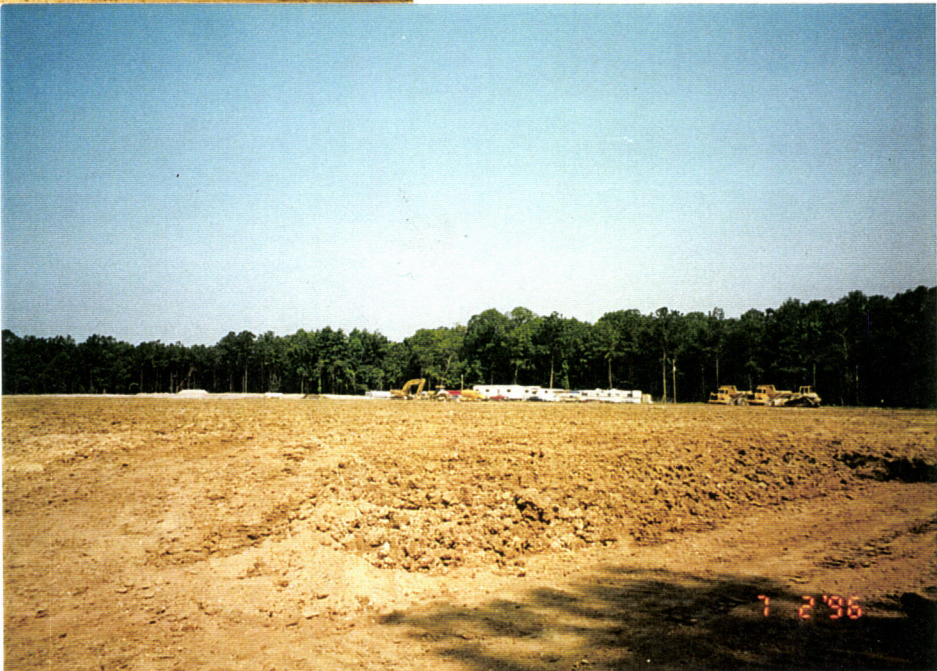
G960154- 02 - O-P

2. View from East side of Corner Station looking Northwest. First lift at grade plowed and disked for drying.

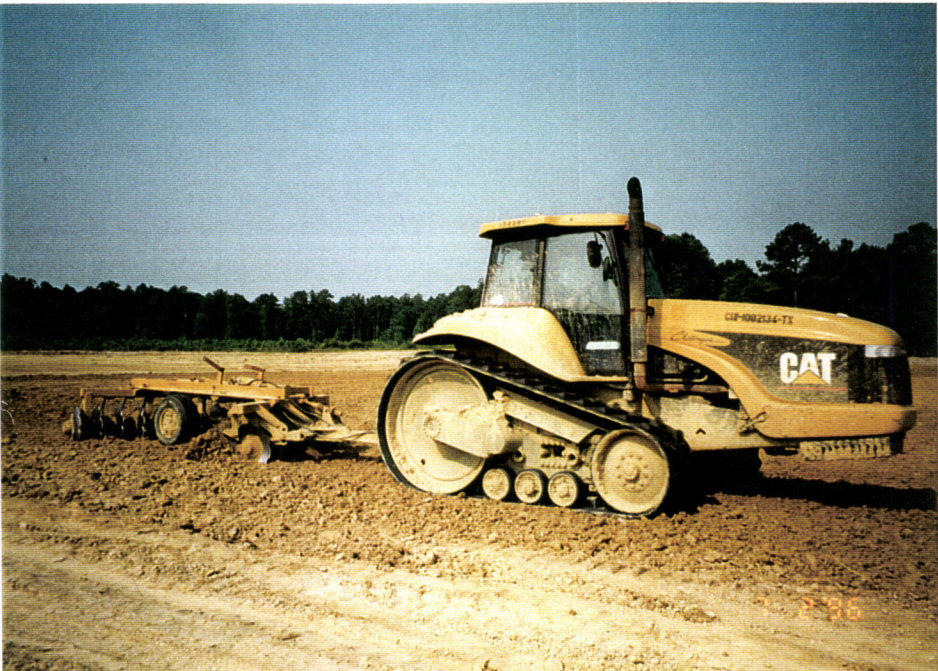
G960154- 03 - O-P

3. Looking West from center of Corner Station. Challenger tractor pulling disk to dry wet soil.

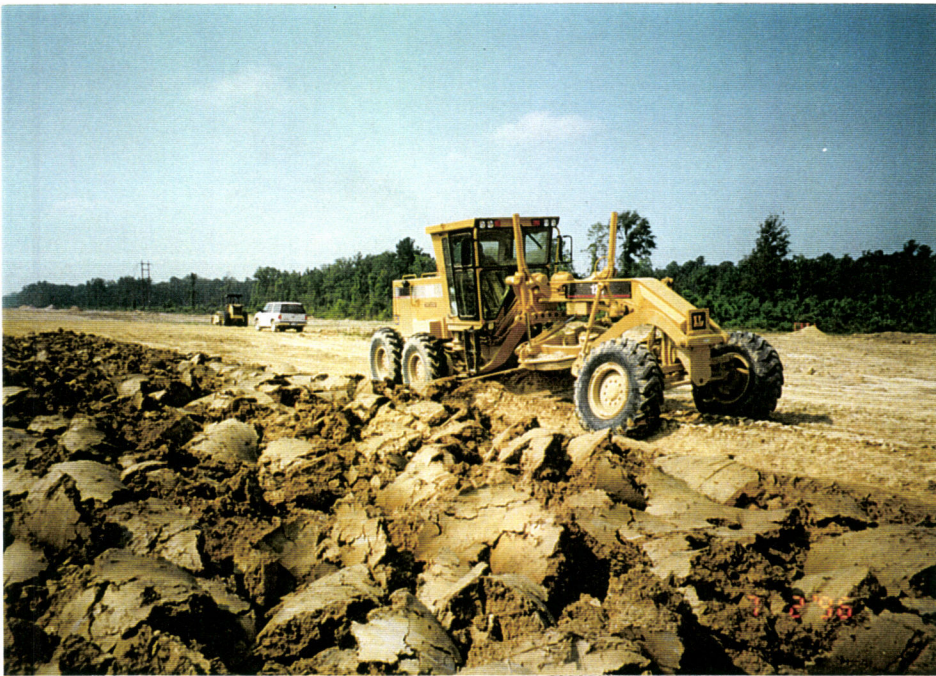
G960154- 04 - O-P

4. Motor grader plowing wet fill for drying prior to disking and compacting at Sta. 42+00 on Southeast Arm.

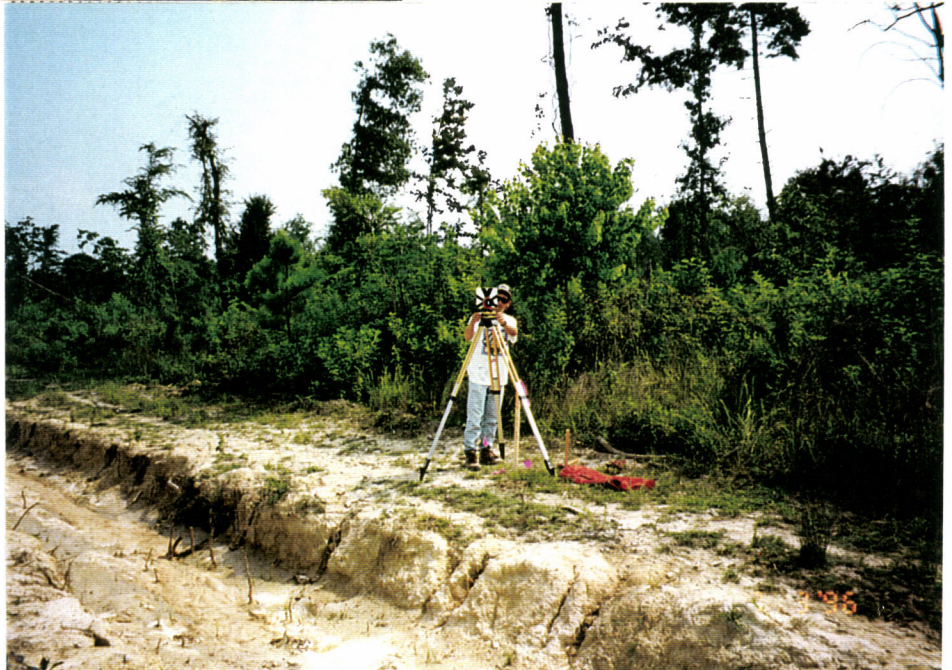
G960154- 05 - O-P

5. ABMB Surveyor on Southeast Arm establishing control points for locating and monitoring fill settlement plates.

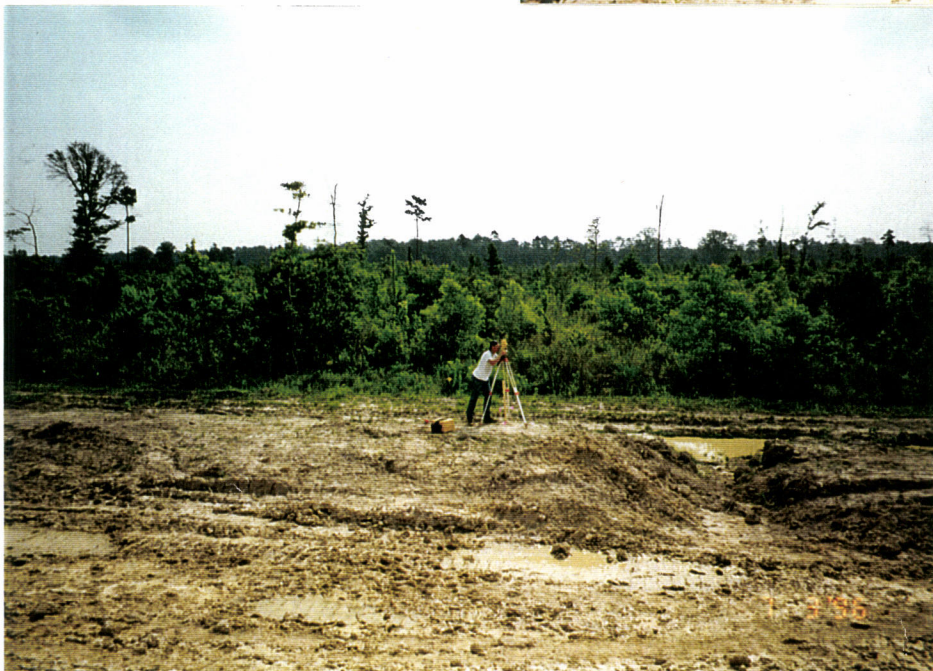
G960154- 06 - O-P

6. ABMB Sureyor on Southeast Arm near Sta. 90+00 establishing control points for locating and monitoring fill settlement plates.

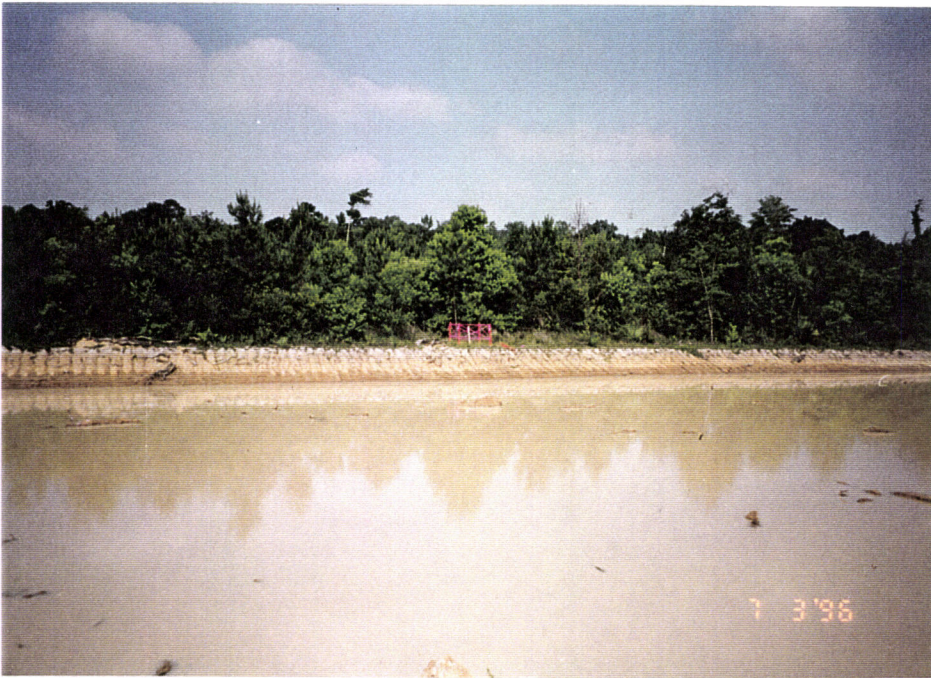
G960154-07 - O-P

7. "Offsite" survey control point on Southeast Arm at Sta. 110+00. (For settlement plate monitoring).

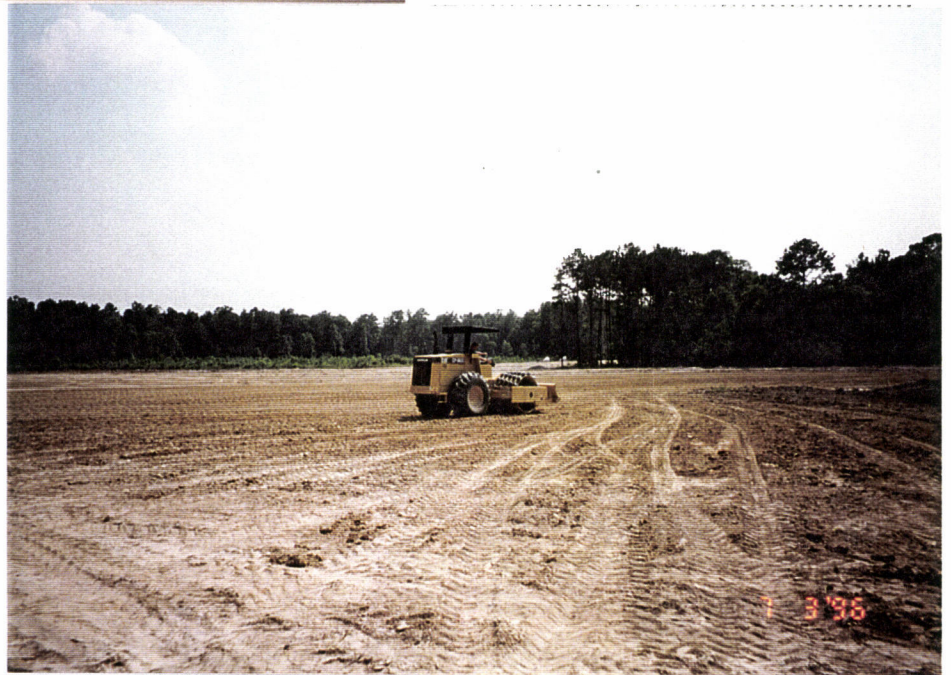
G960154-08 - O-P

8. View from North side of Corner Station looking West. Sheepsfoot roller compacting first lift which has been disked.

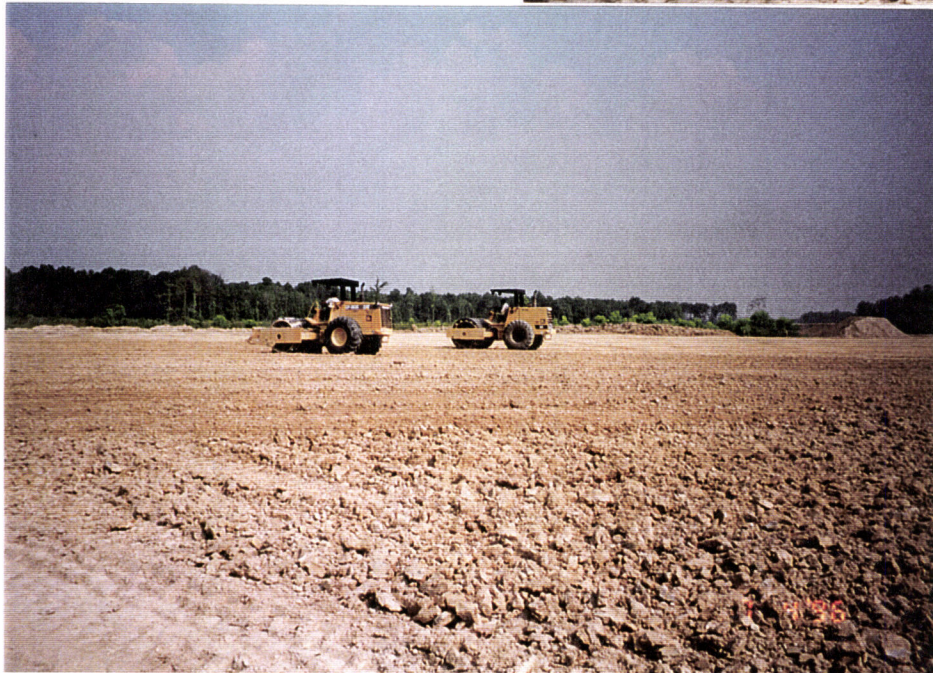
G960154-09 - O-P

9. Disked fill being compacted on Southeast side of Corner Station.

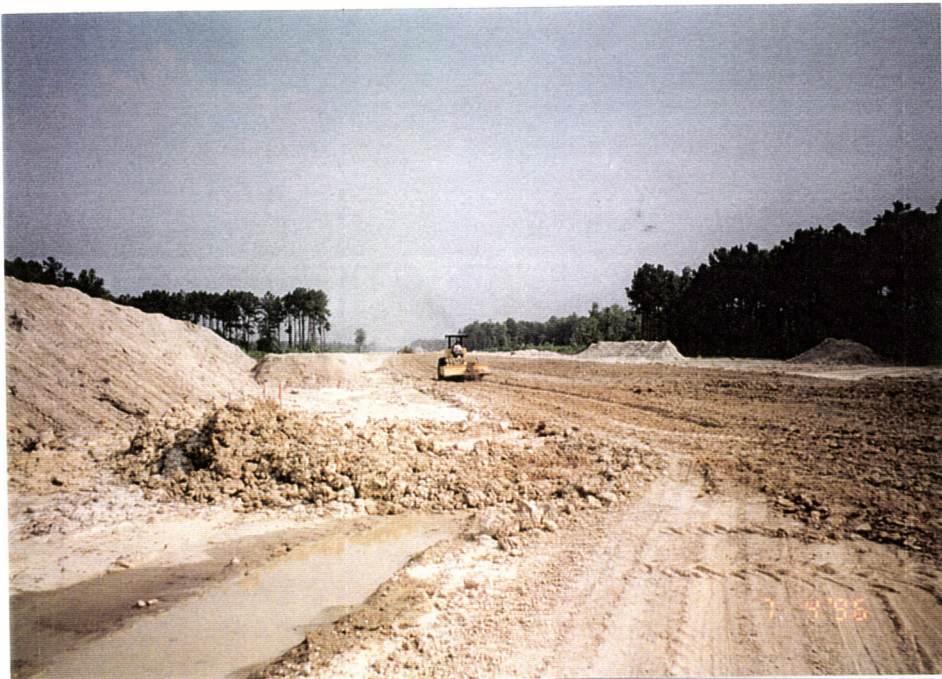
G960154- 10 - O-P

10. View from Sta. 8+00 on Southeast Arm looking South. Plowed and disked fill being compacted..

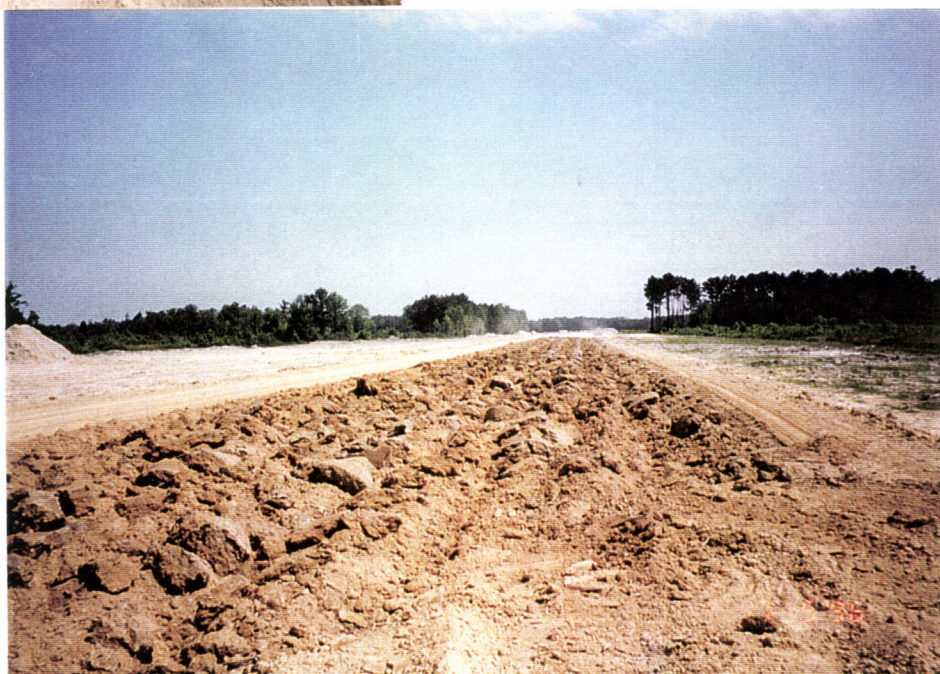
G960154- 11 - O-P

11. Looking North on Southeast Arm at Sta. 40+00. Plowed fill to be disked after further drying.

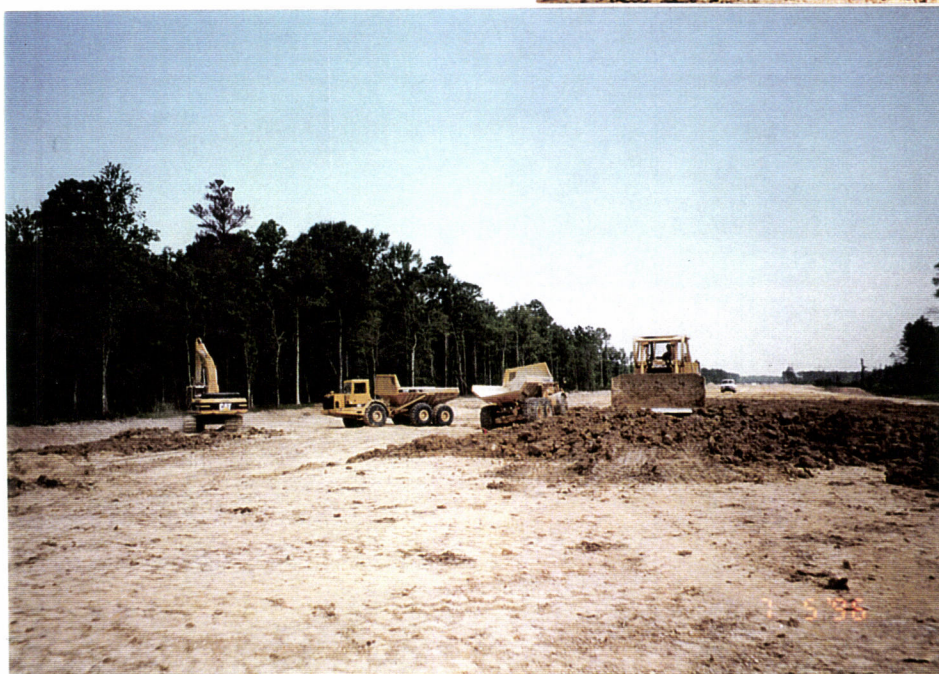
G960154- 12 - O-P

12. Fill being excavated and placed on Southeast Arm at Sta. 80+00.

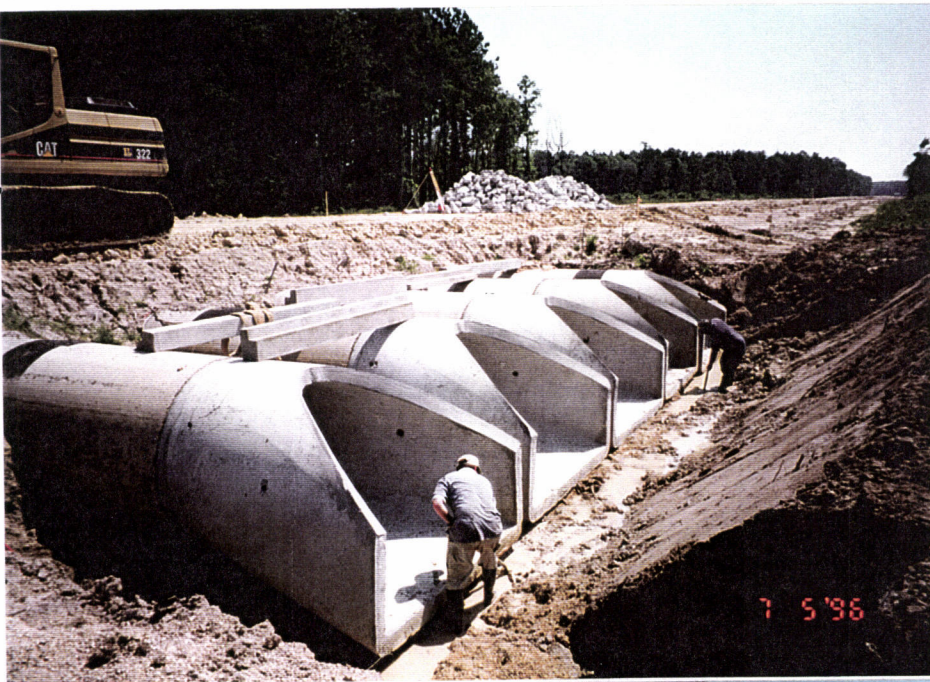
G960154- 13 - O-P

13. Installation of flared ends on 60" culverts at Sta. 44+60 on Southwest Arm.

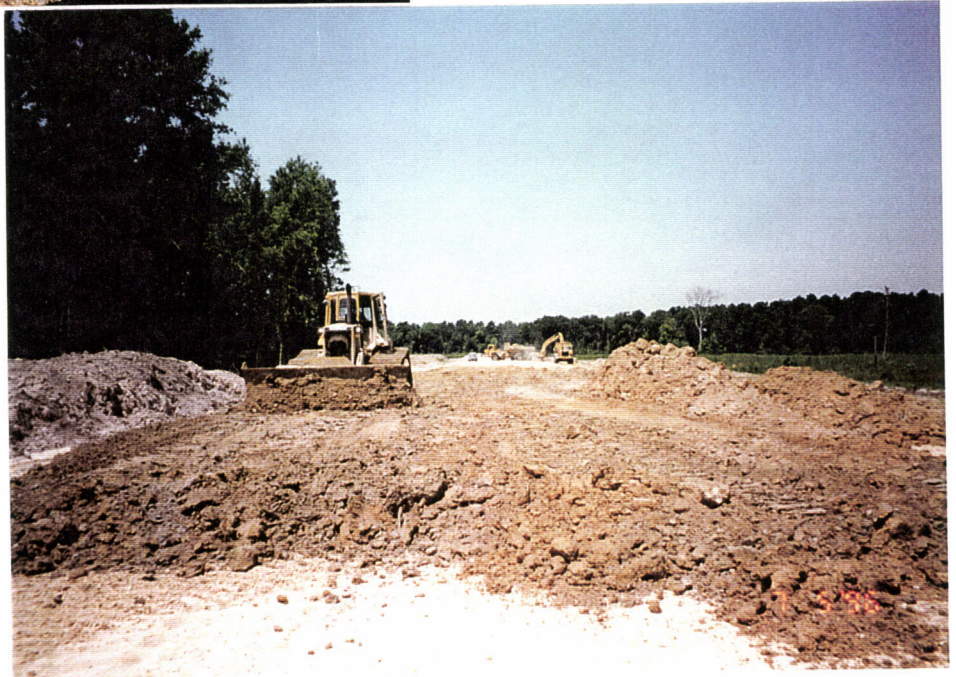
G960154- 14 - O-P

14. Caterpillar dozer spreading fill at Sta. 84+00 Southwest Arm.

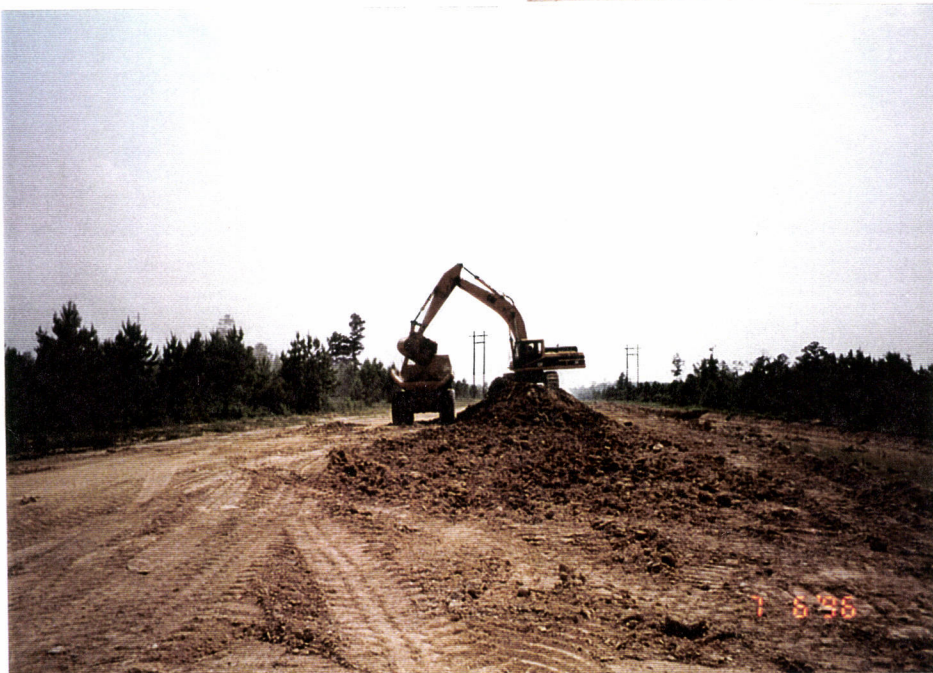
G960154- 15 - O-P

15. Loading fill at Sta. 64+00 on Southwest Arm.

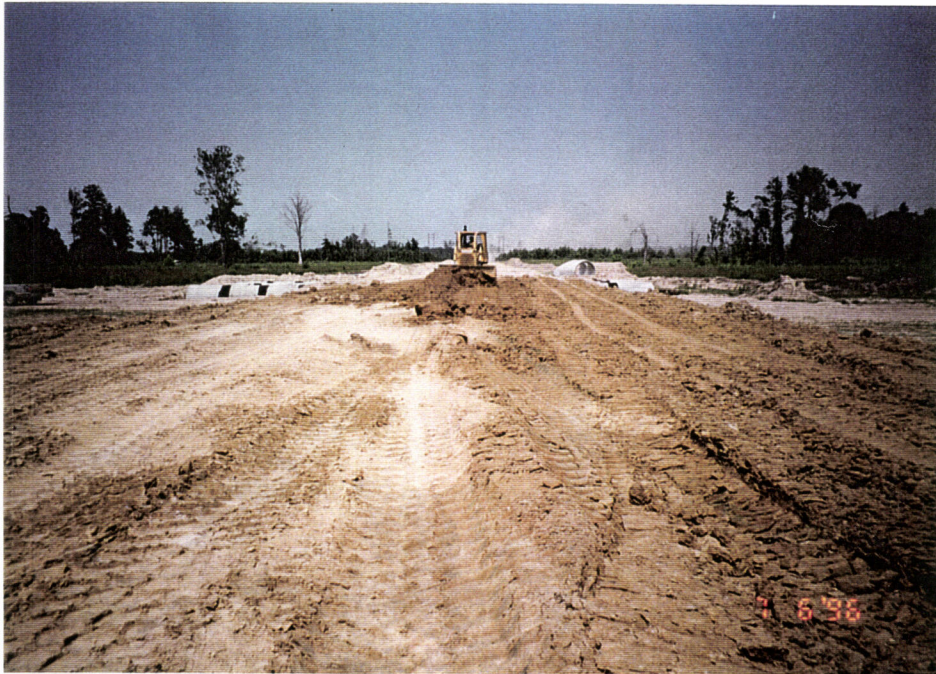
G960154- 16 - OP

16. Southwest Arm at Sta. 90+00. Wet fill being plowed for drying.

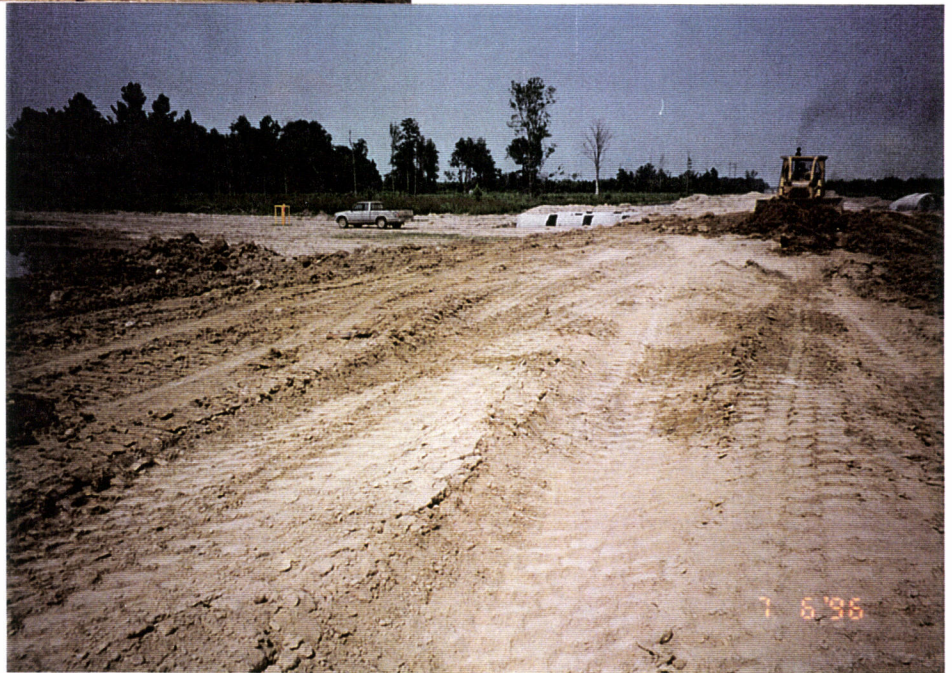
G960154- 17 - OP

17. Southwest Arm at Sta. 90+00. Wet fill being plowed for drying..

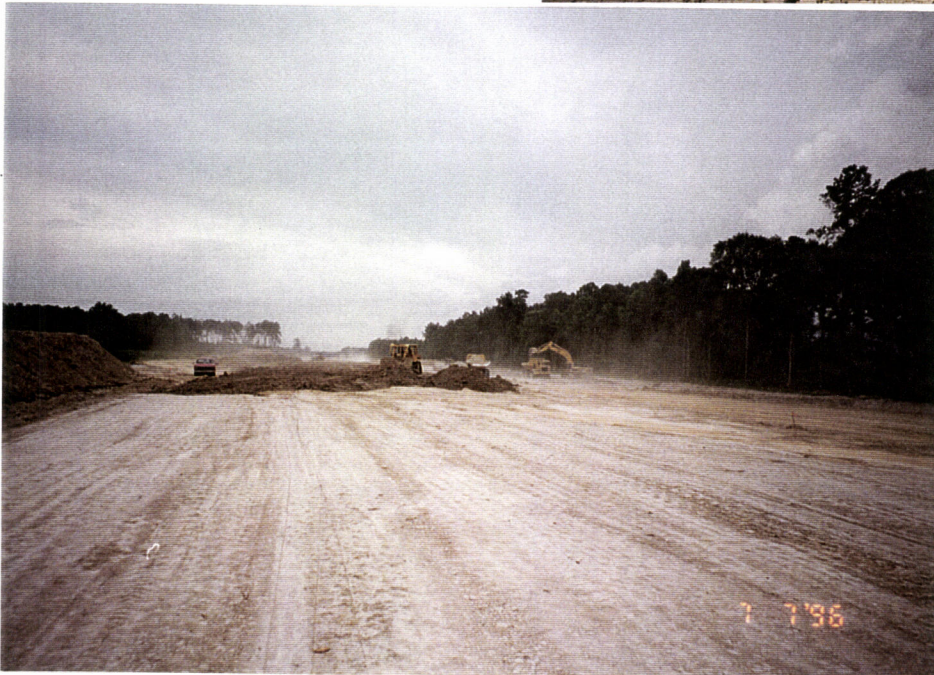
G960154- 18 - OP

18. Depositing and spreading of fill at Sta. 5+00 on Southeast Arm.

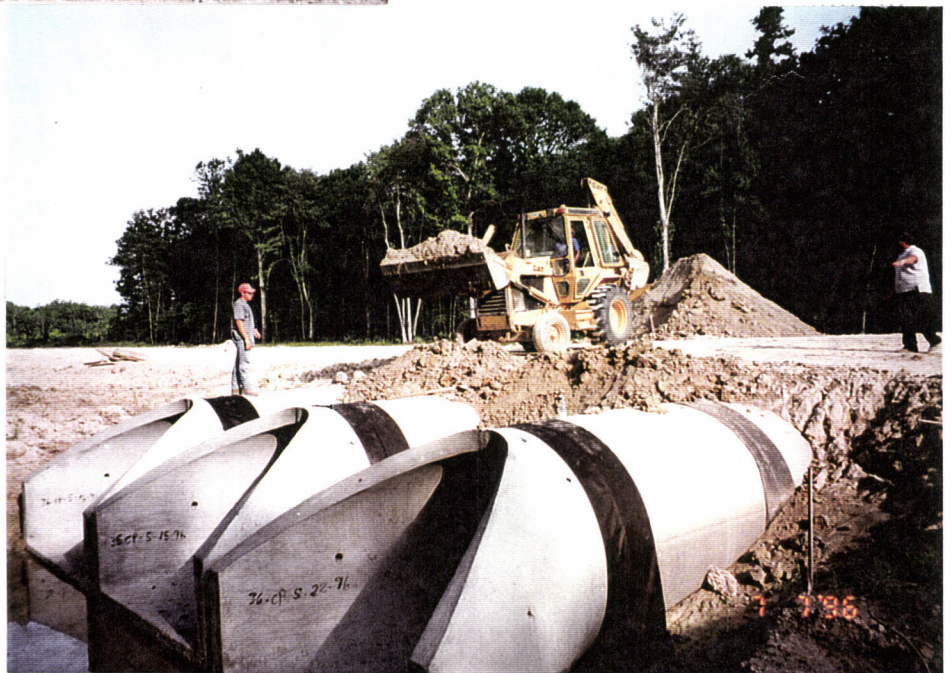
G960154- 20 - O-P

20. Backfilling around
flared ends of 36"
culverts at Sta. 60+00
on Southwest Arm.

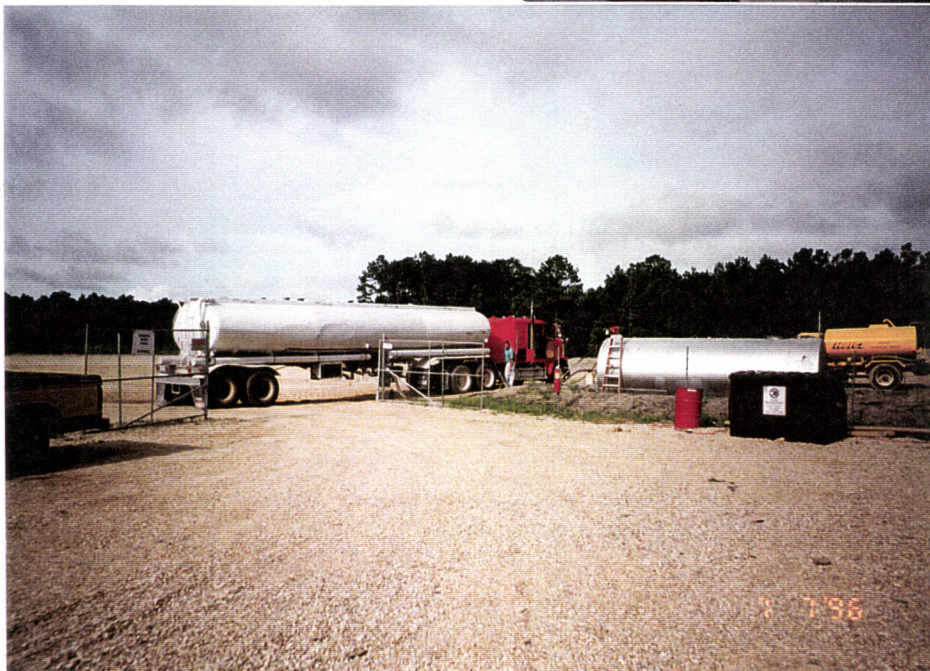
G960154- 21 - O-P

21. Onsite diesel fuel
storage tank being
refilled.

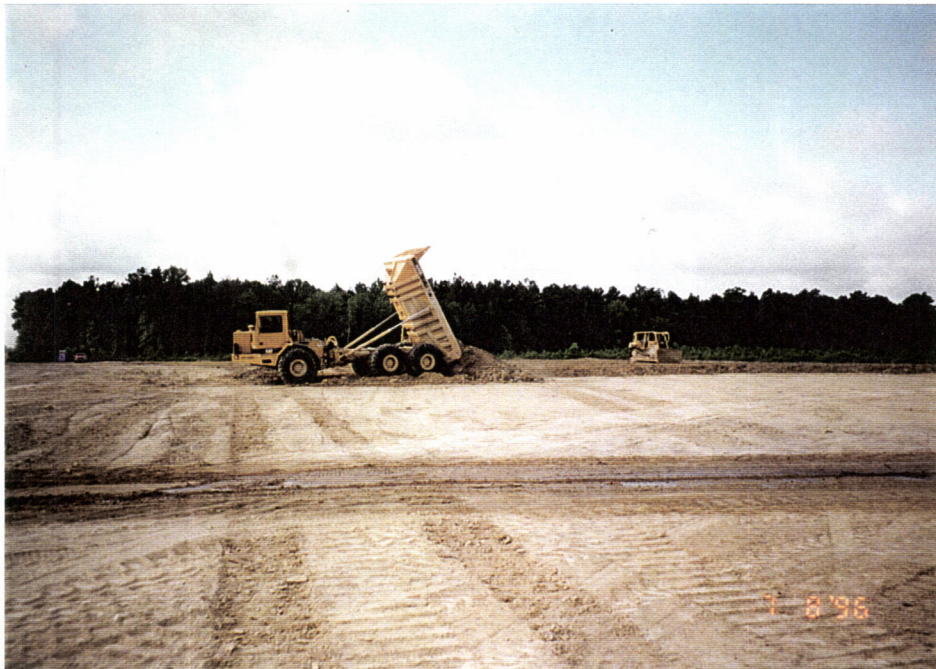
G960154- 22 - O-P

22. First lift above grade being deposited and spread on Southwest side of Corner Station.

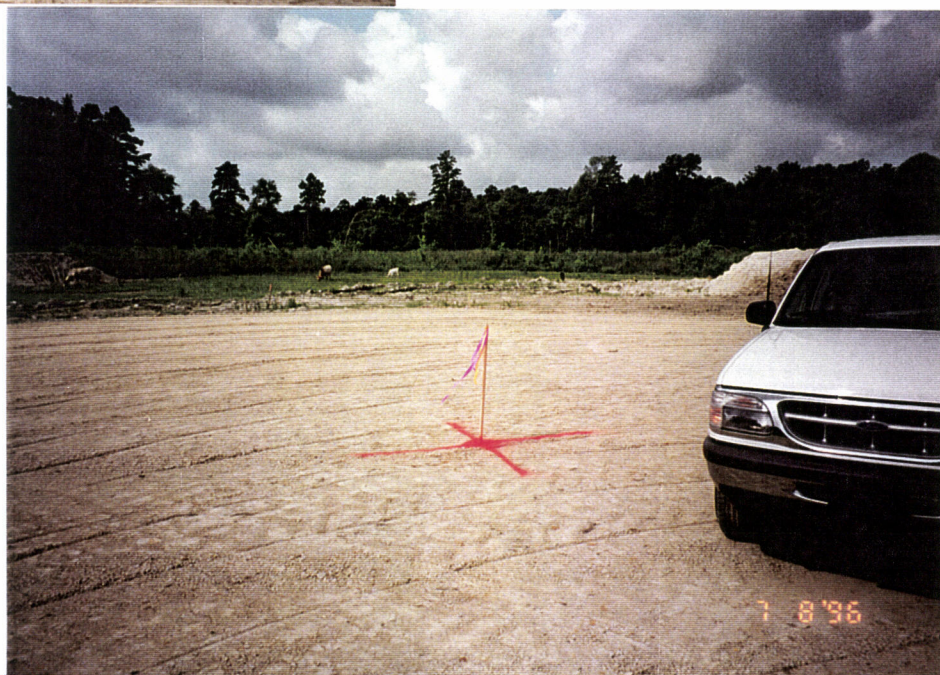
G960154- 23 - O-P

23. Staked location of settlement monitoring plate on Southeast End Station.

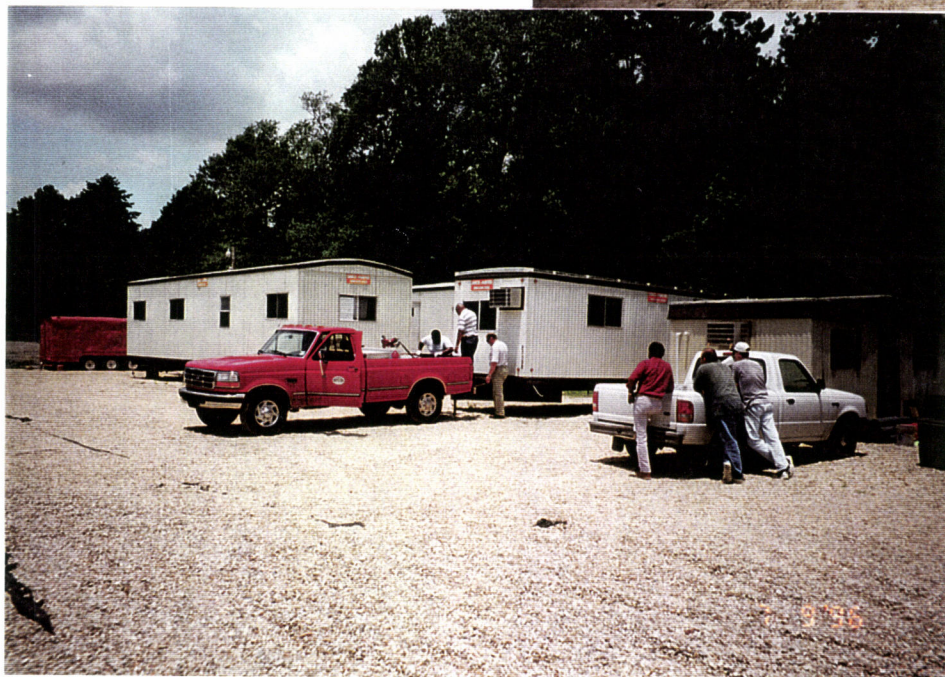
G960154- 24 - O-P

24. Beginning of Stranco demobilization. Storage trailer being removed from site.
