G960156-

Loading MC-250, the first layer of the multiple layer bituminous road surfacing.

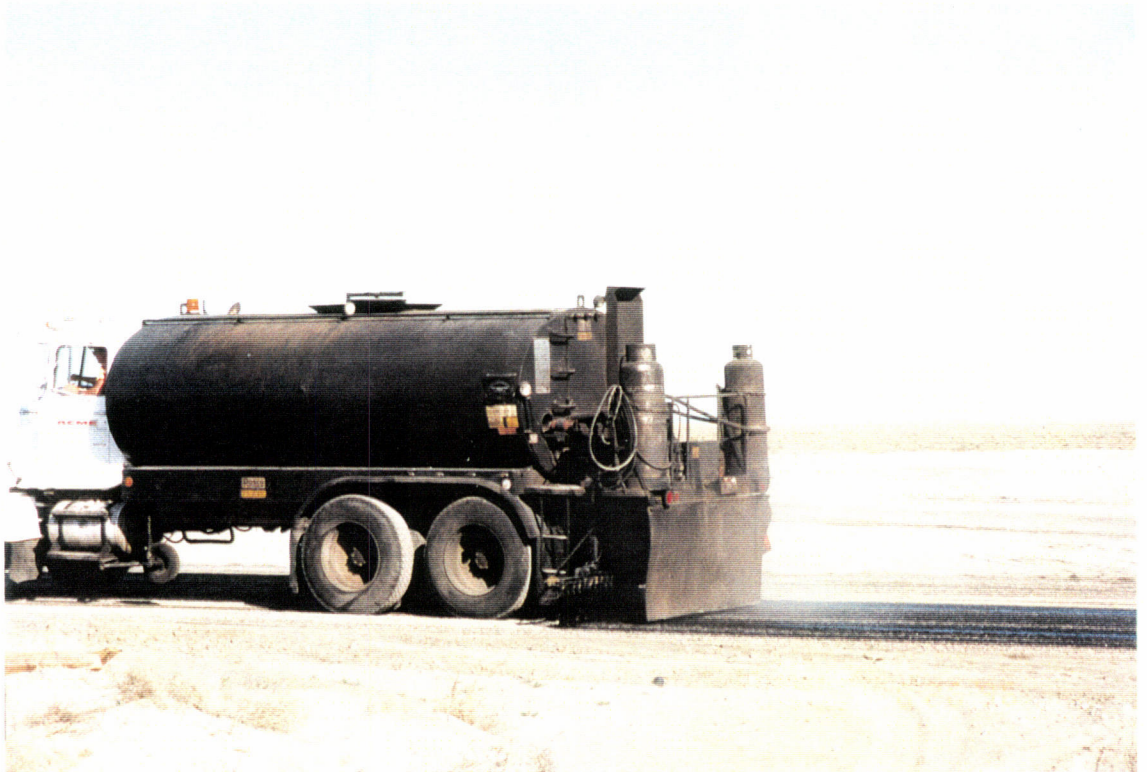
G960156-02-O-PV

Spraying MC- 250 for the temporary access road around the Corner Station.

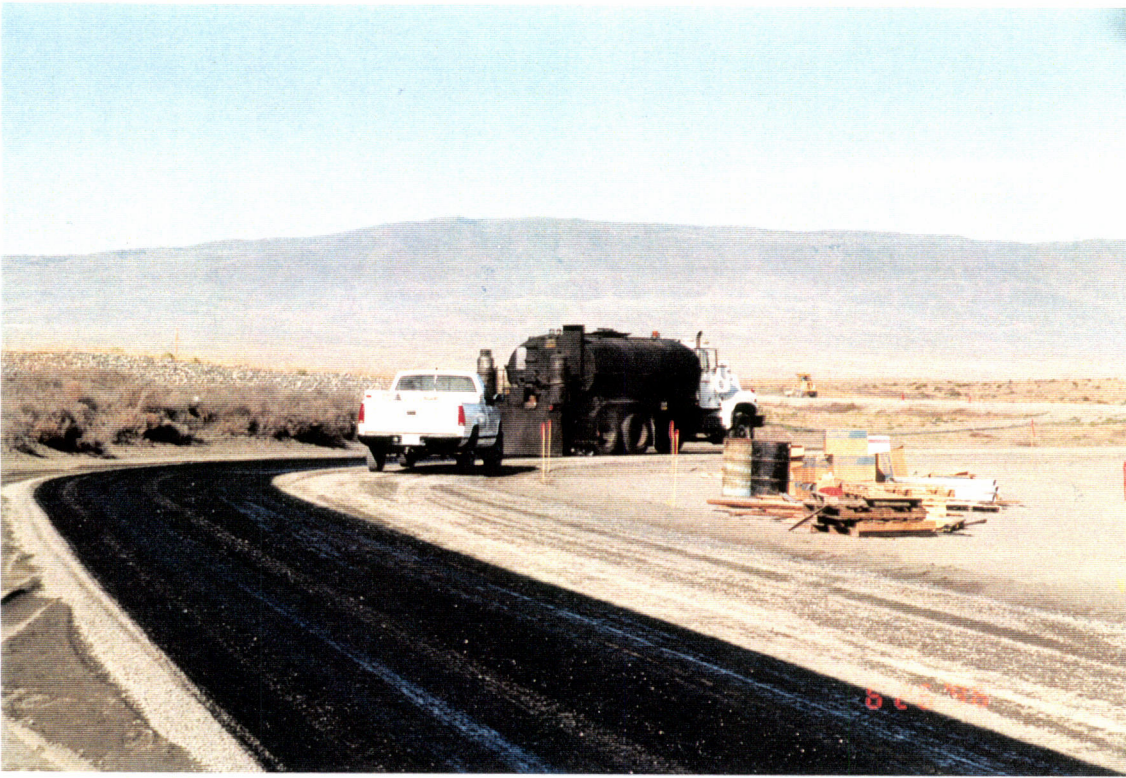
G960156-03 - O-P

MC-250 spraying is continued along the temporary access road

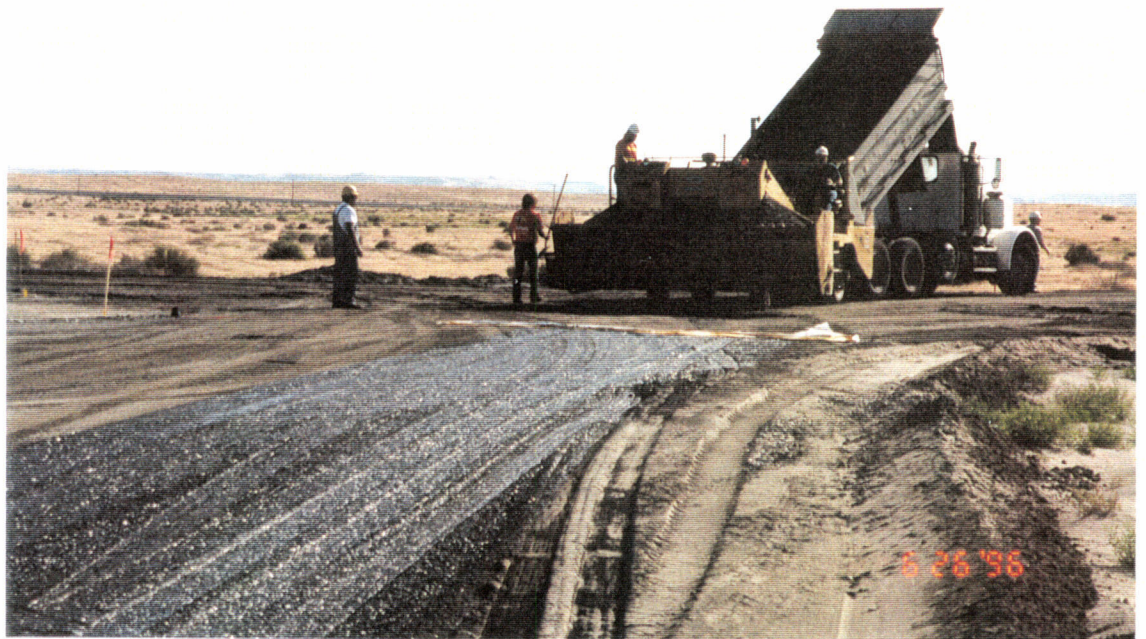
G960156-04 - O-P

Loading the gravel spreader with the first layer of gravel to be placed following the MC-250 application.

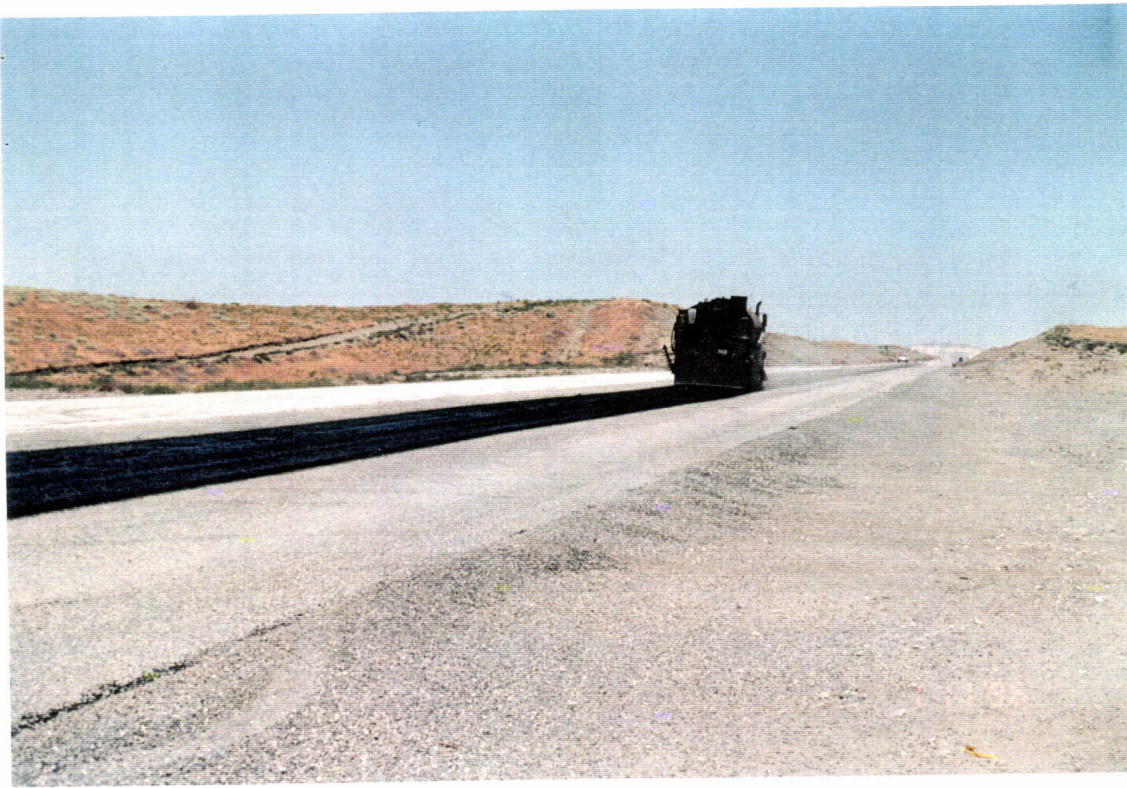
G960156-05 - OP

Spraying CRS-2, the second layer of multiple layer of bituminous road surfacing along the southwest arm.

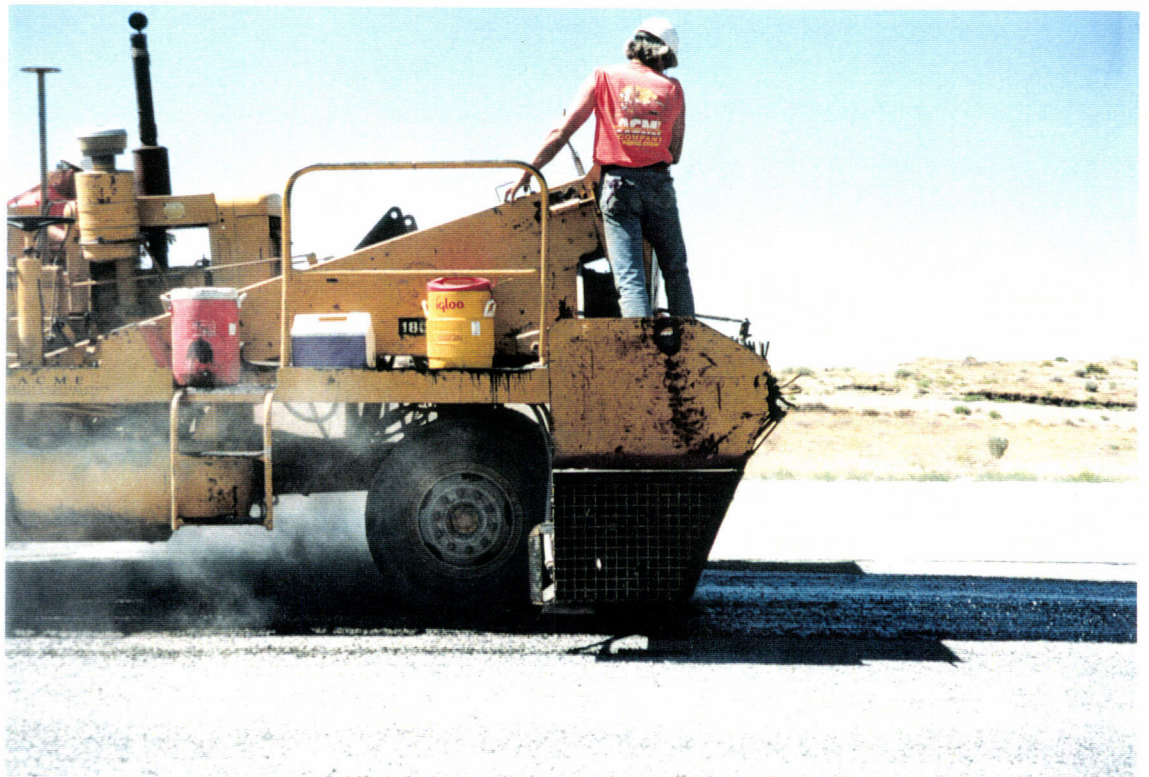
G960156-06 - OP

Following placing the second and final layer of gravel along the southwest arm.

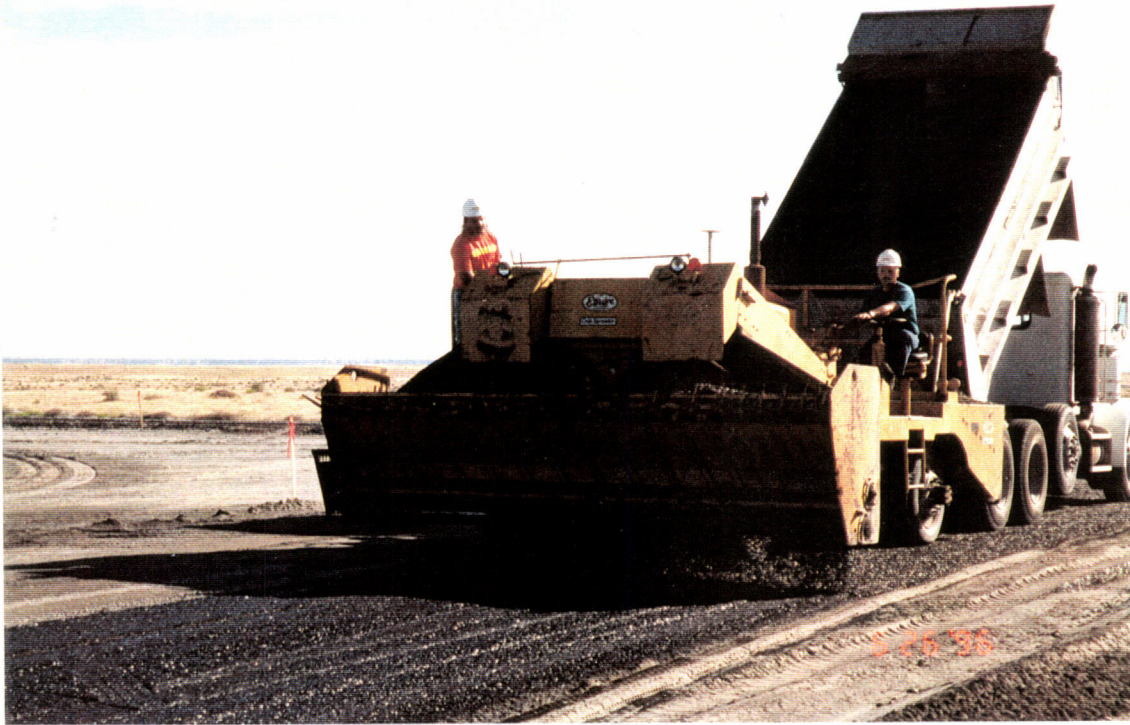
G960156-07 - 0-P

Close up view of the gravel spreading equipment.

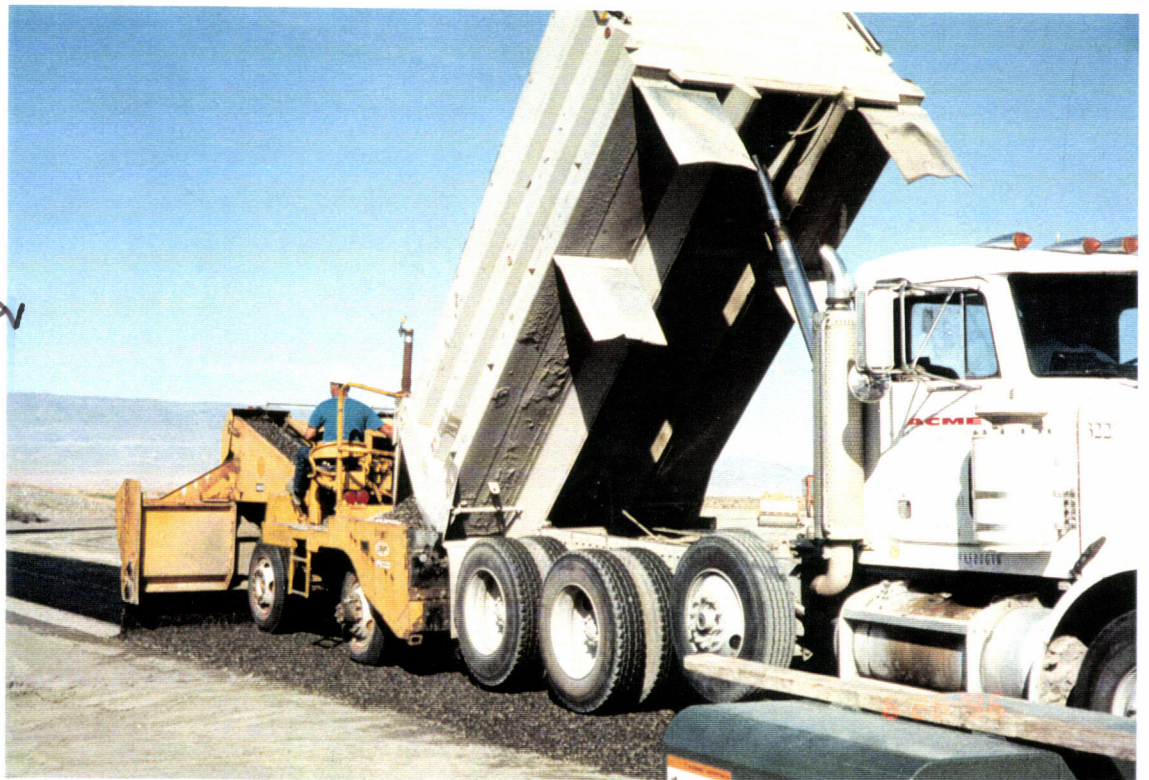
G960156-08 - 0-FV

Another view of the gravel spreading equipment being loaded with gravel.

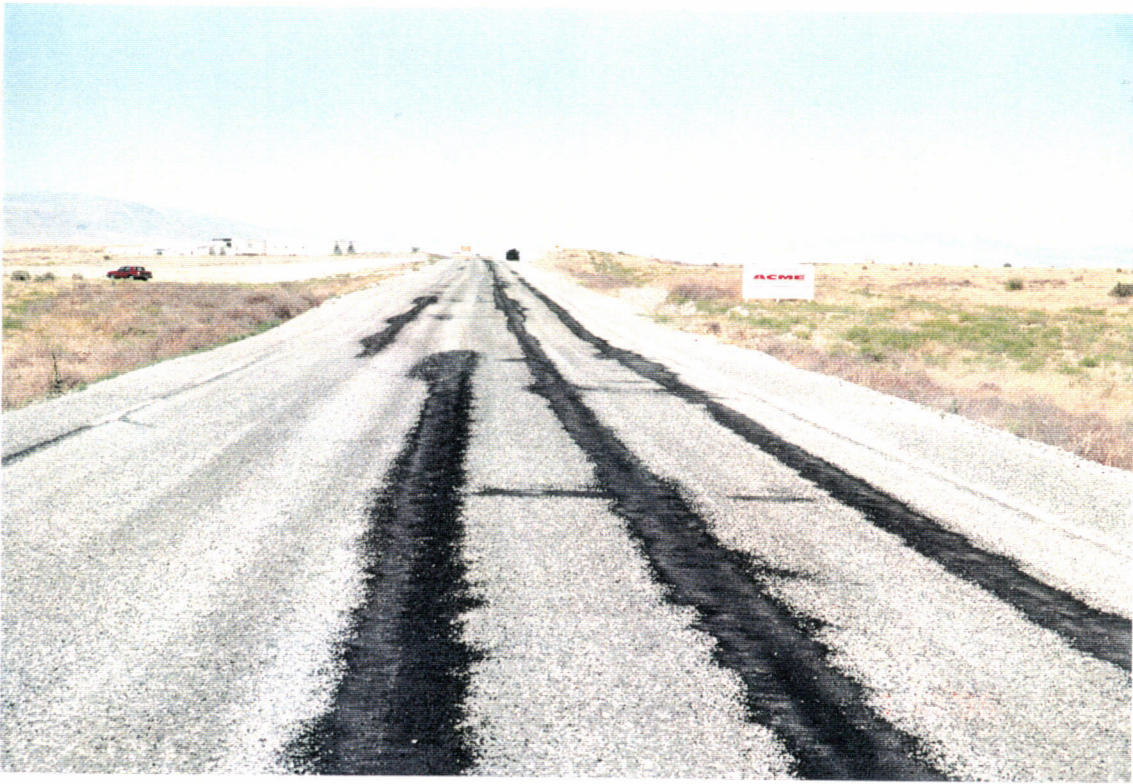
G960156- 09 - 0-P

Remedial work after the placing the first layer of the road surfacing material in areas that were not properly covered with bituminous material.

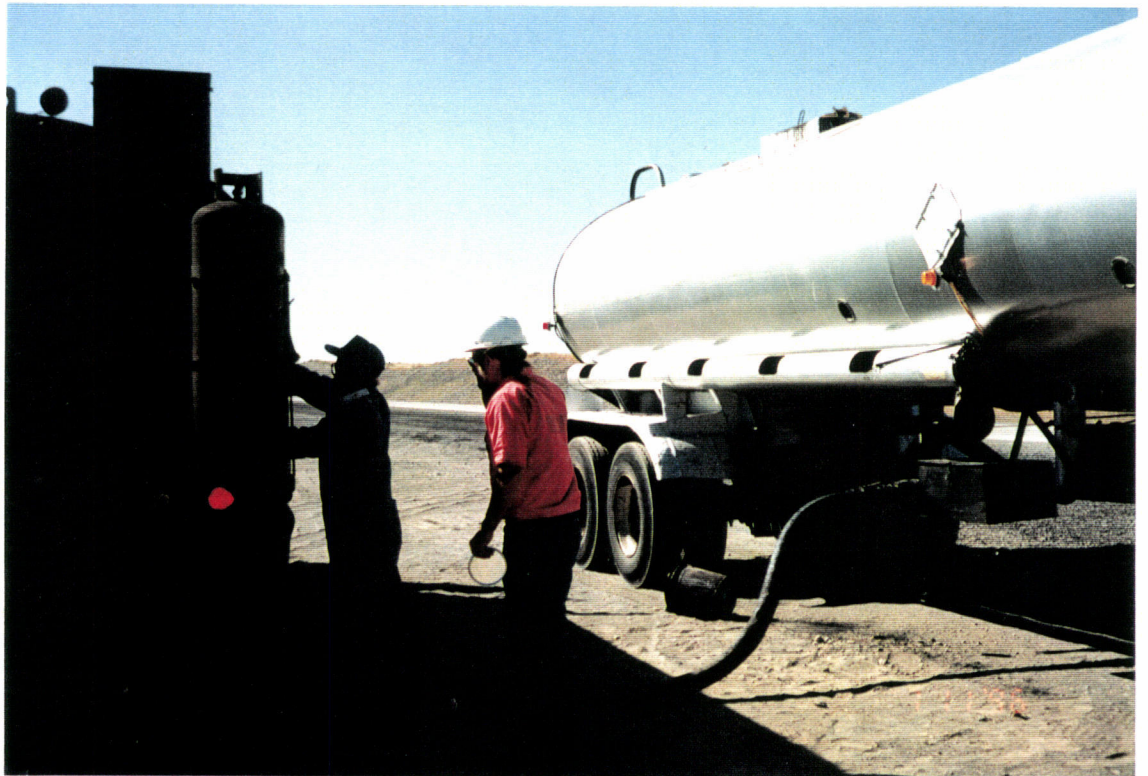
G960156- 10 - 0-P

Sampling the material for future laboratory testing should it become necessary.

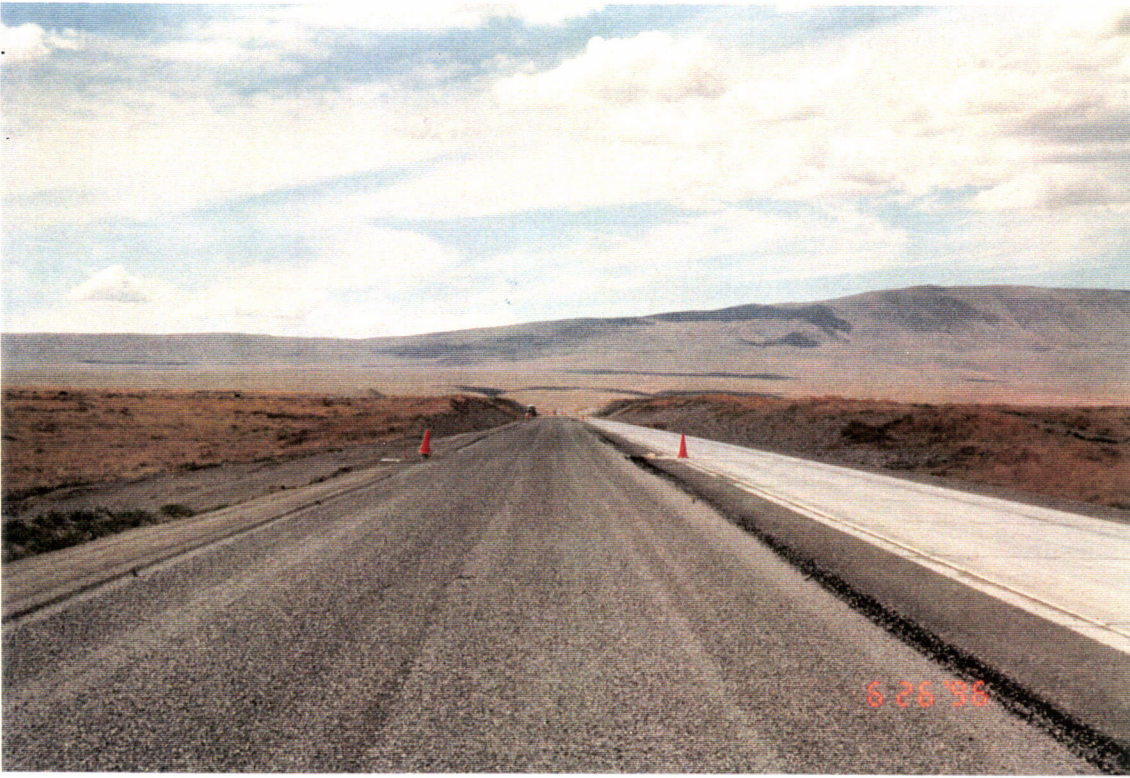
G960156- 11 - O-PV

View of the southwest arm where road surfacing is virtually completed.

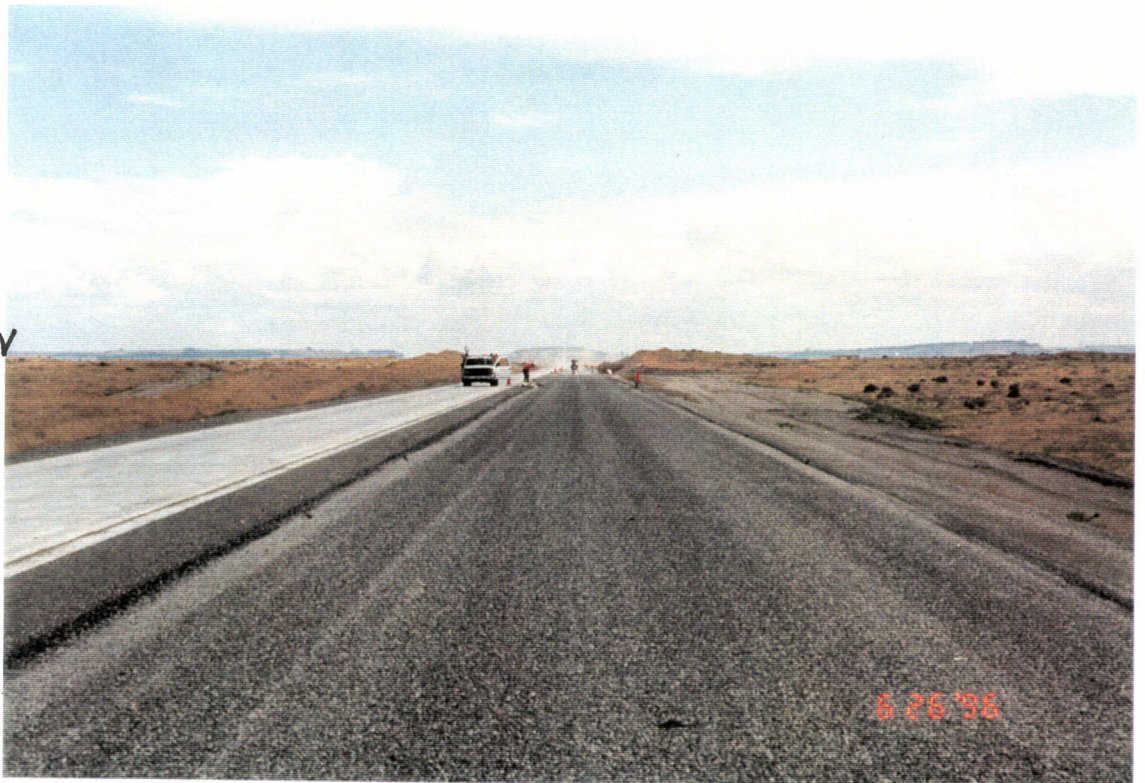
G960156- 12 - O-PV

View of the northwest arm where the road surfacing is virtually completed.

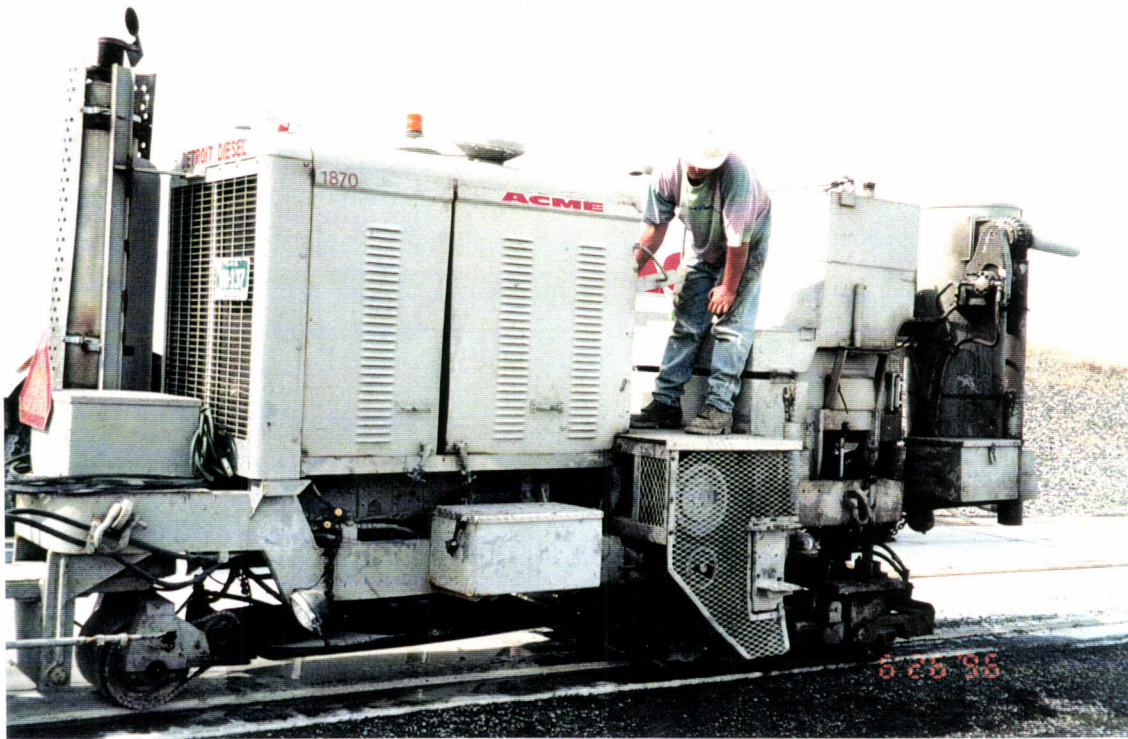
G960156-13 - O-P

Grinding equipment used to verify the proper elevation of the alignment grooves along both arms.

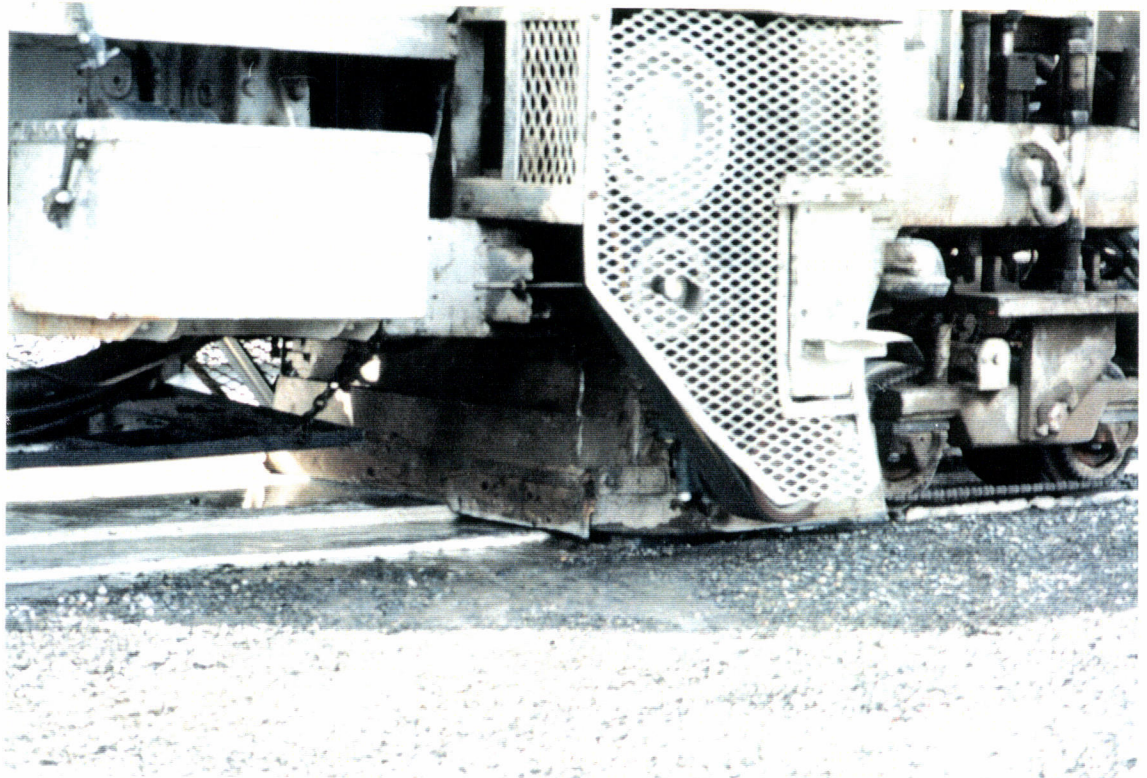
G960156-14 - O-P

Close up view of the grinding equipment that is grinding the alignment groove in areas where the elevation of the alignment groove is out of specification.

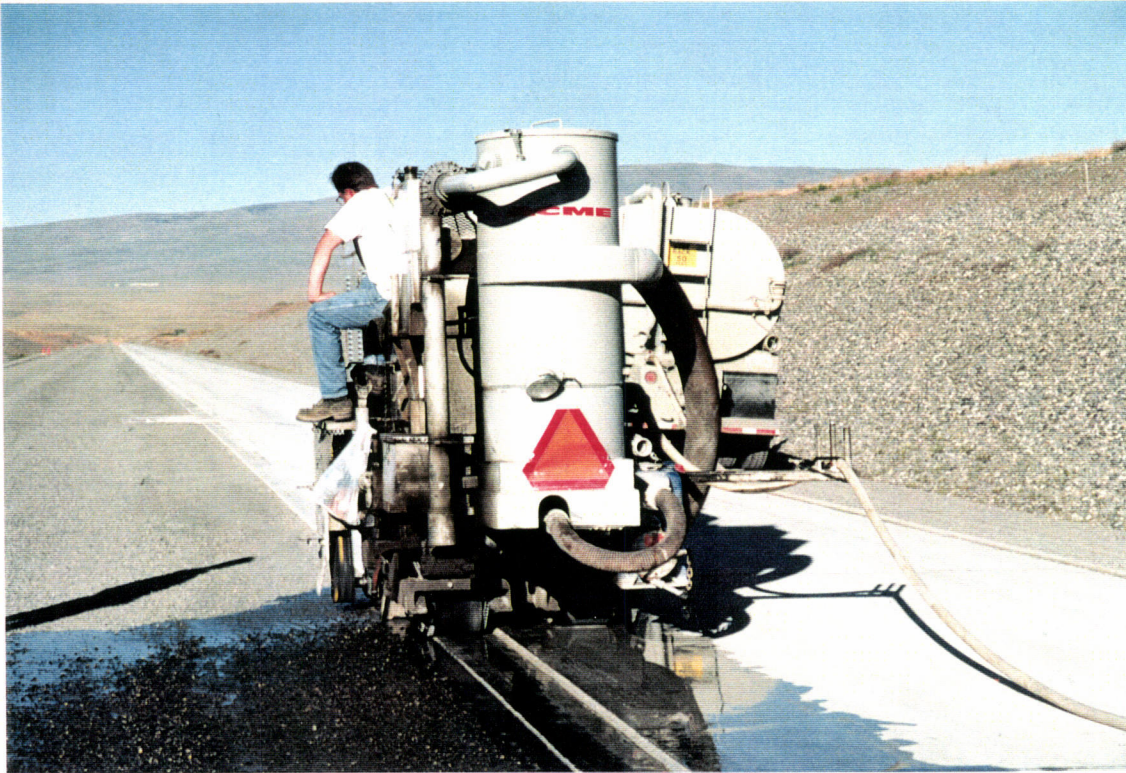
G960156- 15 - 0-PV

Another view of the grinding equipment at work.

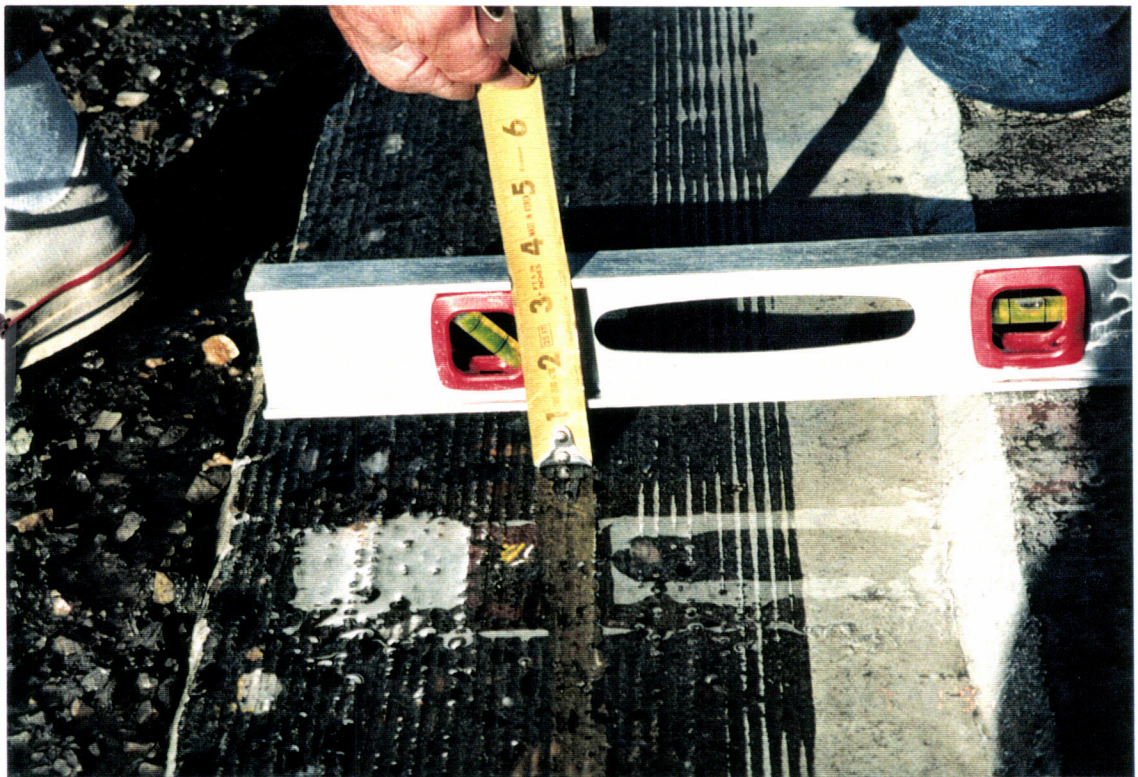
G960156- 16 - 0-PV

View of a section of the alignment groove where the elevation was high.

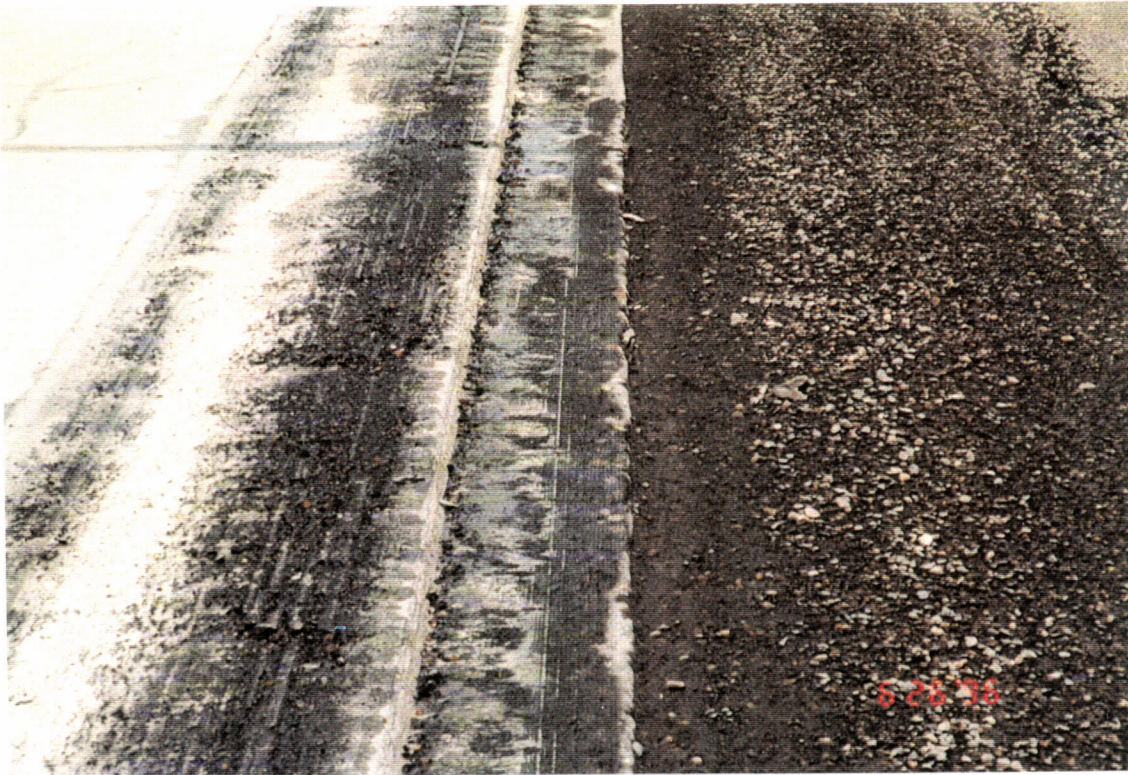
G960156- 17 - OP

View of the alignment groove showing that cutting was limited to the areas where the alignment groove finished elevation was out of tolerance.

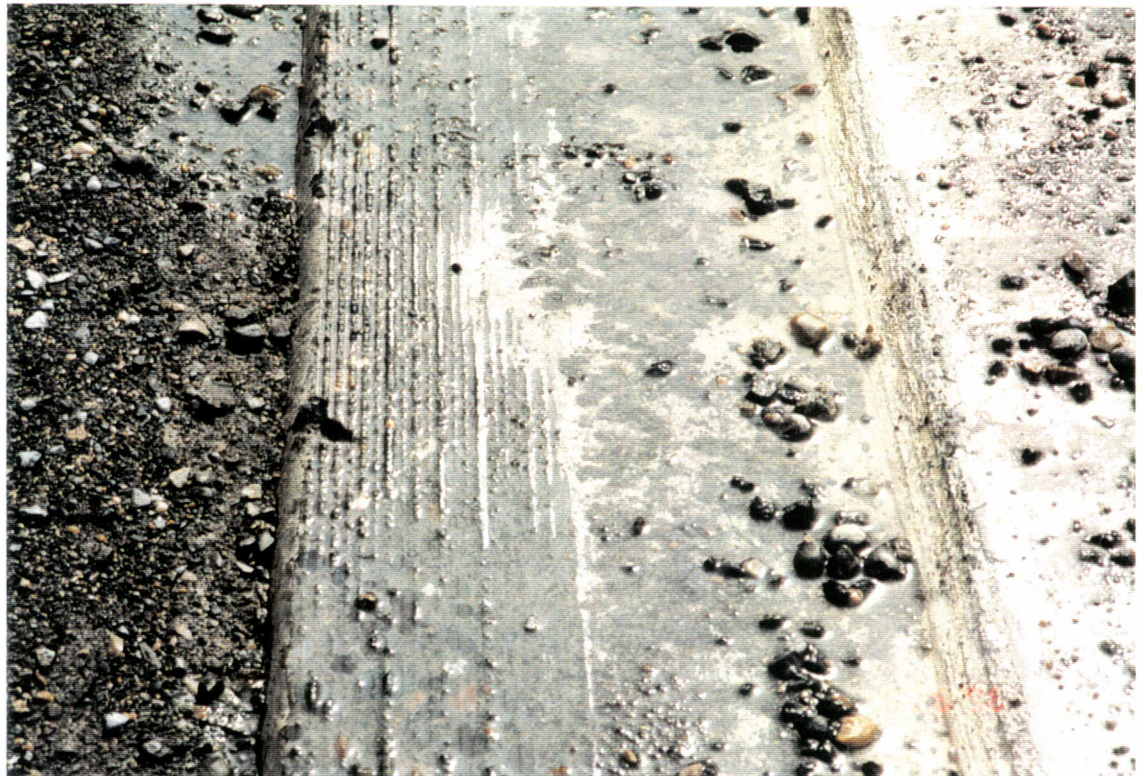
G960156- 18 - OP

Close up view of the grinding ridges.

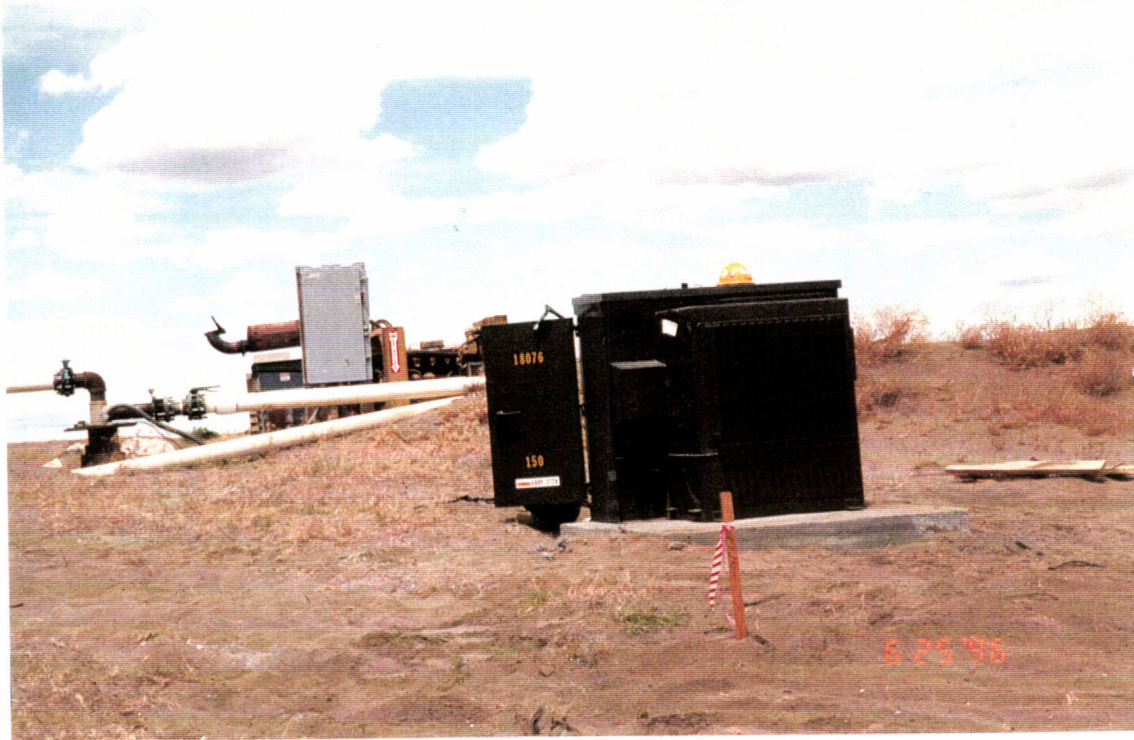
G960156- 19 - O-P

PUD provided and installed 500 kva transformer at the well No. 1.

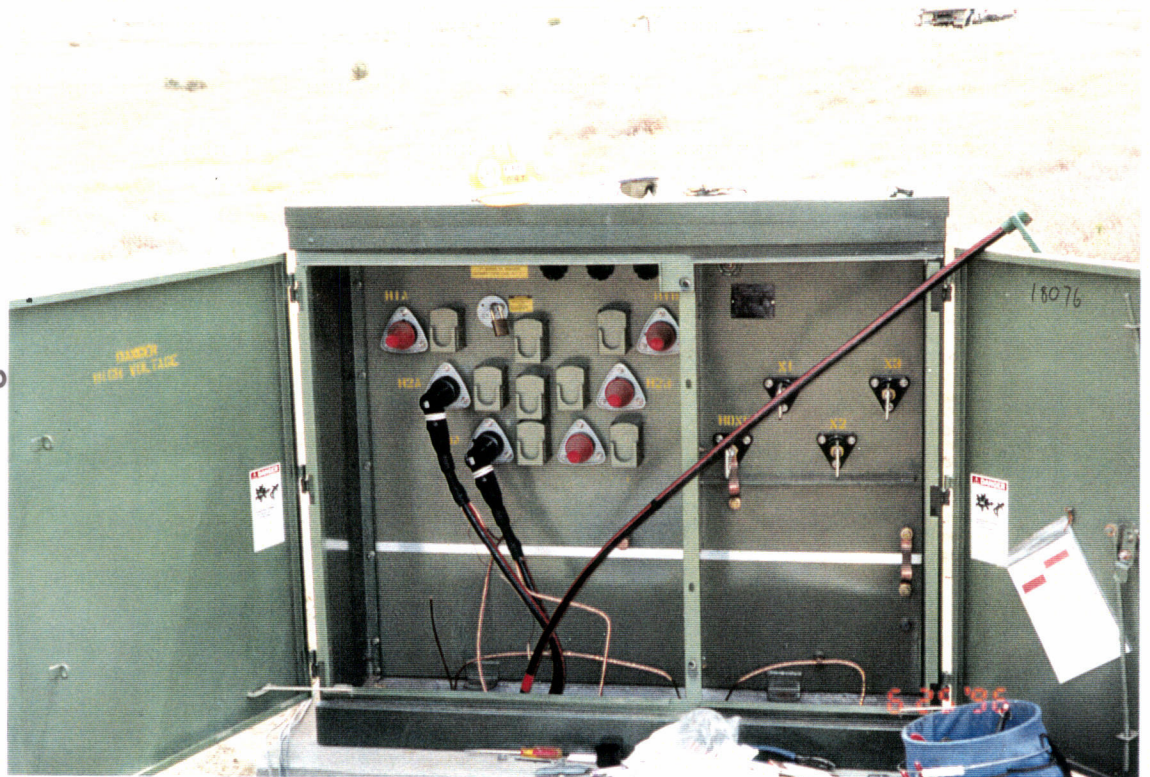
G960156- 20 - O-P

Front view of the PUD provided and installed transformer at well No. 1.

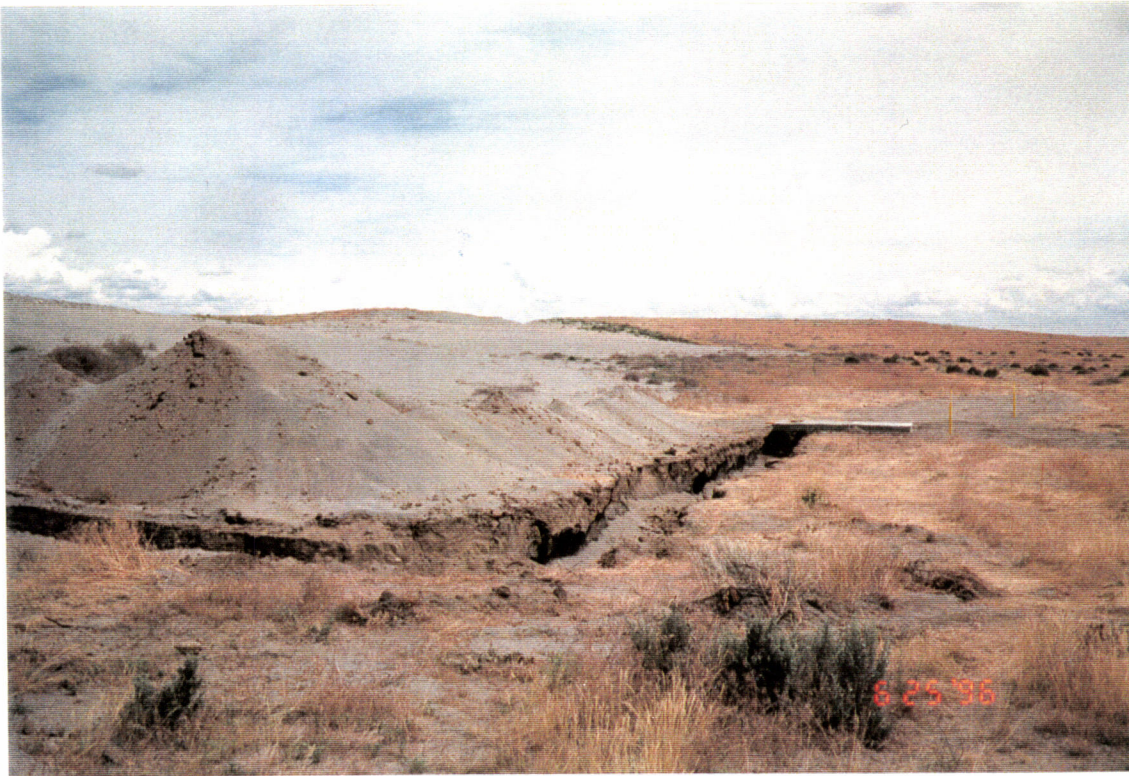
G960156-21 - OP

Duct bank trench for the chiller pad at the southwest arm End Station.

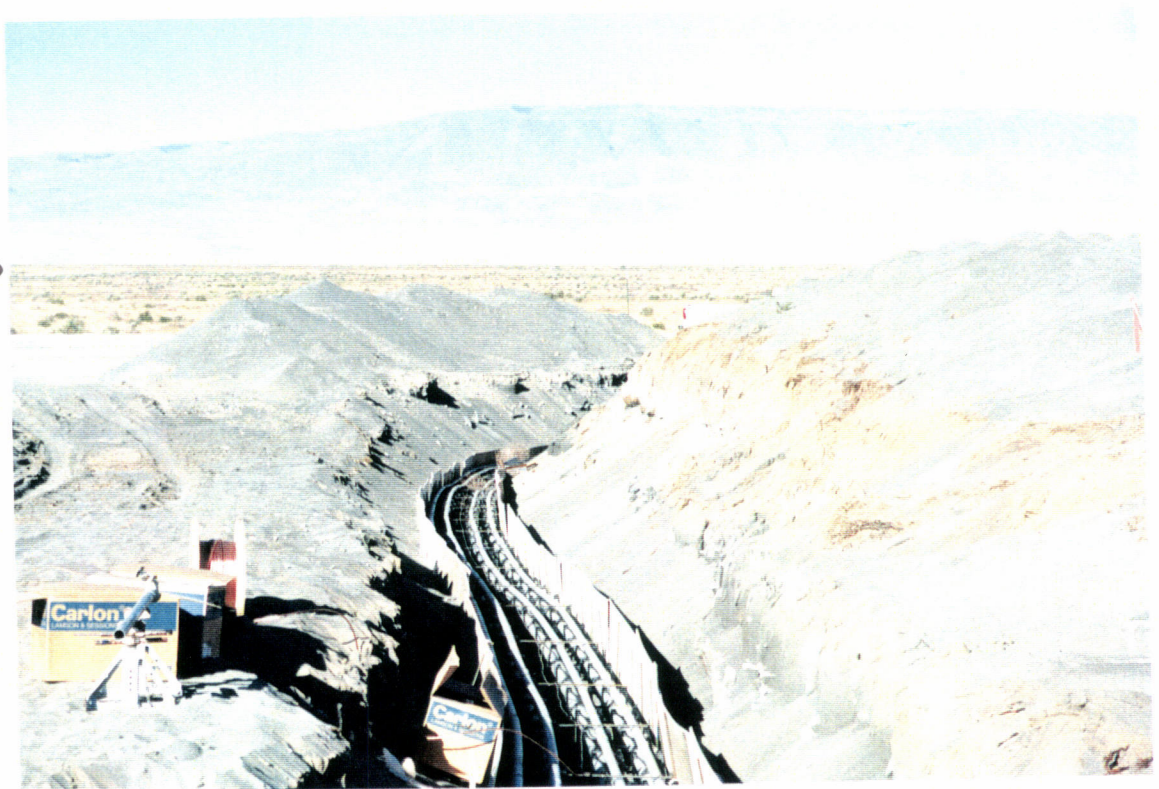
G960156-22 - OP

View of the conduit for the duct bank at the northwest arm End Station.

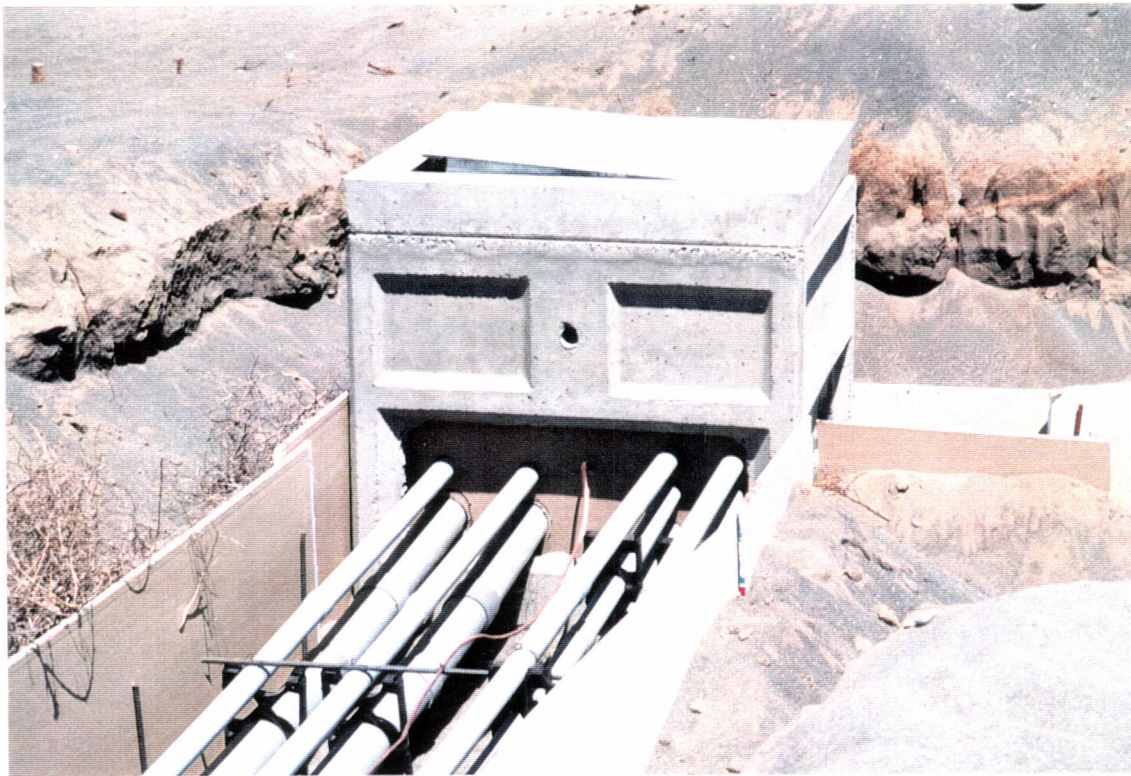
G960156- 23 - 0P

Typical electrical cable pull box and conduit penetration supply side to the southwest arm End Station.

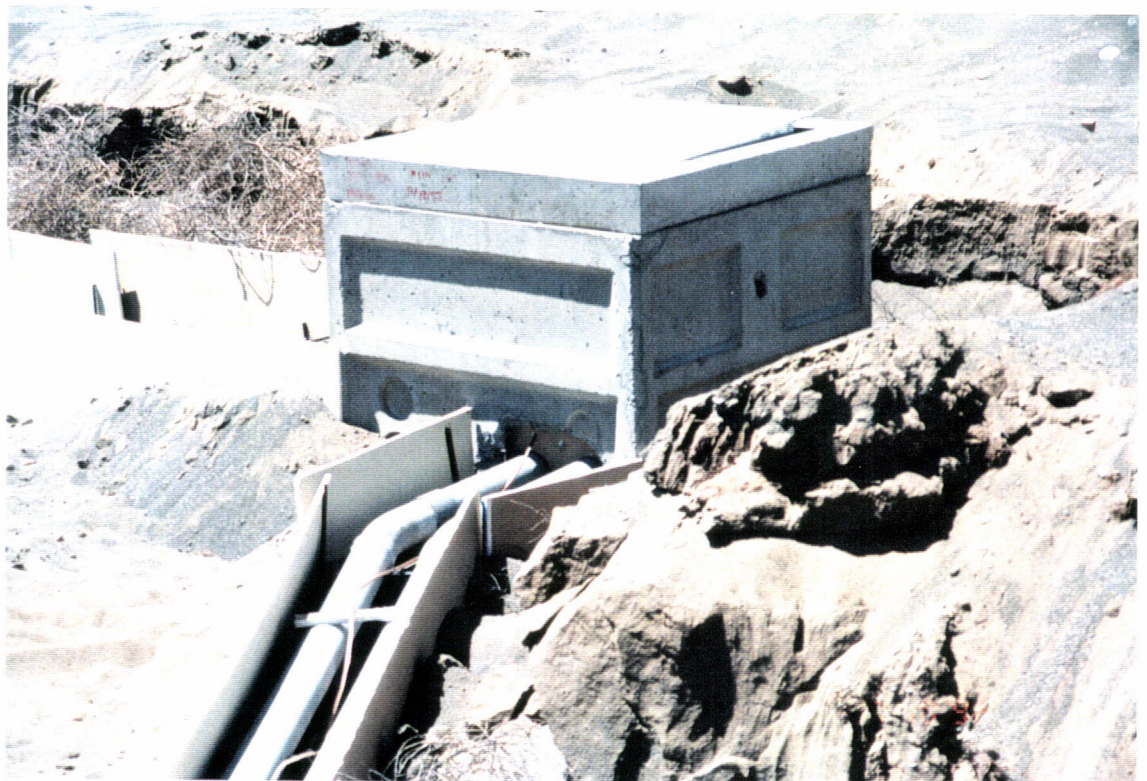
G960156- 24 - 0P

Typical duct bank for the supply power from the transformer to the electrical cable pull box.

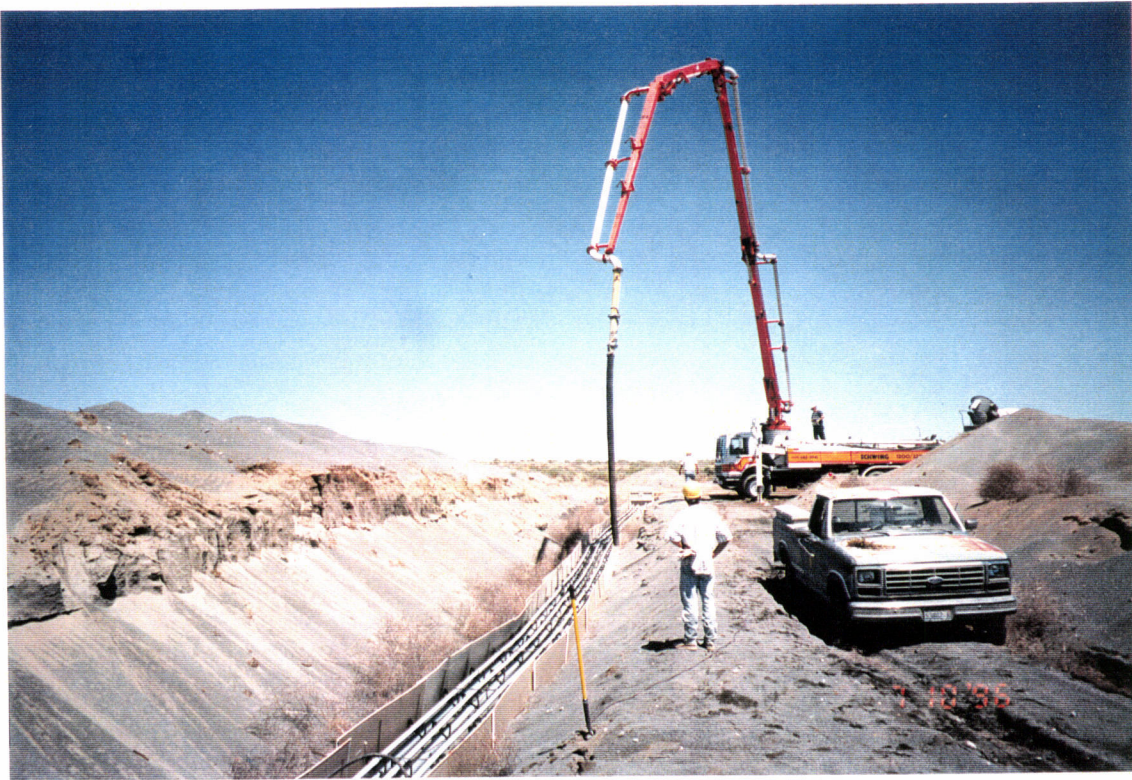
G960156-25 - 09

Placing concrete for the duct bank, in some areas the contractor had to place concrete by utilizing a concrete pump truck because of limited access to the trench area.

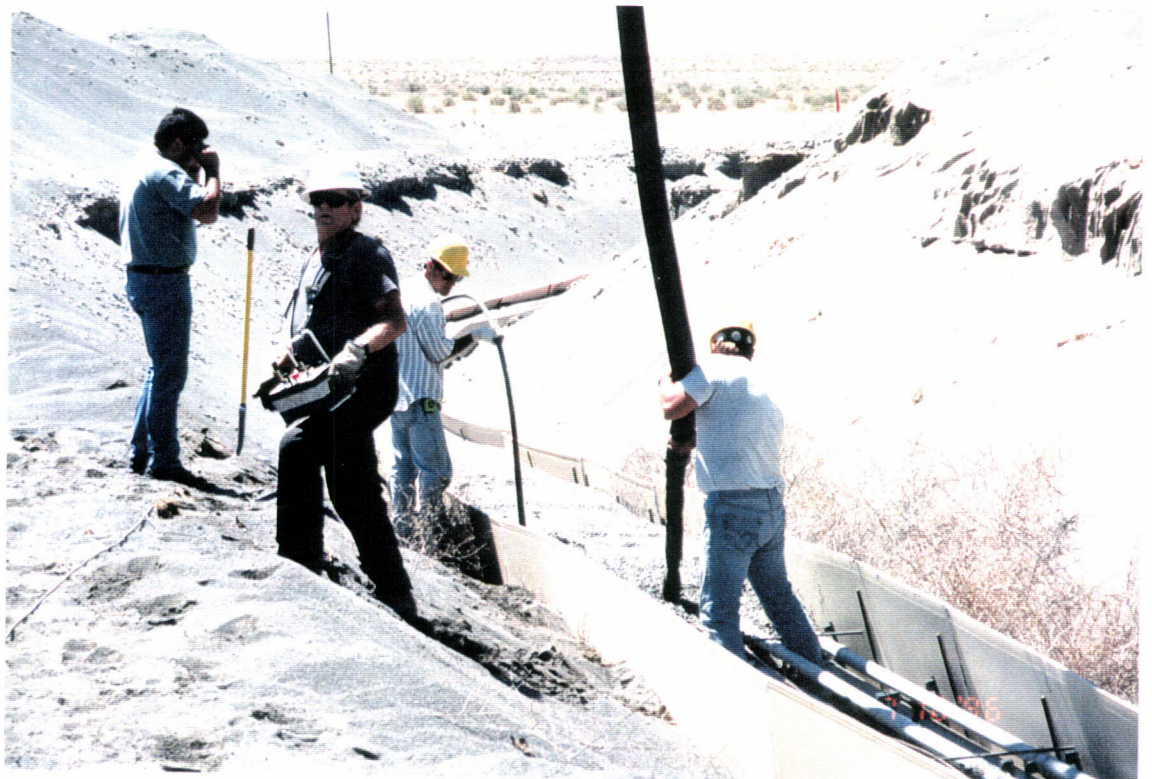
G960156-26 - 09

Another view of placing concrete for the duct bank.
