G960156-

Loading MC-250, the first layer of the multiple layer bituminous road surfacing.

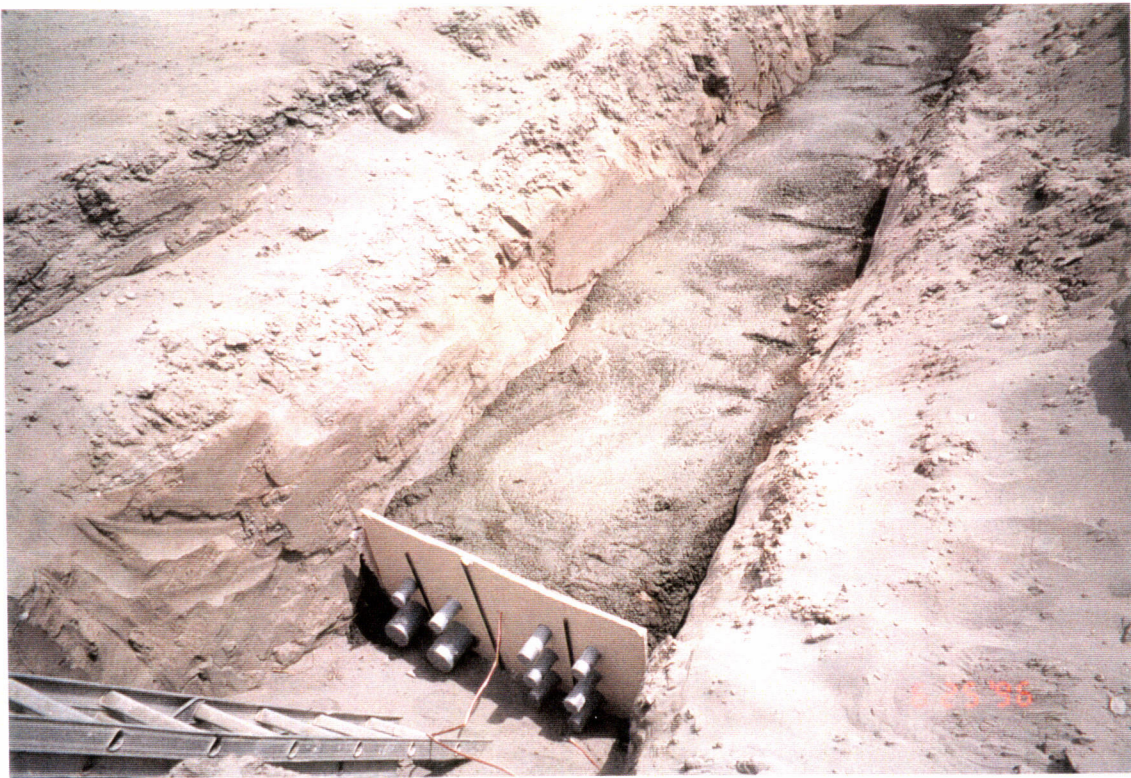
G960156-27 - O-PV

Typical duct bank at the contract interface point near the buildings.

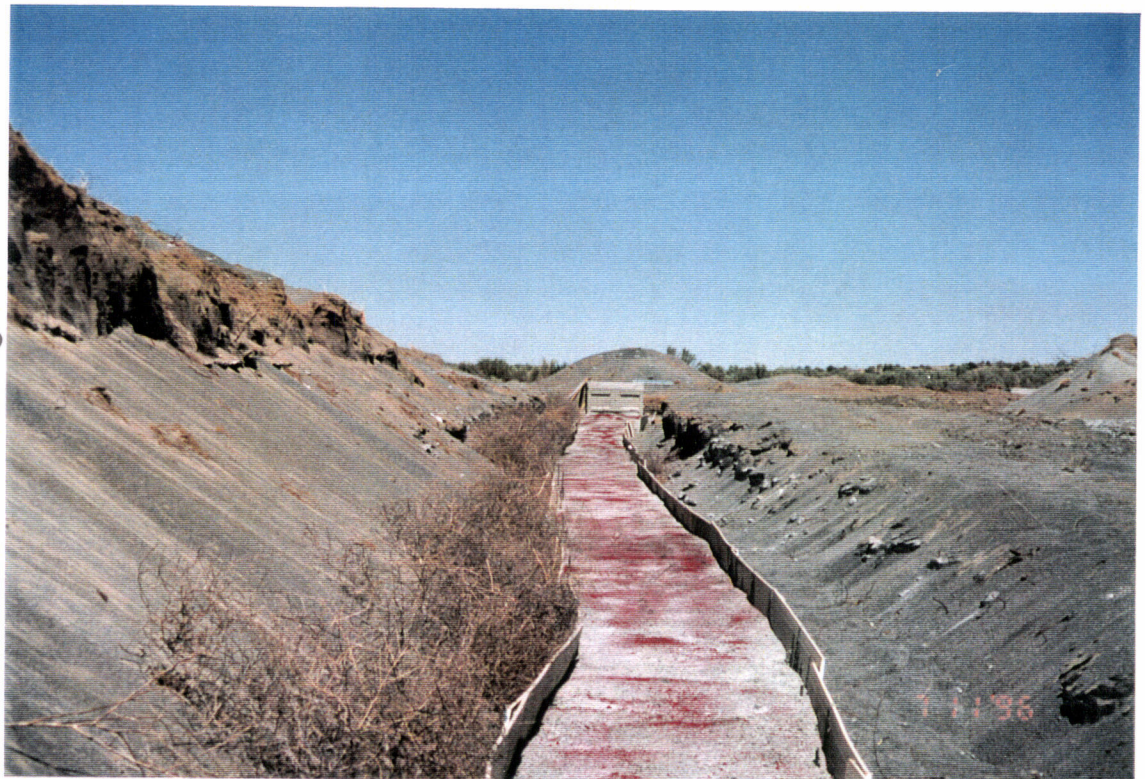
G960156-28 - O-P

Red oxide is scattered on top of duct bank prior to concrete curing.

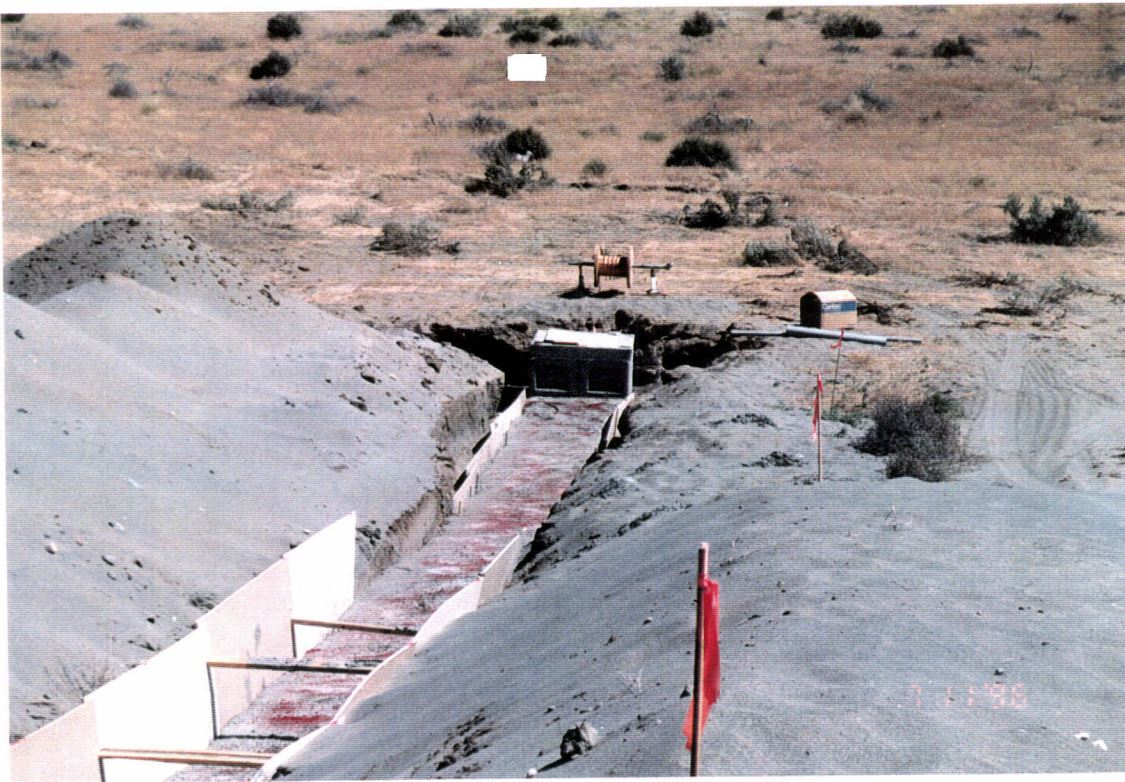
G960156-29 - O-P

Another view of the duct bank from the southwest End Station to the electrical pull box.

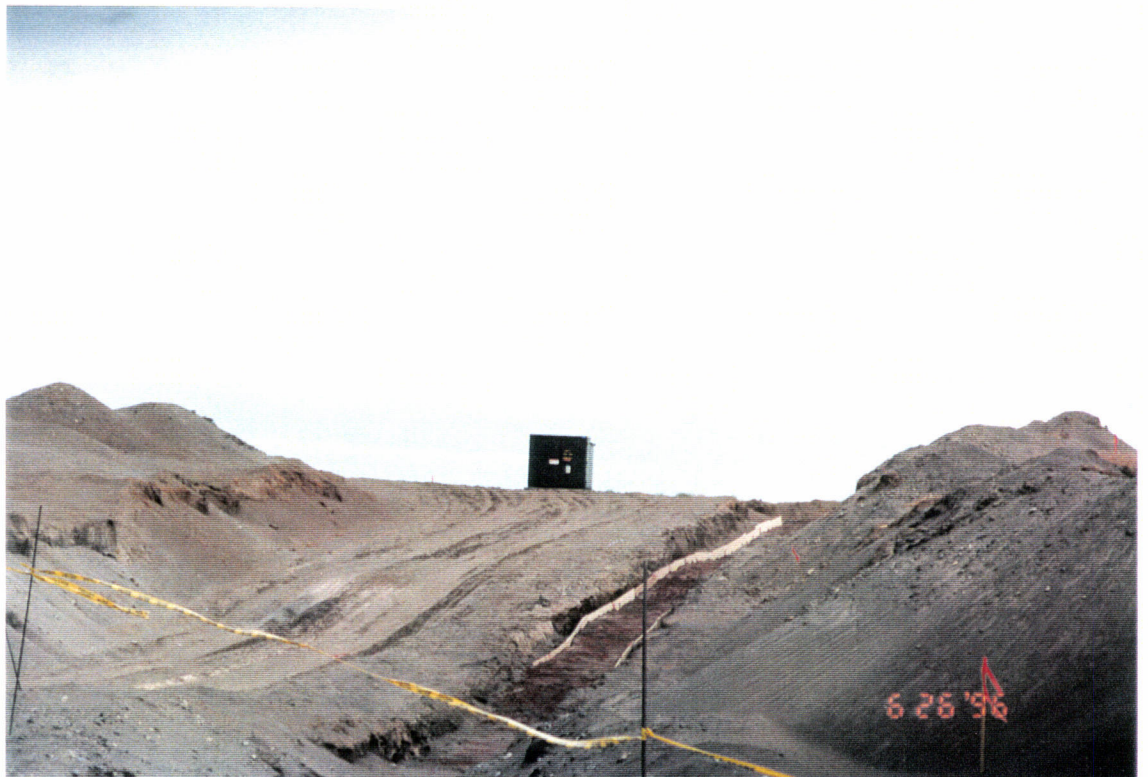
G960156-30 - O-P

Lone transformer provided and installed by the PUD at the southwest arm Mid Station.

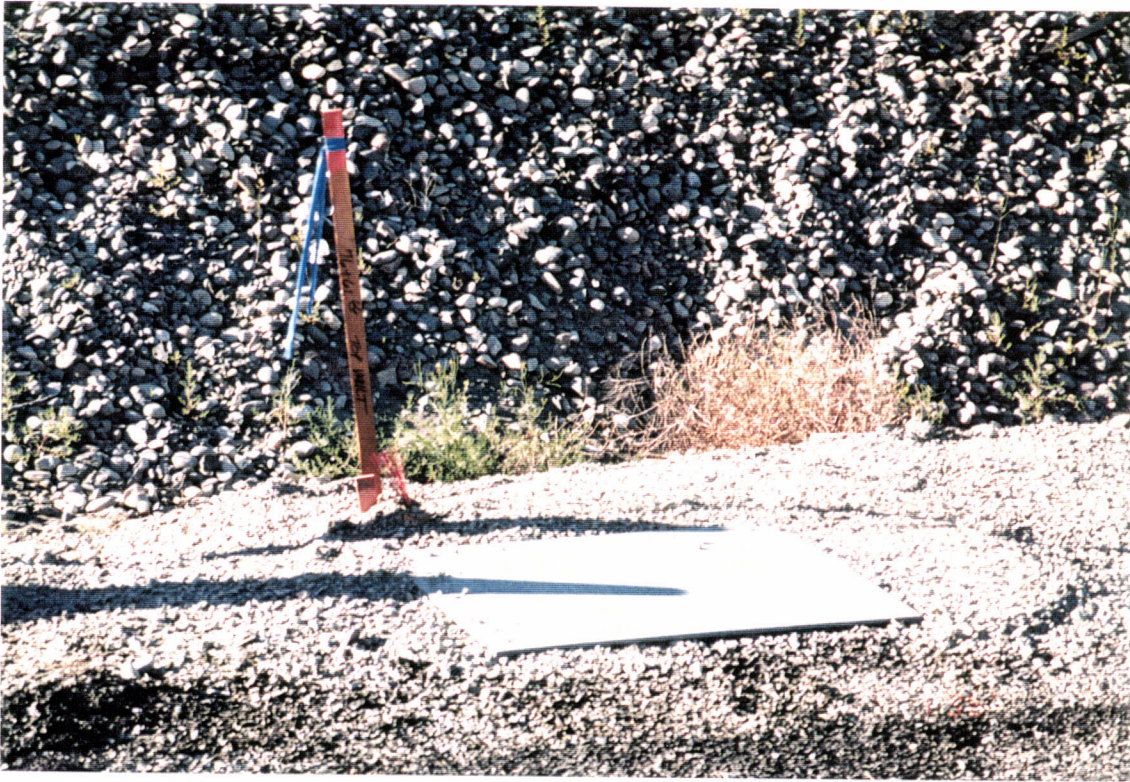
G960156-31 - O-P

Typical LIGO installed plate cover for the power interface conduits near the electrical bake out vaults.

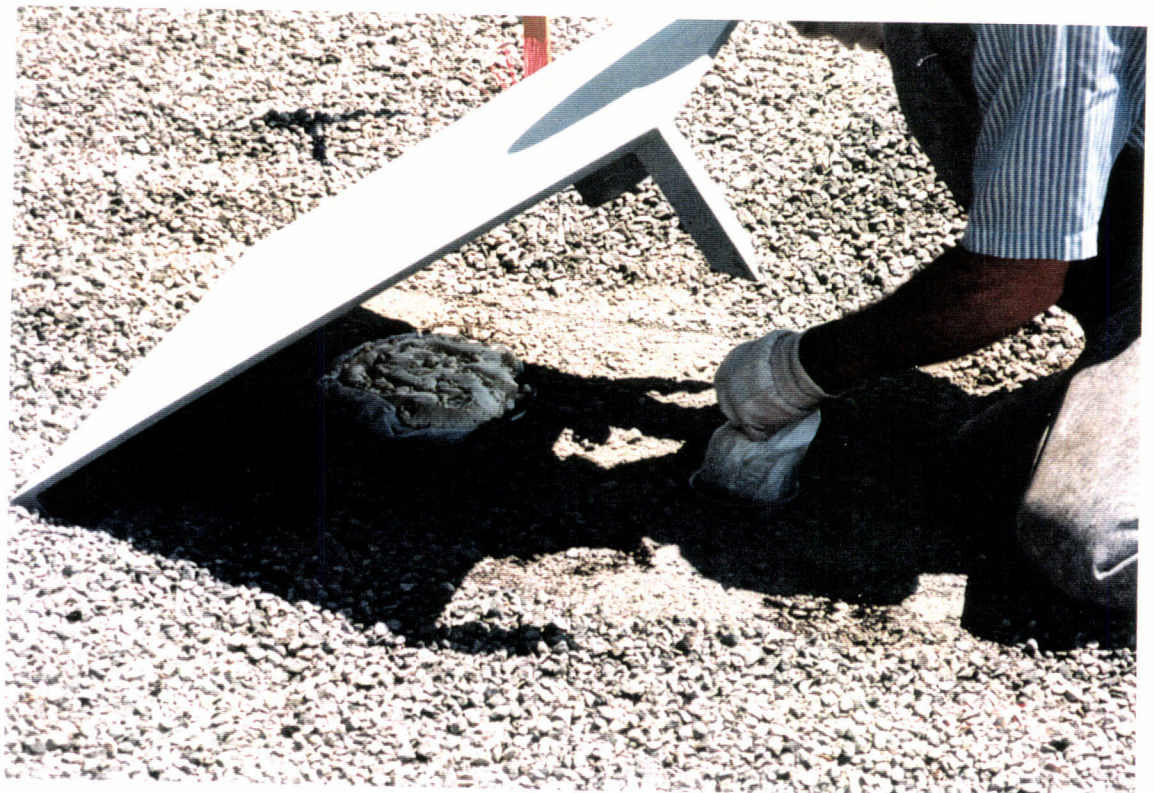
G960156-32 - O-P

View of underside of the plate cover, conduits are sealed with a foam plug.

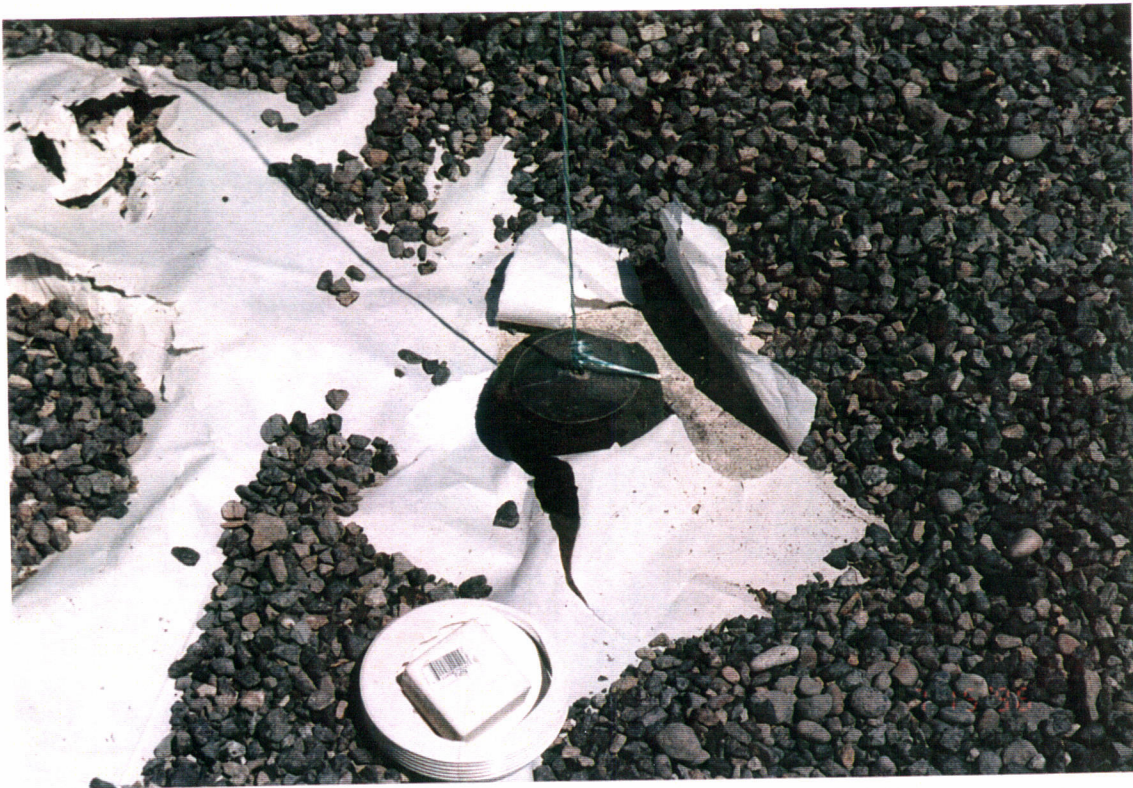
G960156-33 - O-P

At the service entrance, verifying the integrity of the duct bank conduits and installing the pull rope for the future power cable installation.

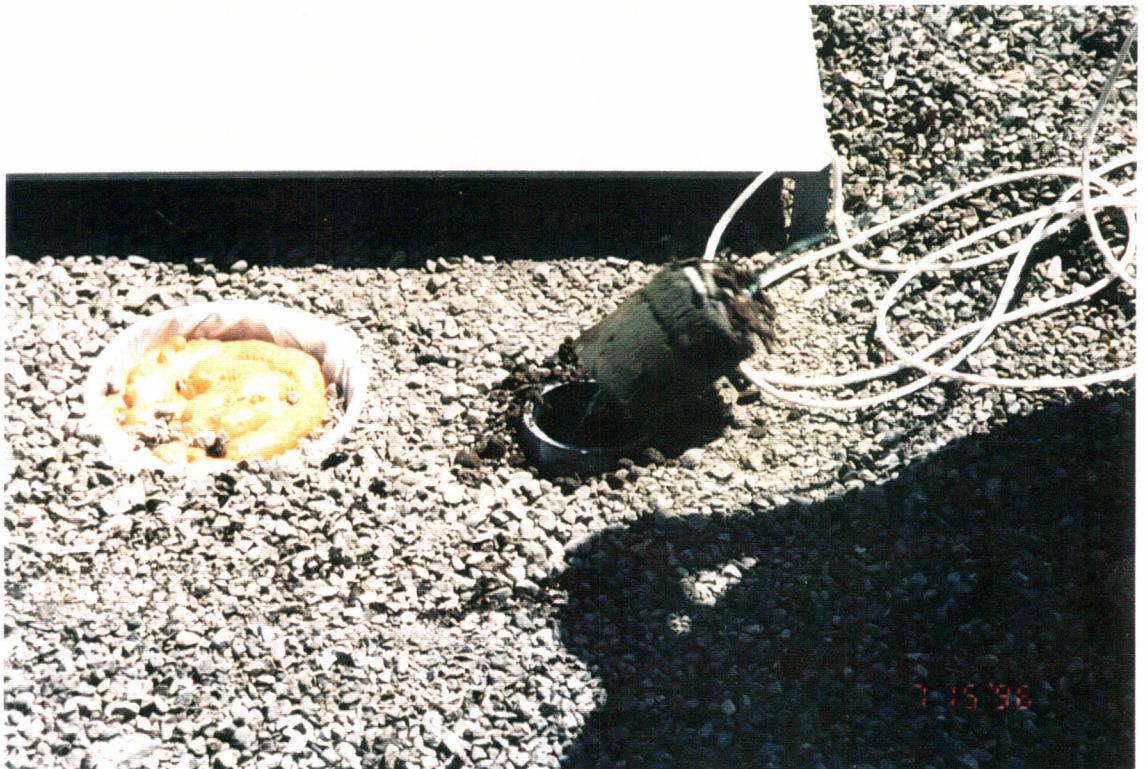
G960156-34 - O-P

At the transformer side, verifying the integrity of the duct bank conduits and installing the pull rope for the future power cable installation.

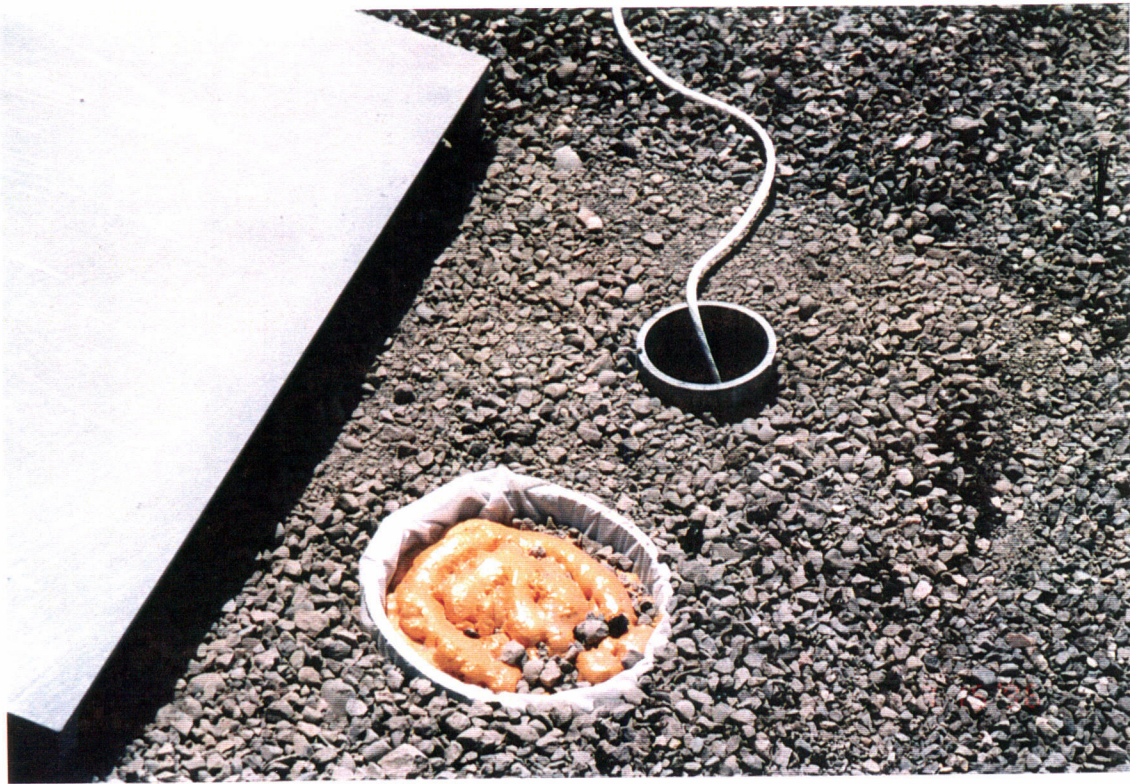
G960156-35 - OP

Verifying the cable pull rope installation at both ends of the conduit at the future
bake out transformer location.

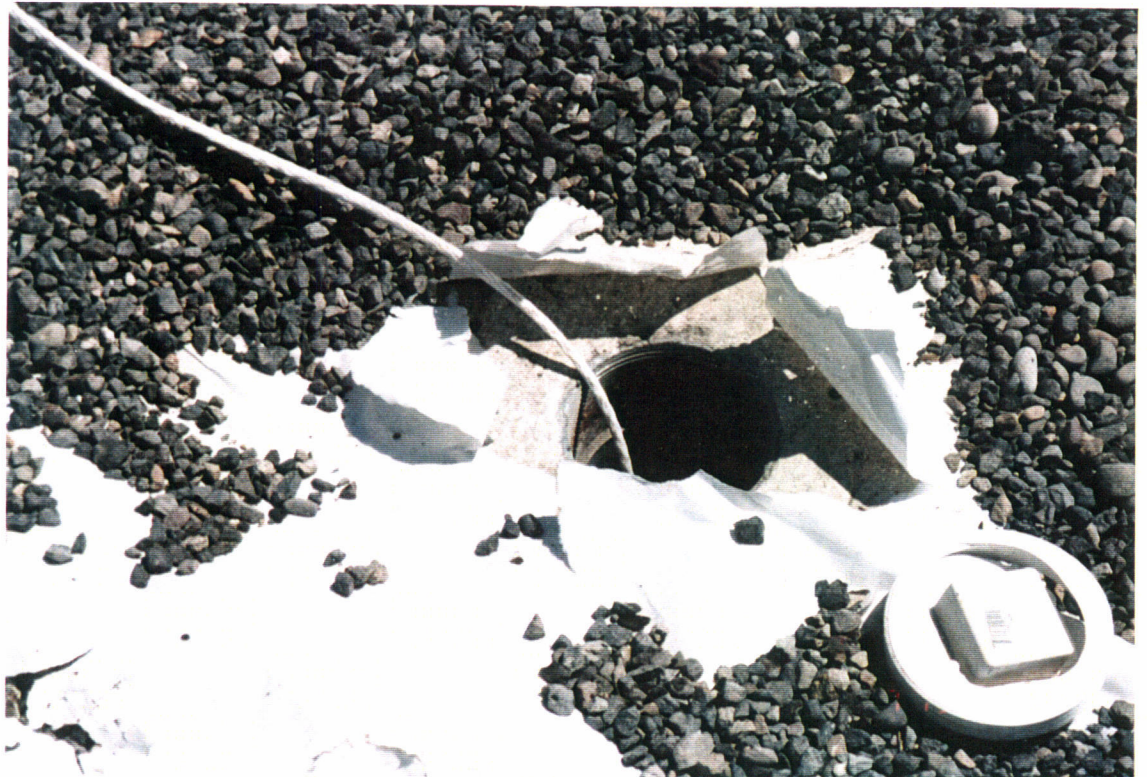
G960156-36 - OP

Verifying the cable pull rope installation at both ends of the conduit at the service
entrance location.
