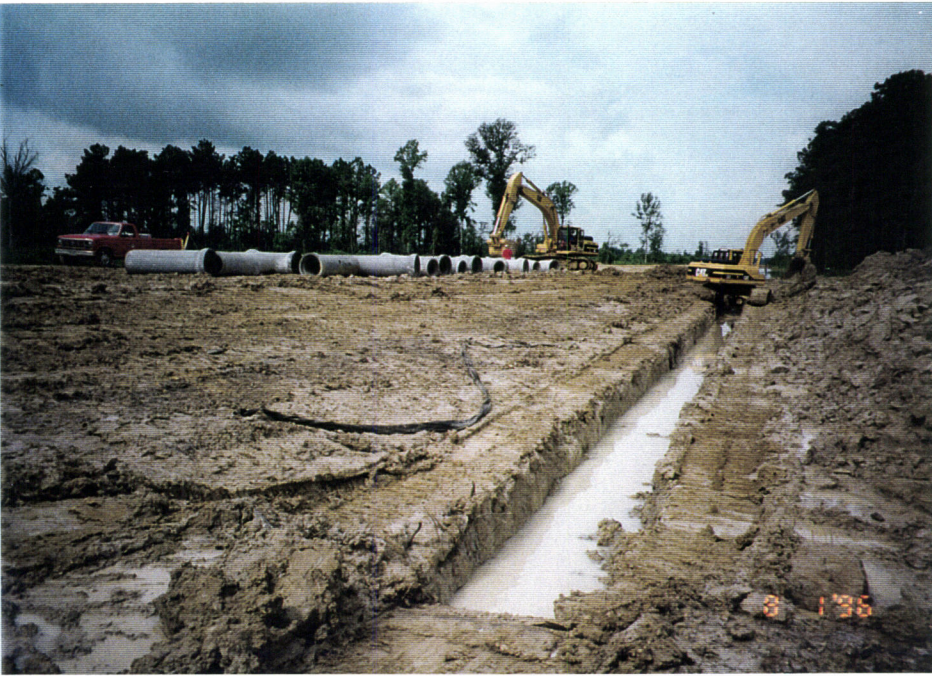
G960166- 01 - O-P

1. Southwest Arm at station 38+00 Installing 24in. RCP Pipe balance line between ditches.

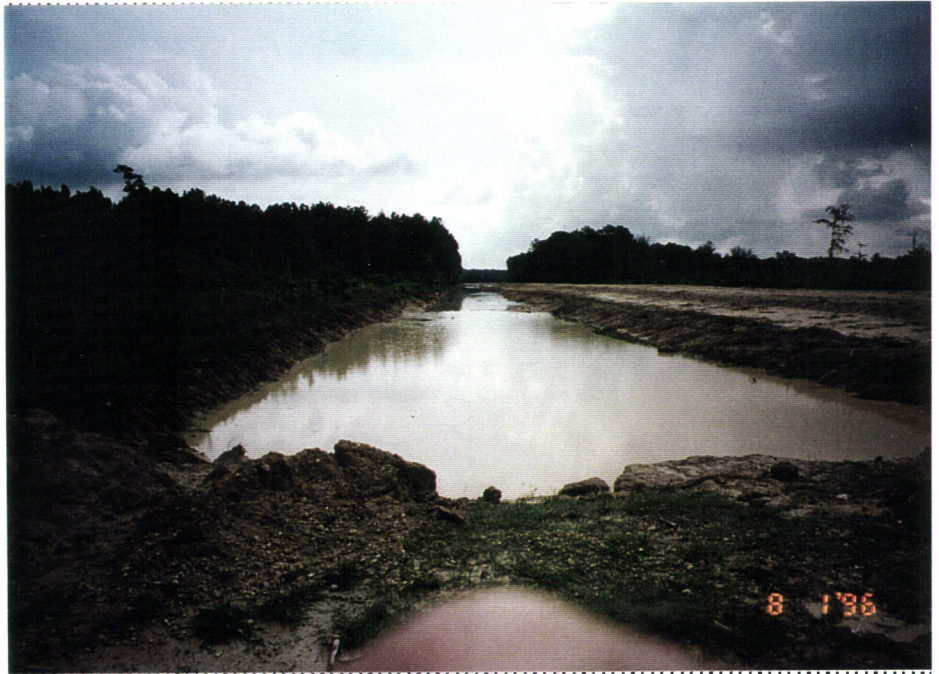
G960166- 02 - O-P

2. Southwest Arm at Station 38+00 looking northeast at trench.

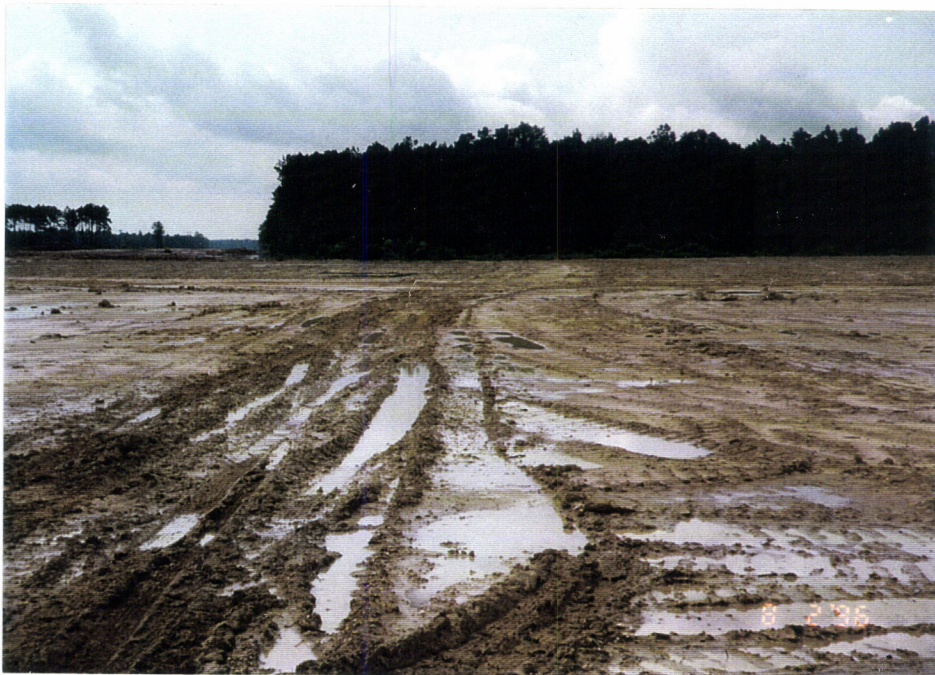
G960166- 03 - O-PV

3. Standing at construction site yard looking southeast at Apex area and result of a storm.

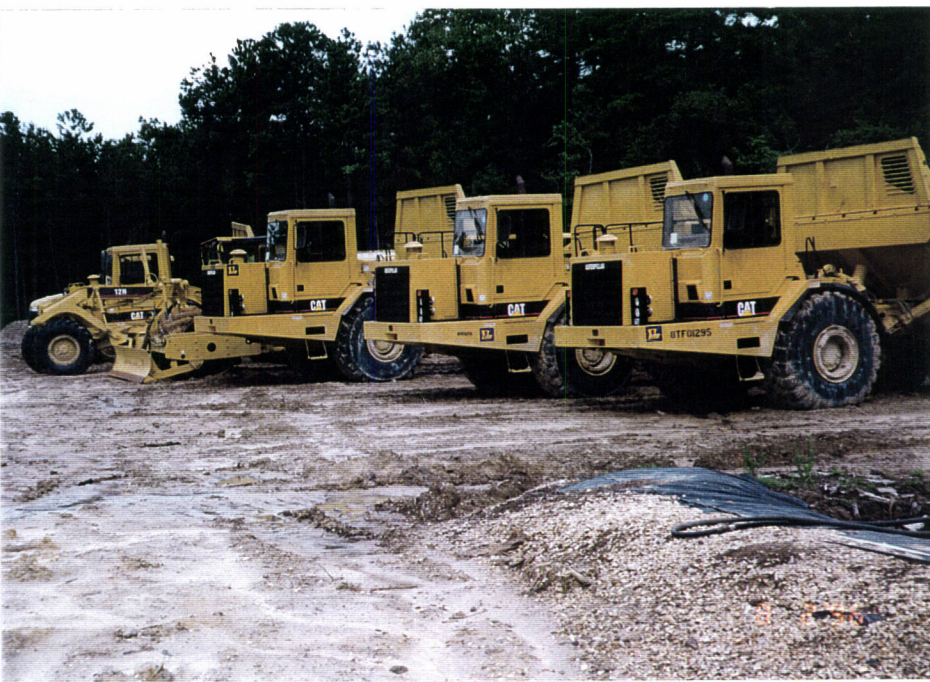
G960166- 04 - O-P

4. Stranco equipment waiting on bench for the game to start.

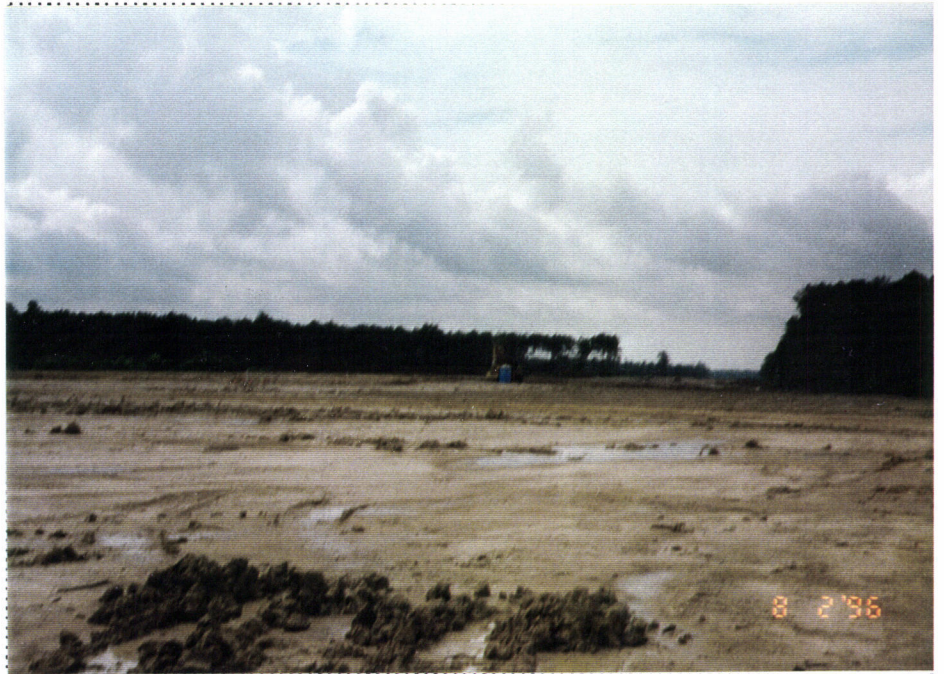
G960166- 05 - O-PV

5. Apex area showing effects after rain shower.

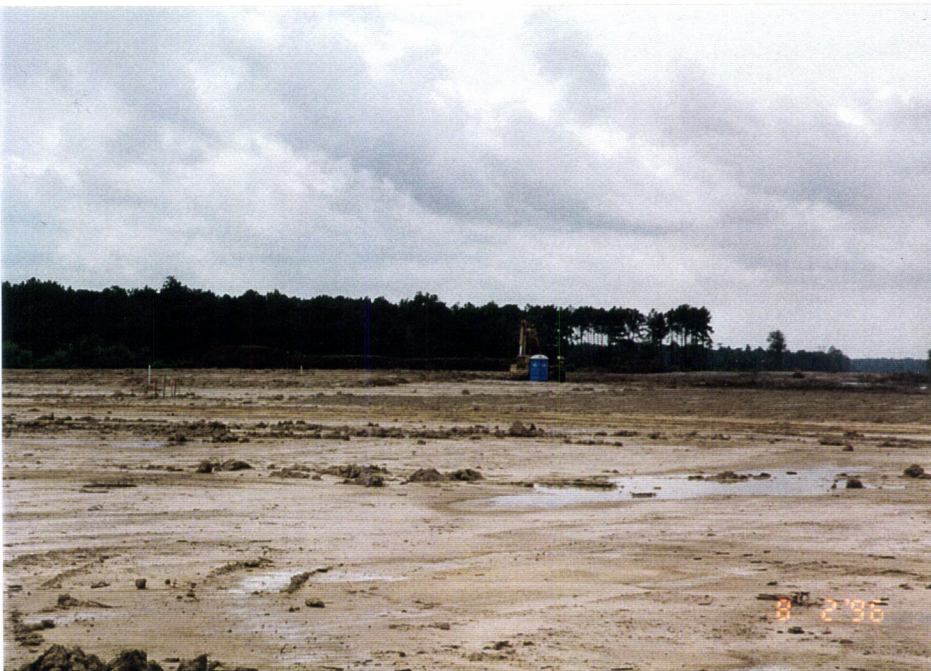
G960166- 06 - O-P

6. Apex area showing clearing after the storm.

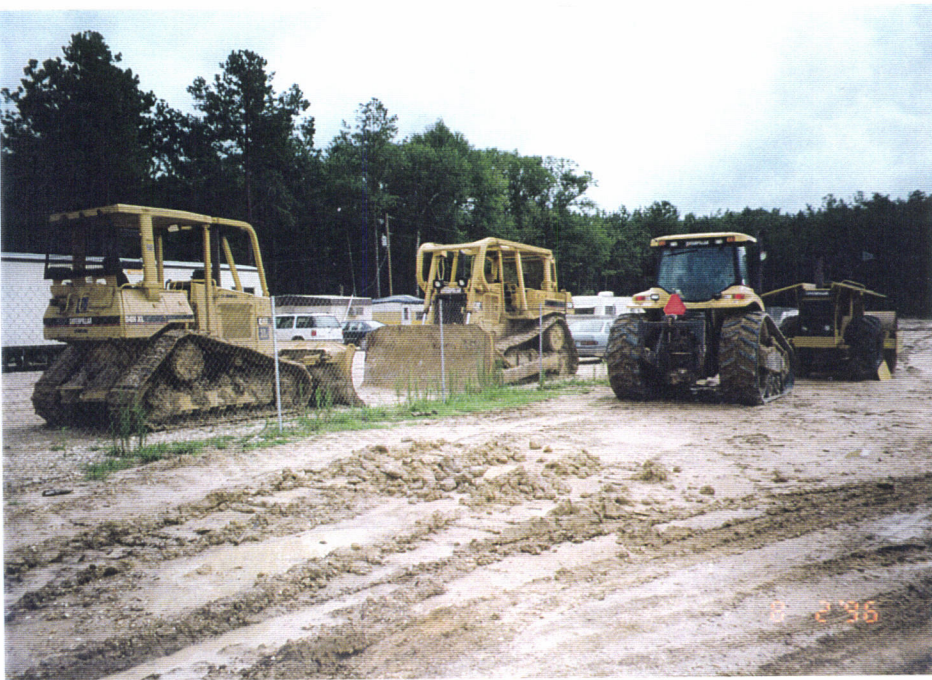
G960166- 07 - O-P

7. Stranco equipment being serviced and awaiting for conditions to be favorable to start work.

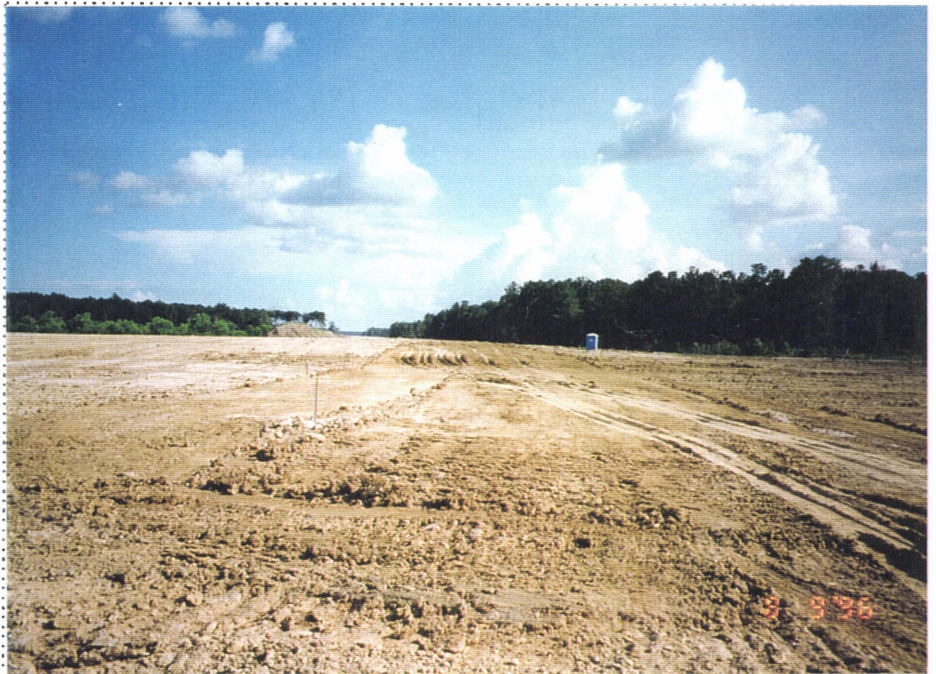
G960166- 08 - O-P

8. Apex area looking southeast at soil conditions after working the drying process.

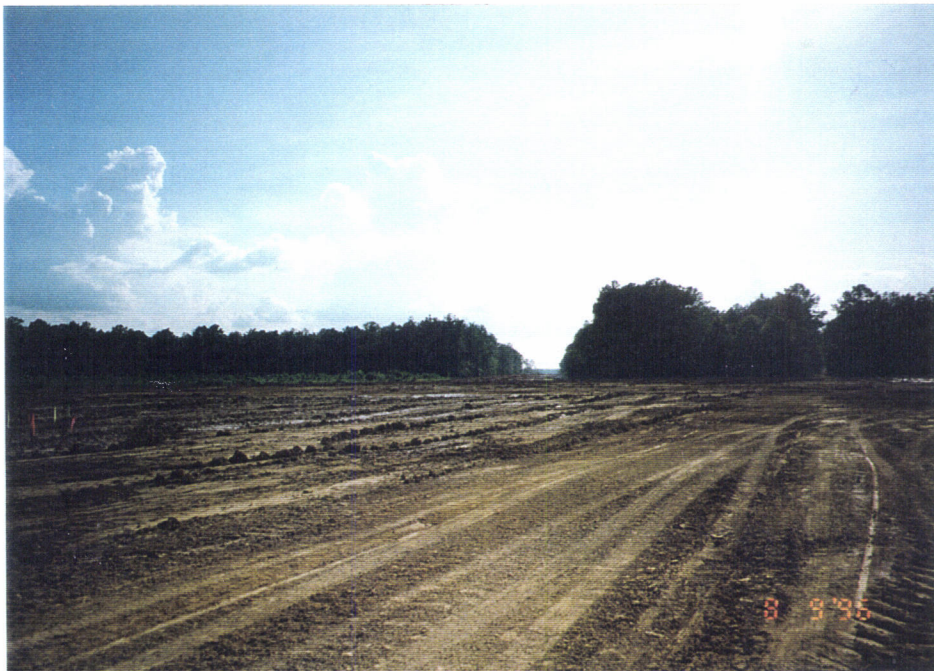
G960166-09 - O-P

9. Apex area looking southwest at Arm #2. The soil is being dried.

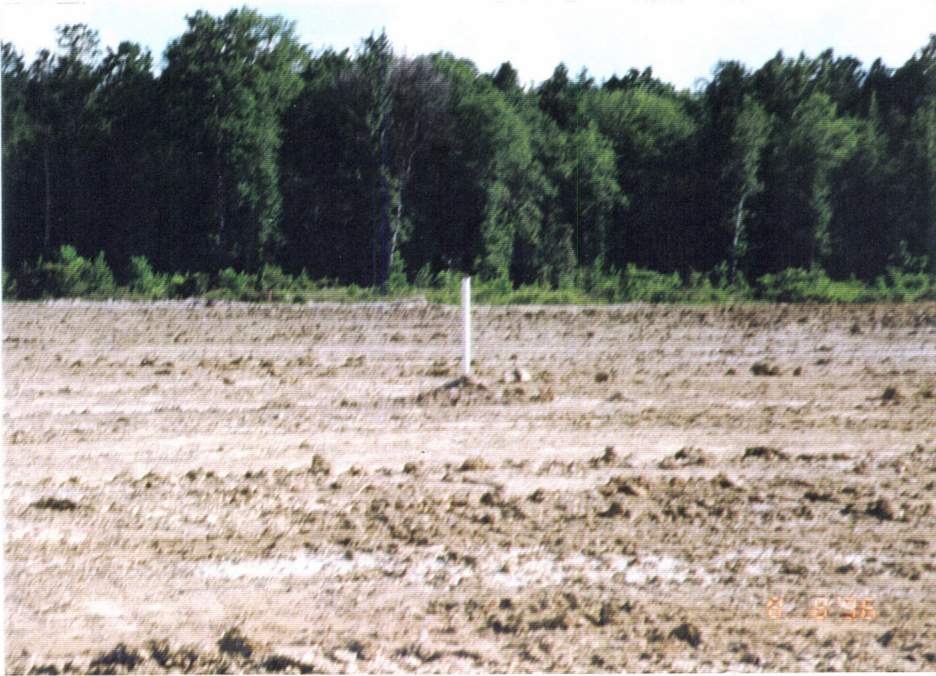
G960166- 10 - O-PV

10. Apex area showing the plastic sleeve for one of the settling plates.

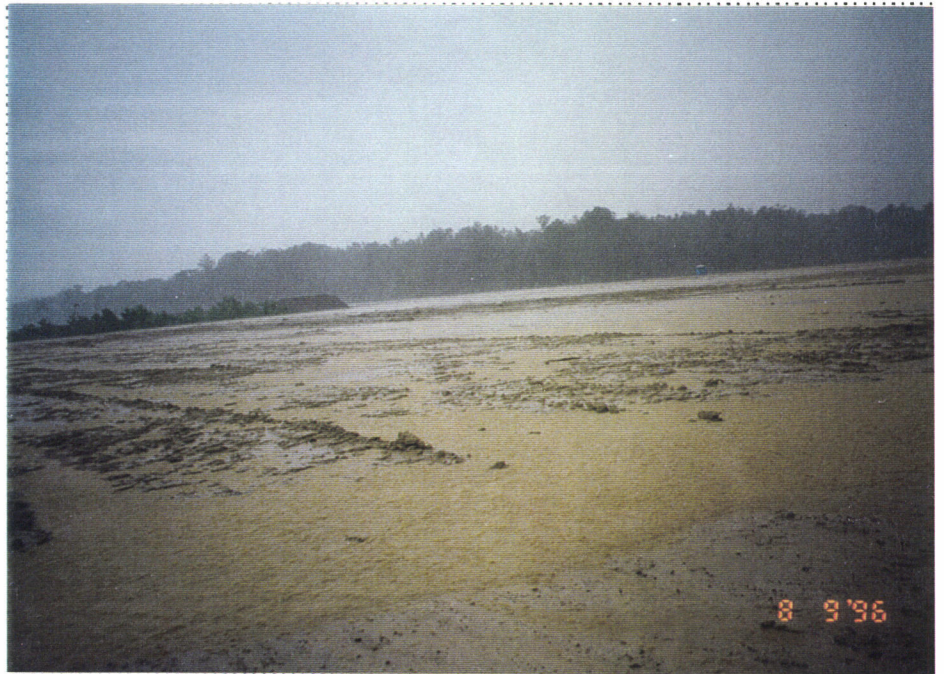
G960166- 11 - O-P

11. Apex area showing rain just starting “see clearing spot in clouds upper left corner.”

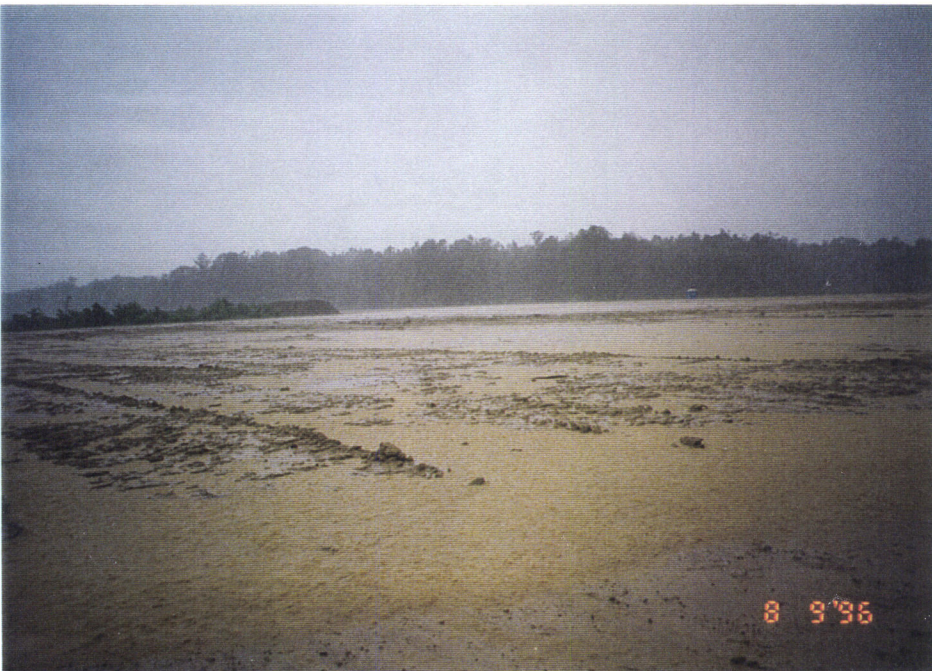
G960166- 12 - O-P

12. More rain.

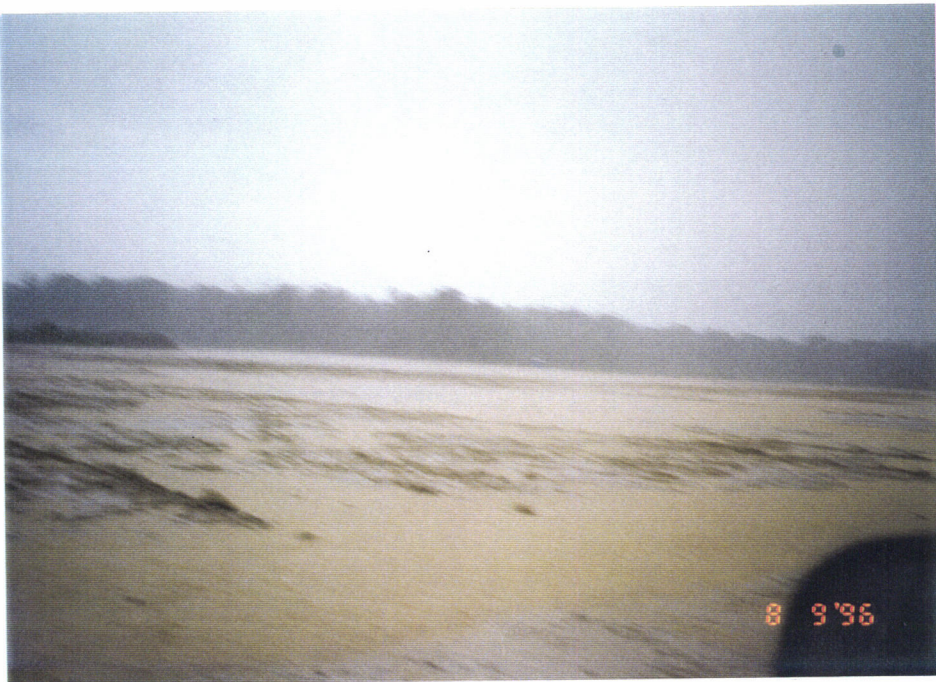
G960166- 13 - O-P

13. Same shot as previous picture, but raining much harder. Notice right side of picture where rain is more prominent.

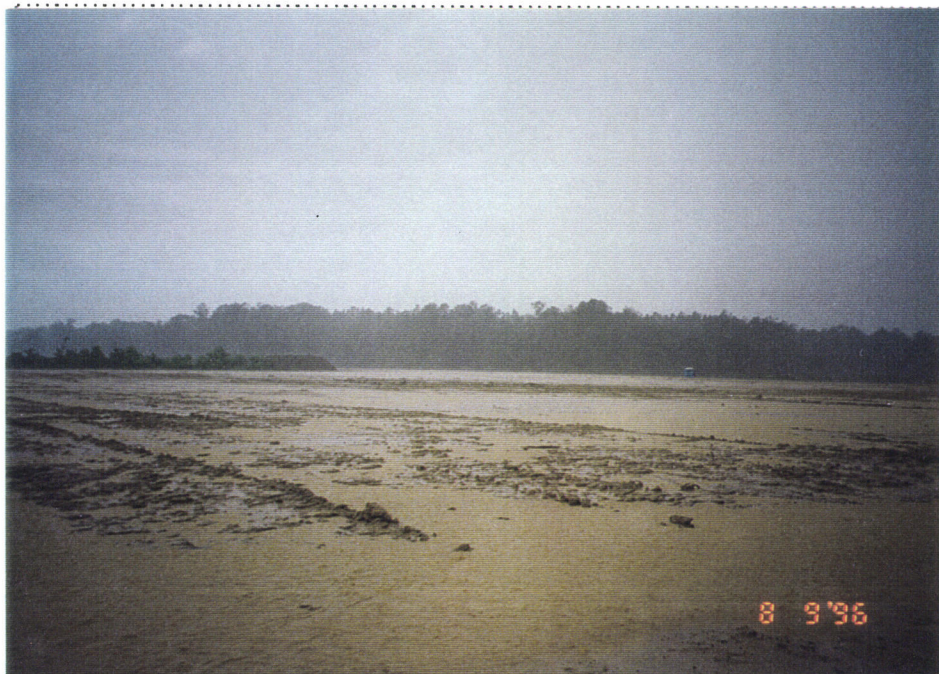
G960166- 14 - O-P

14. Same shot as previous two pictures. Notice the rain passing through.

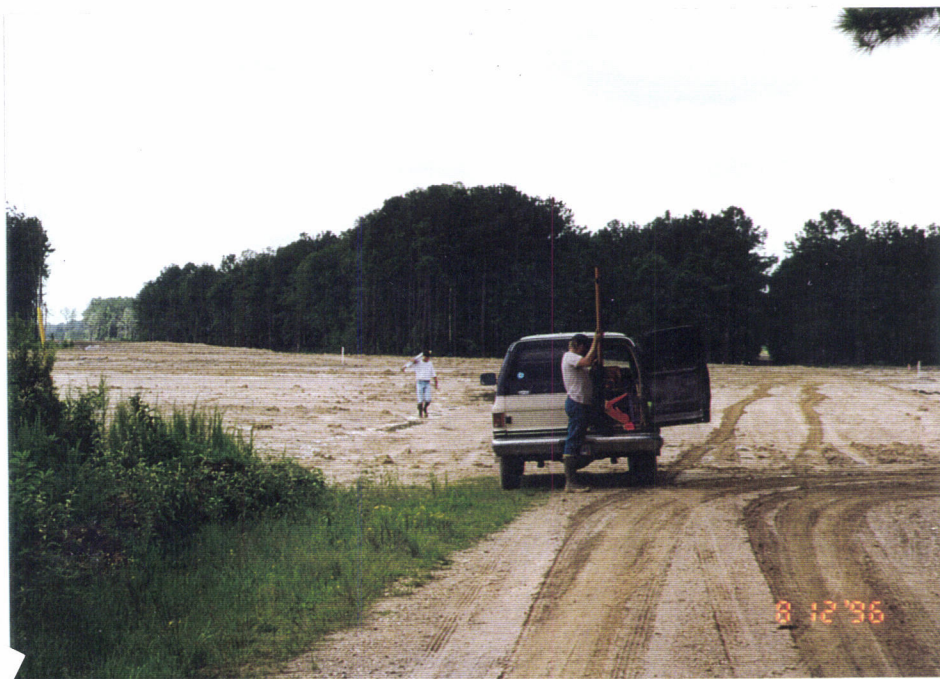
G960166- 15 - O-P

15. ABMB survey crew checking settlement plates at Apex area.

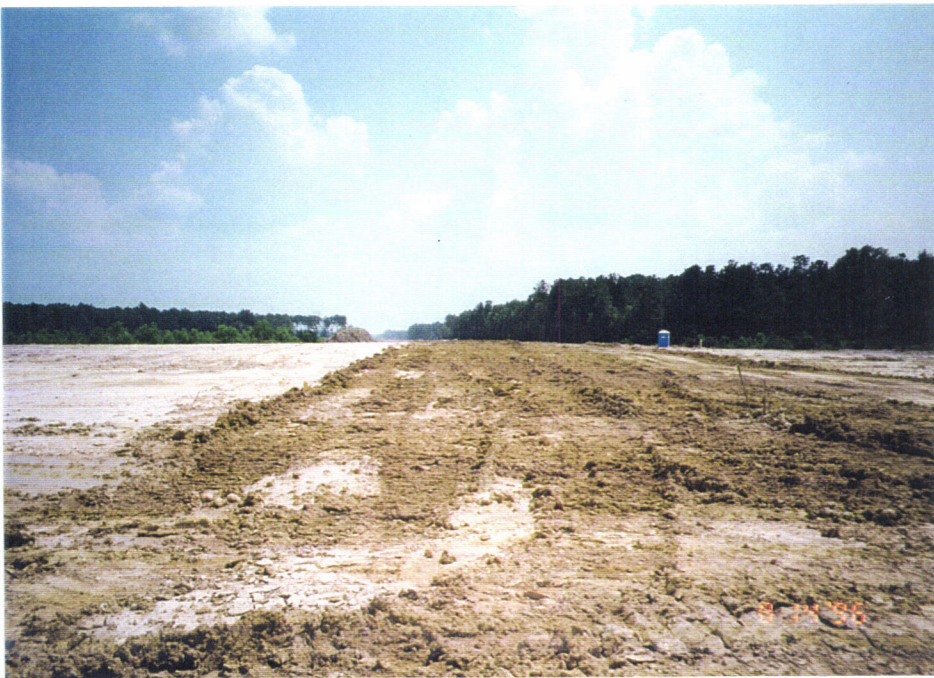
G960166- 16 - O-P

16. Apex area looking down Southeast Arm #1 showing preparations of soil for more fill.

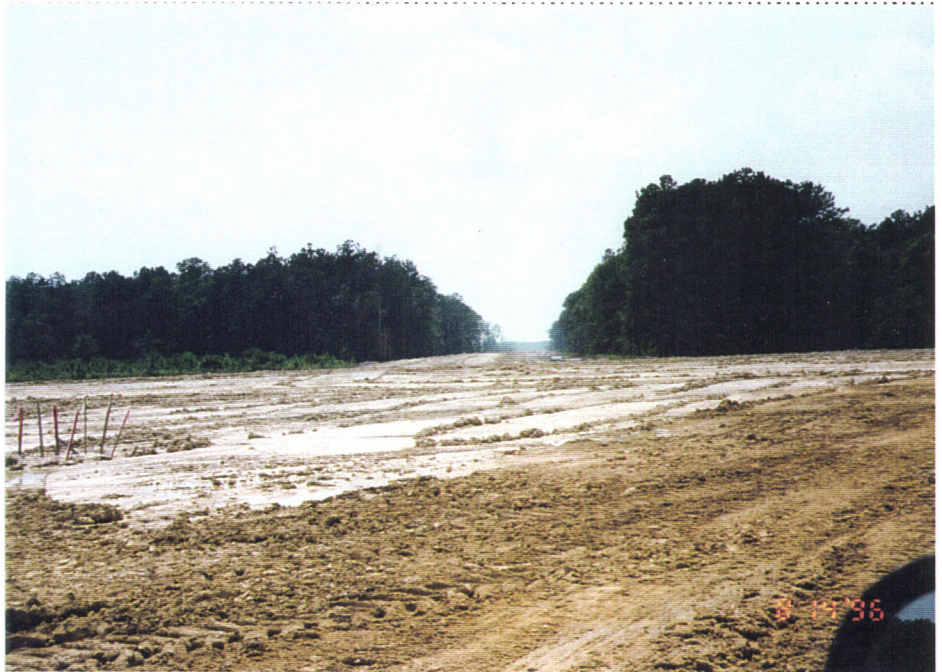
G960166- 17 - O-P

17. Apex area looking at the Southwest Arm #2. This area still too wet to work.

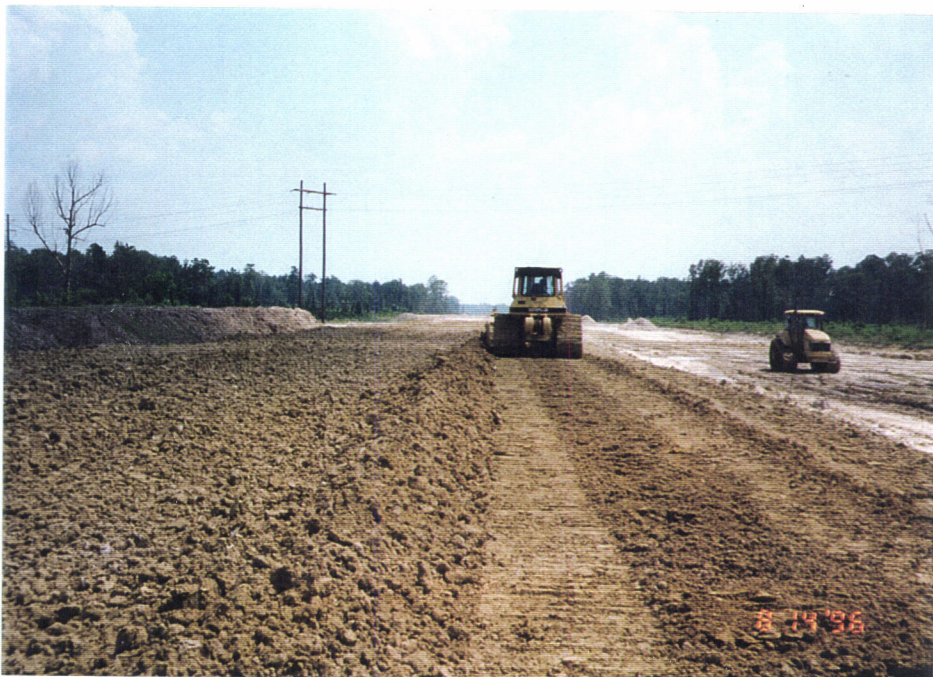
G960166- 18 - O-PV

18. Southeast Arm berm, cutting side slopes and spreading material for a new lift.

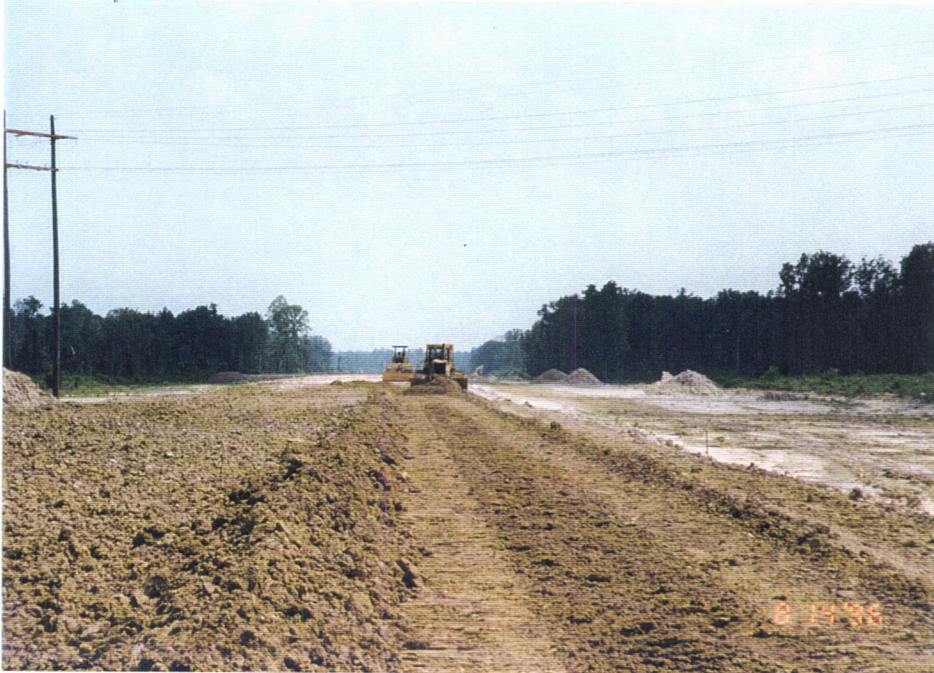
G960166- 19 - O-PV

19. Southeast Arm, working side slopes, up on top of berm.

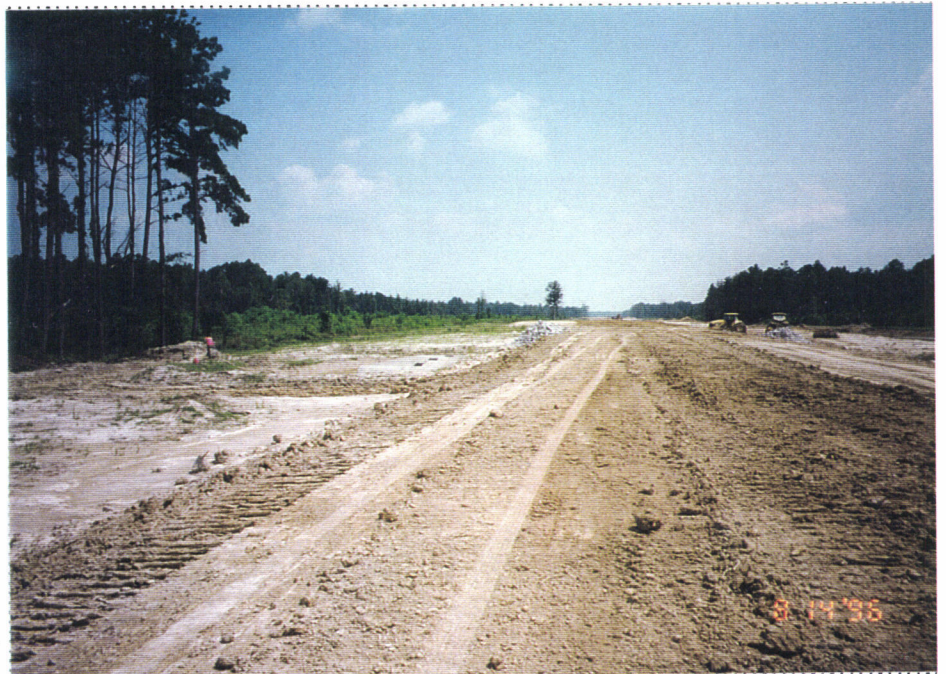
G960166- 20 - O-P

20. Southeast Arm showing the pumping out of culvert crossing 27+00 to complete Rip Rap installation.

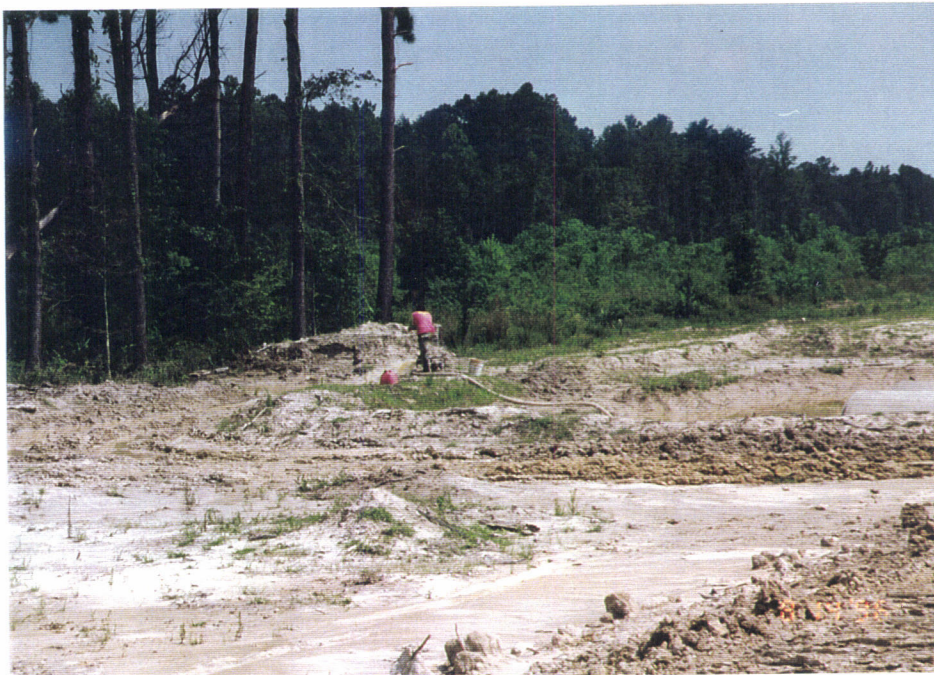
G960166- 21 - O-P

21. Southeast Arm showing a close-up of previous photo. Notice the sediment washed from berm (foreground).

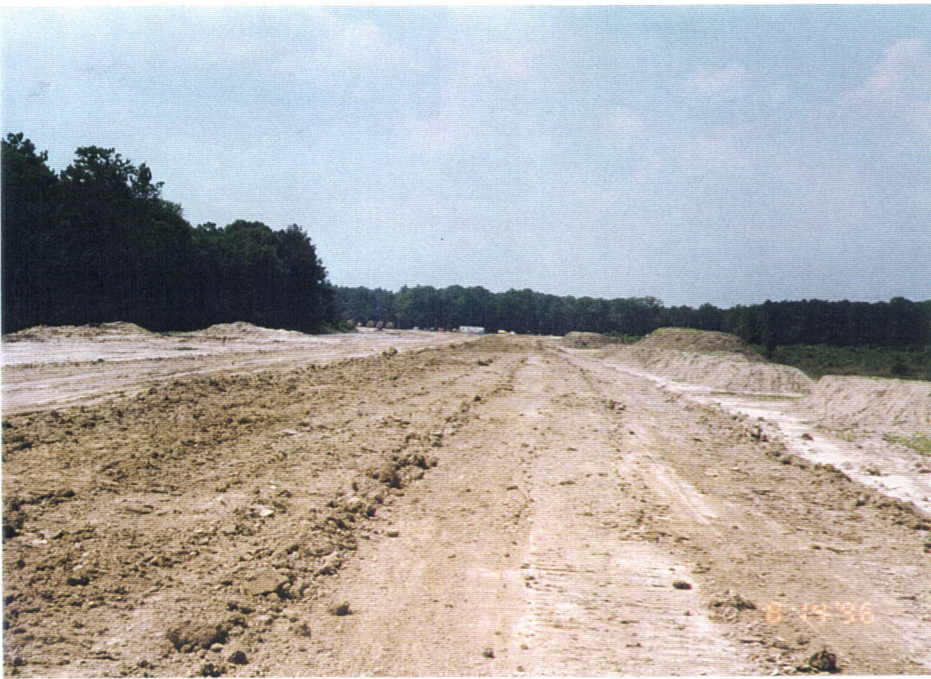
G960166-22 - O-P

22. Southeast Arm looking a site office background and trimming of side slopes, moving material up on top of berm.

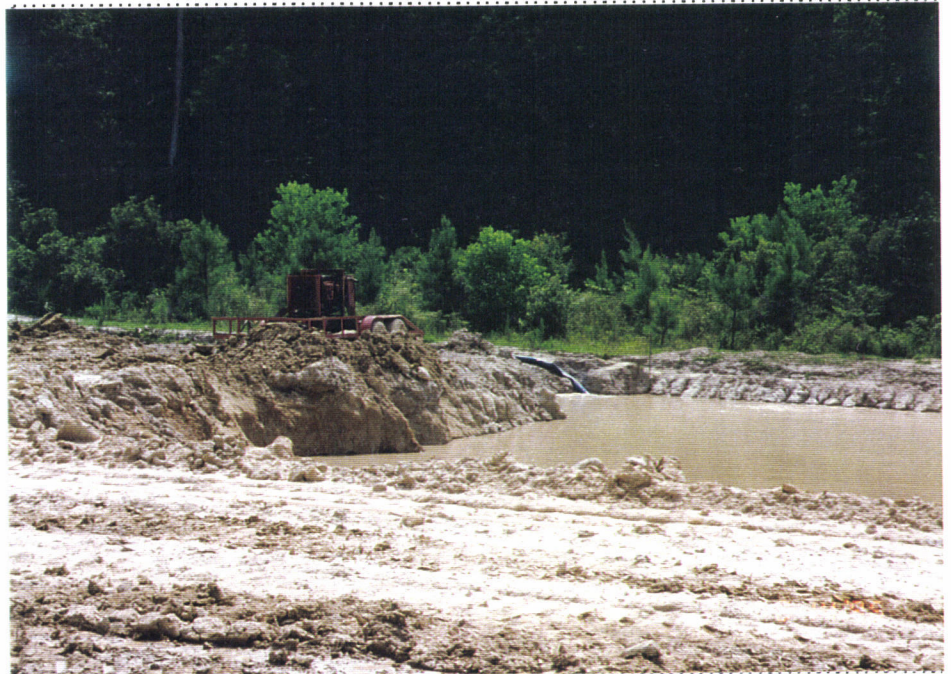
G960166-23 - O-P

23. Southeast Arm, at culvert crossing 27+00 inlet, showing earth dam and pumping operation for Rip Rap work.

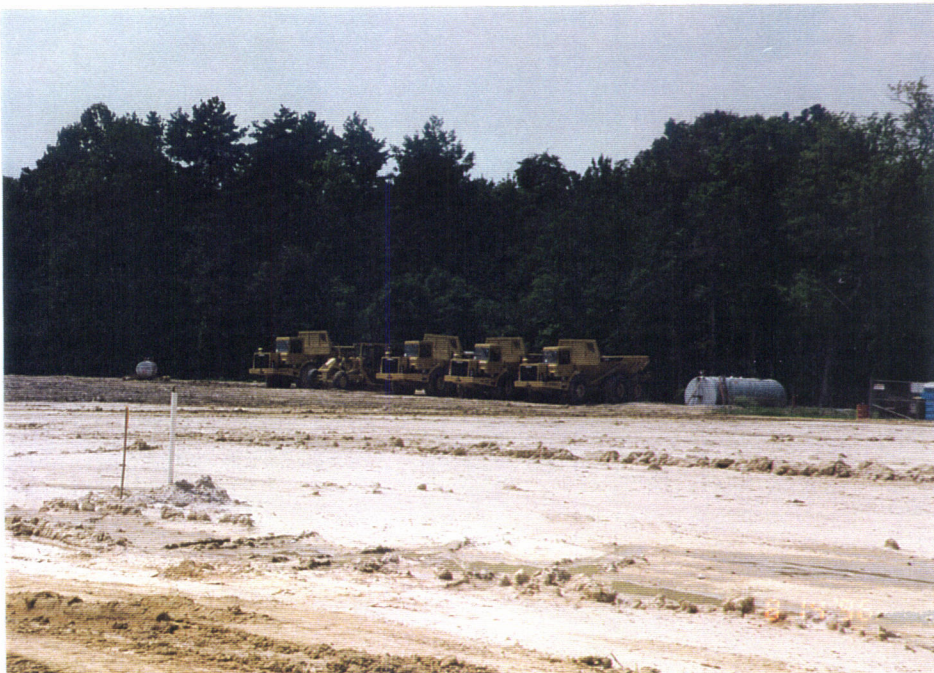
G960166-24 - O-P

24. Forty ton trucks standing by waiting to haul when berm permits travel.
