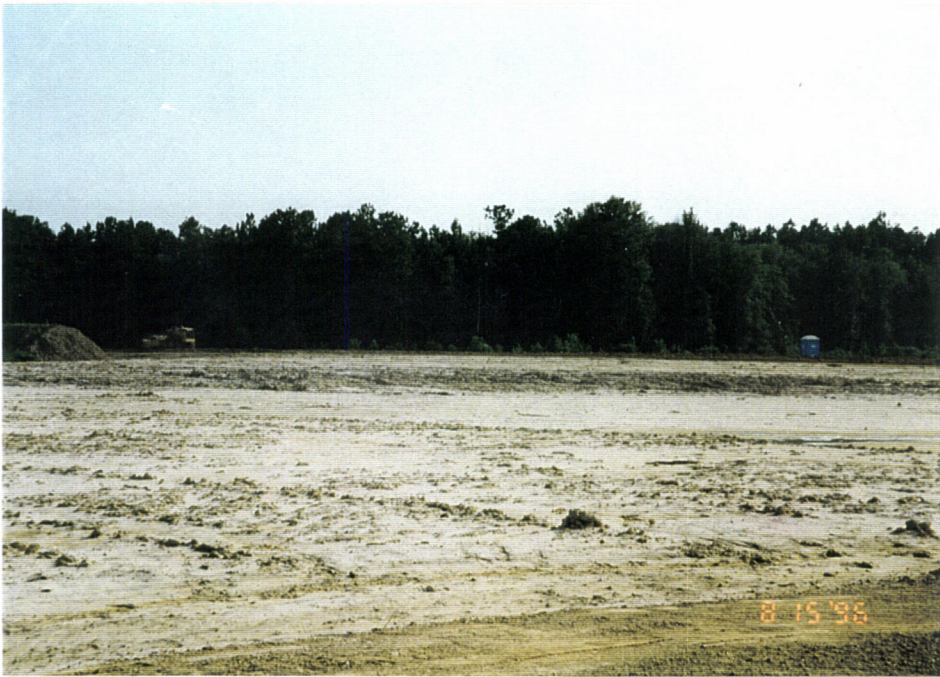
G960167-01 - O-P

1. East side of Corner Station looking south showing after math of storm. Background you will see dozer drying out SE berm .

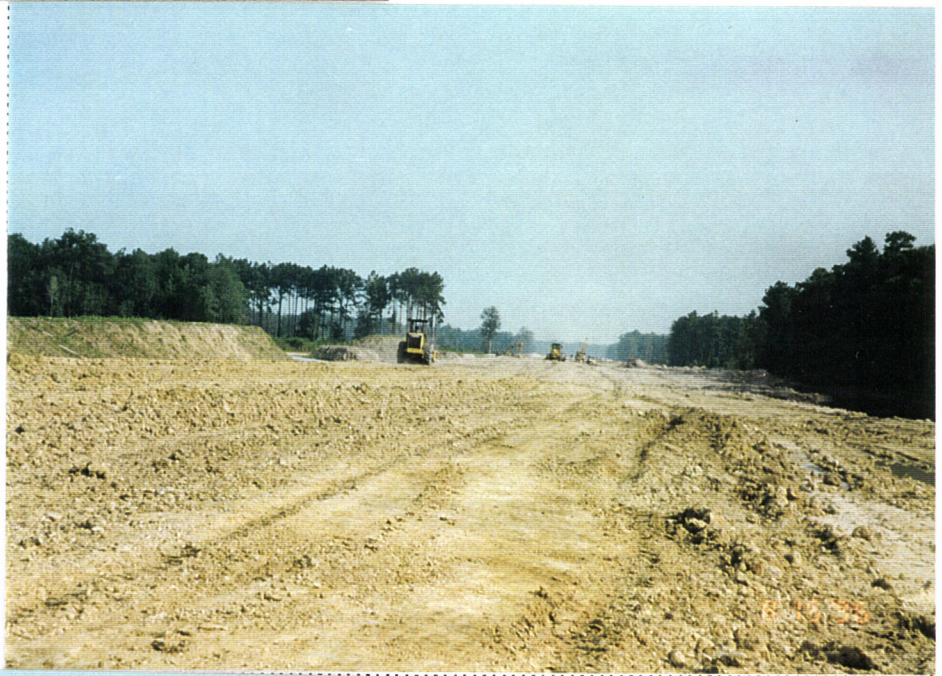
G960167-02 - O-P

2. Equipment drying out berm for preparation for more lifts of berm material.

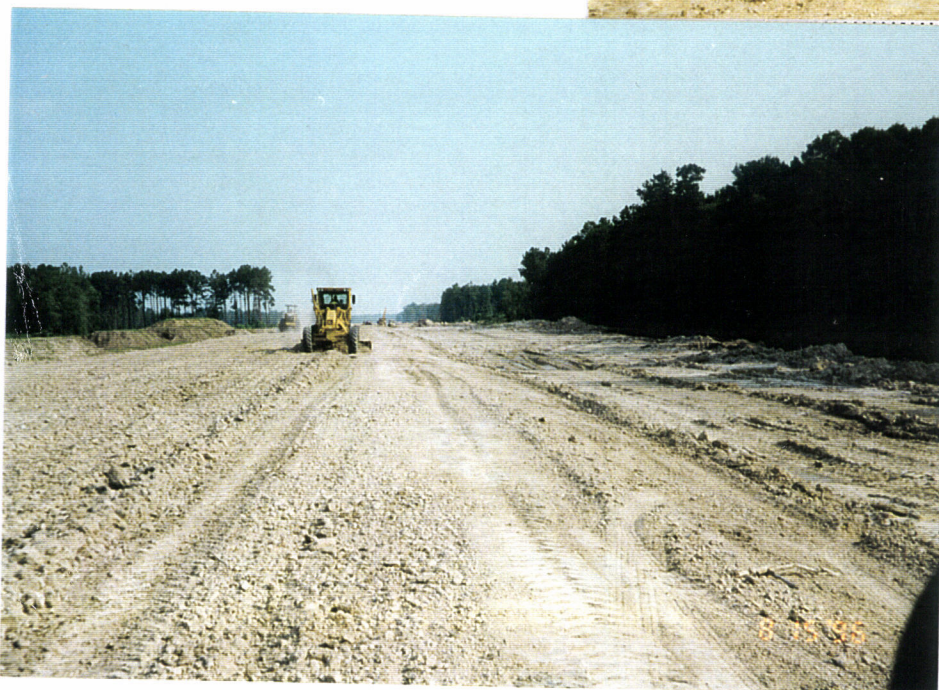
G960167-03 - O-P

3. South East Arm (#1) Here a grader is shaping the slopes of the berm then spreading the material over the berm.

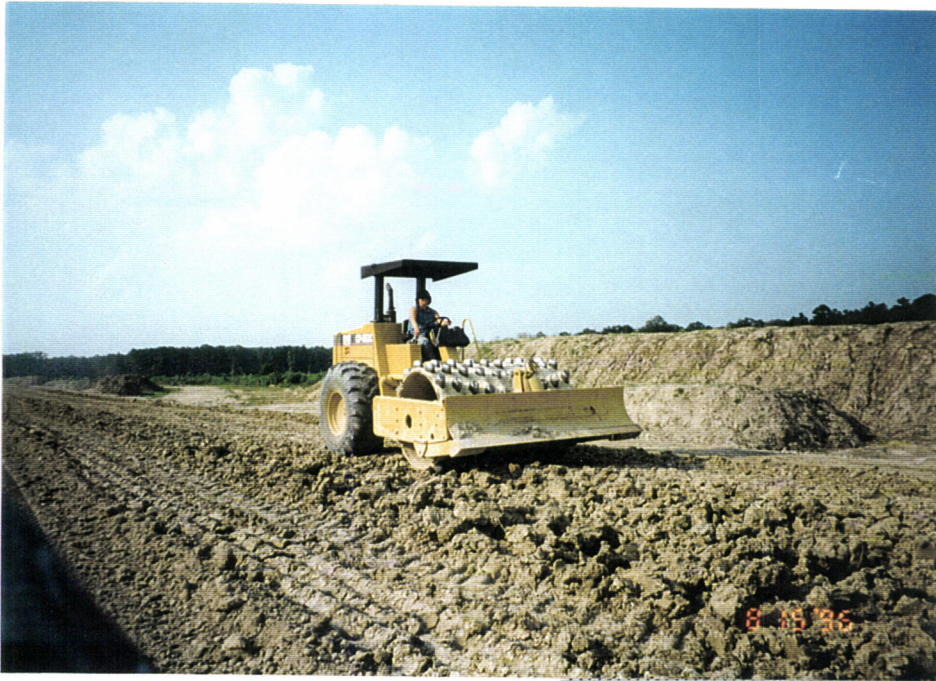
G960167-04 - O-P

4. Southeast Arm at station 13+00 , rolling berm for compaction.

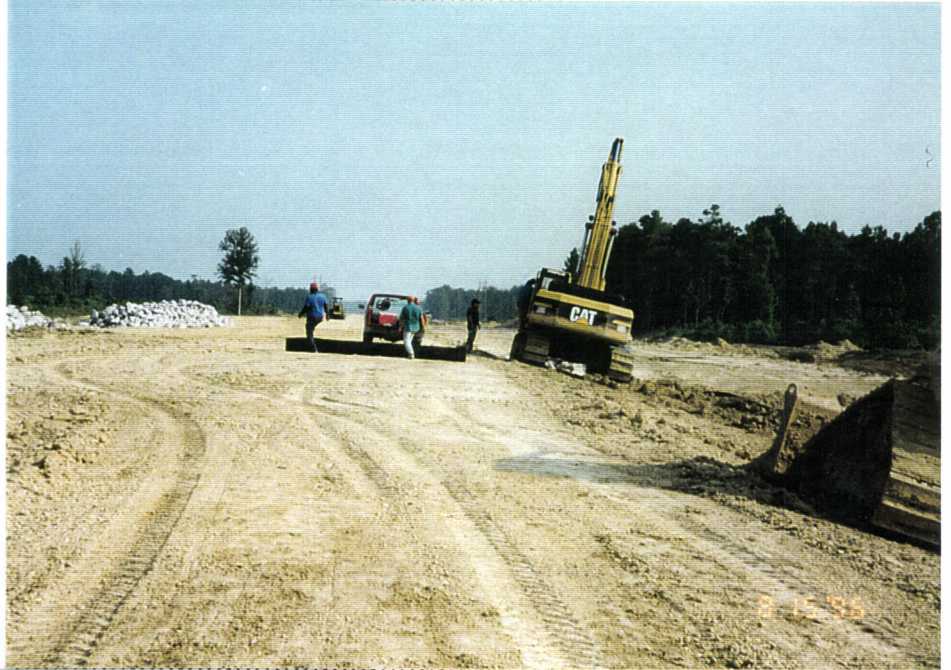
G960167-05 - O-P

5. Southeast Arm at station 27+00 where the workers are installing geotech fabric at culvert for receiving rip rap.

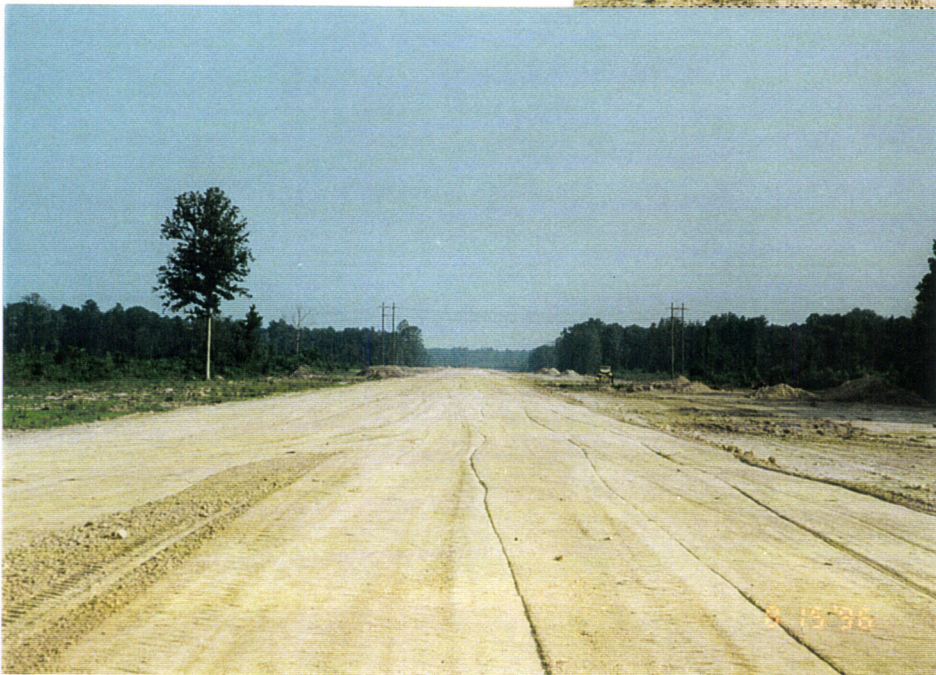
G960167-06 - O-P

6. Southeast Arm at station 35+00 this shows where a smooth roller was used to seal off the berm to protect it from rain

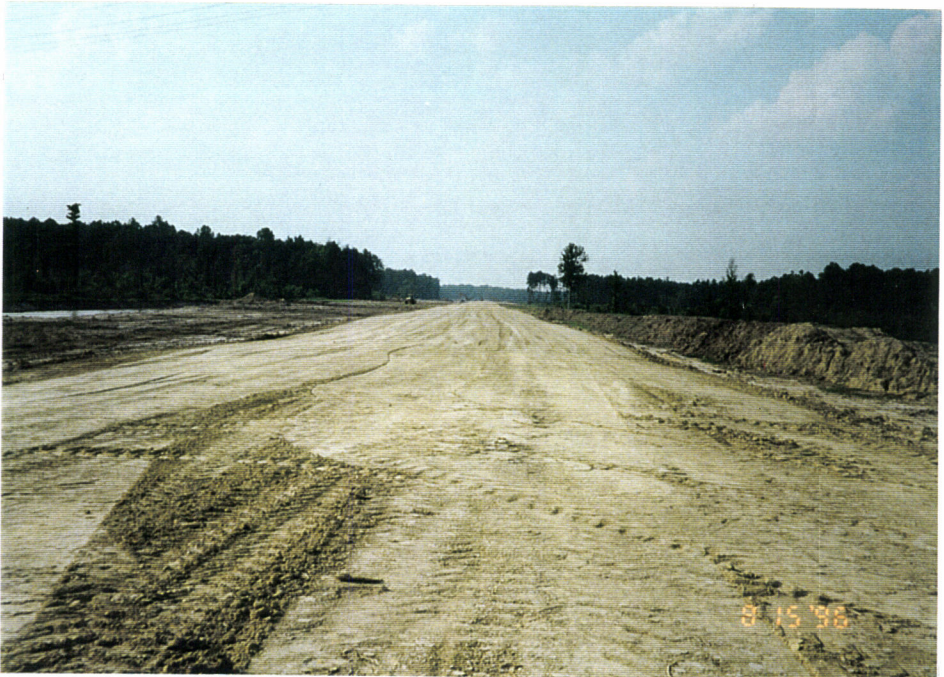
G960167-07 - O-P

7. Southeast Arm at station 100 +00 showing the berm rolled and sealed to prevent rain damage.

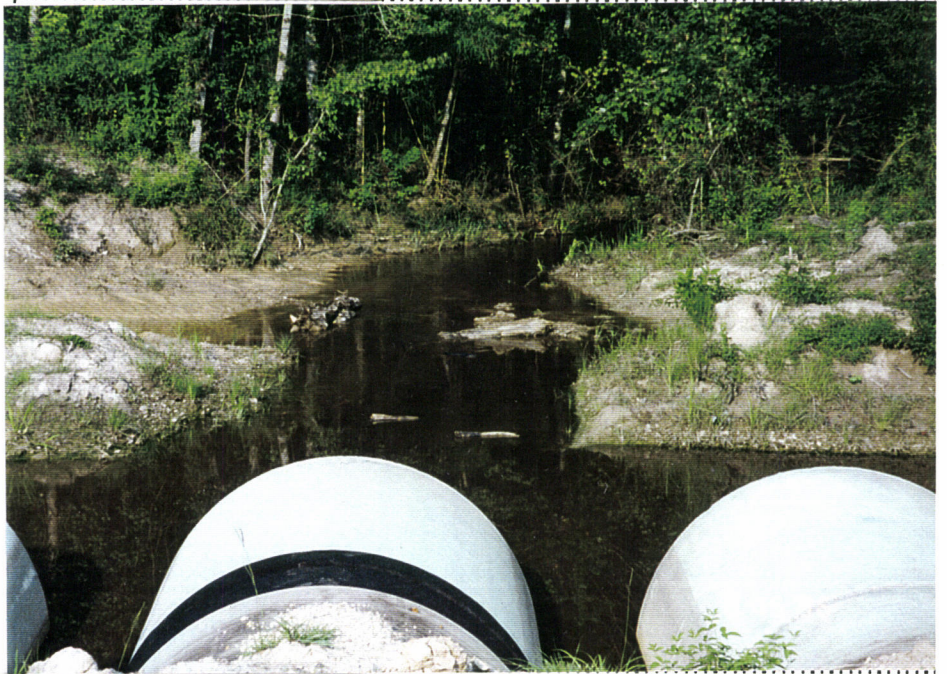
G960167- 08 - O-P

8. Southeast Arm at station at 83+00 culvert inlet .

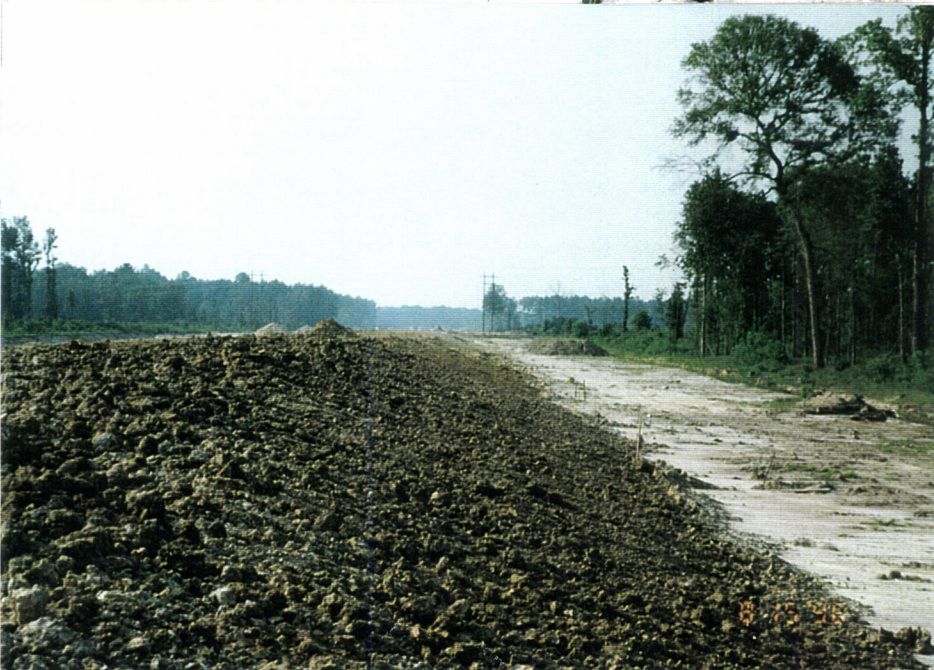
G960167-09 - O-P

9. Southeast Arm at station 80+00 showing the shaping of side slopes and moving the material to top of berm.

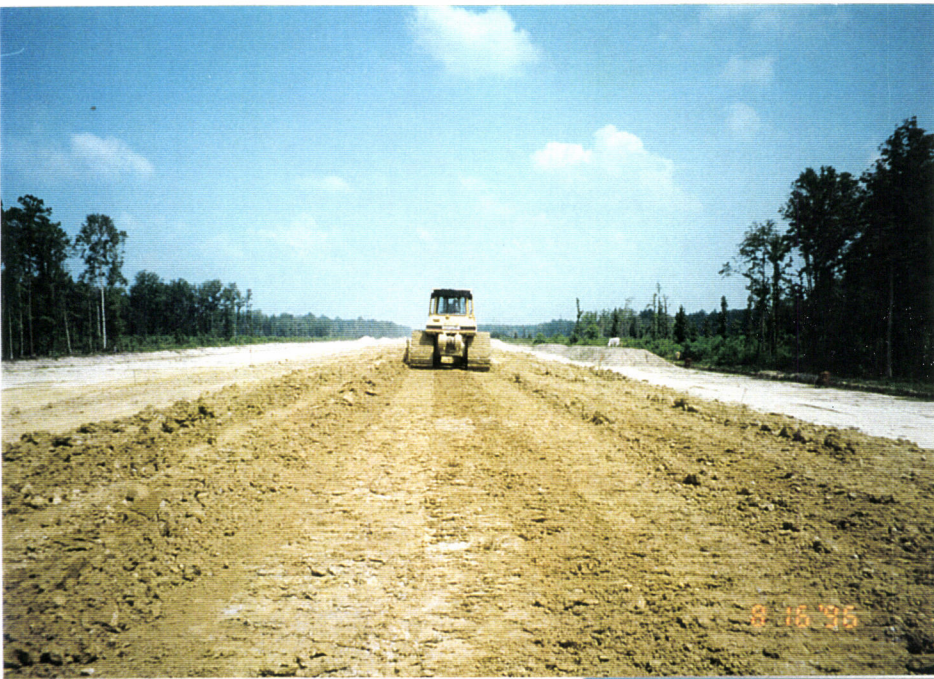
G960167- 10 - O - PV

10. Southeast Arm showing a dozer spreading material that came from side slopes.

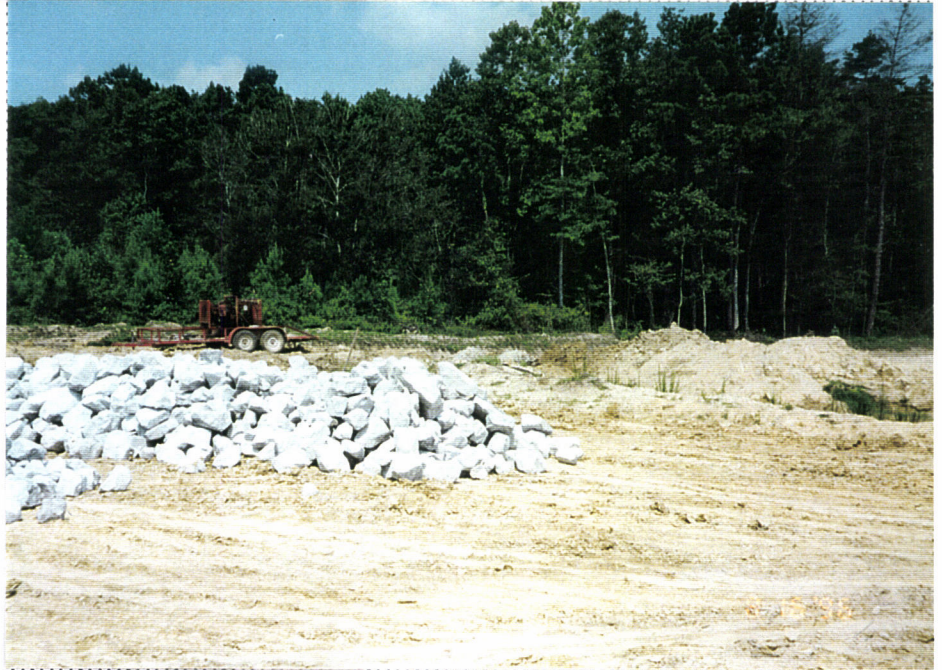
G960167- 11 - O - P

11. Southeast arm at station showing rip rap that will be installed to inlet of culvert 43+00.

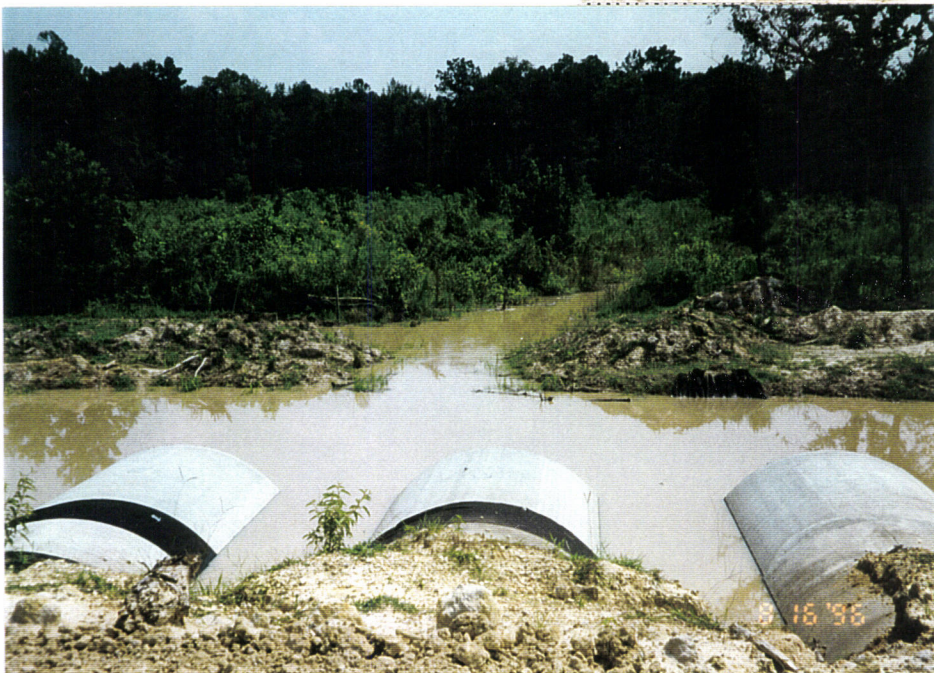
G960167- 12 - O - PV

12. Southeast arm at station 43+00 culvert showing the outlet Stranco will pump out the water and then install rip rap.

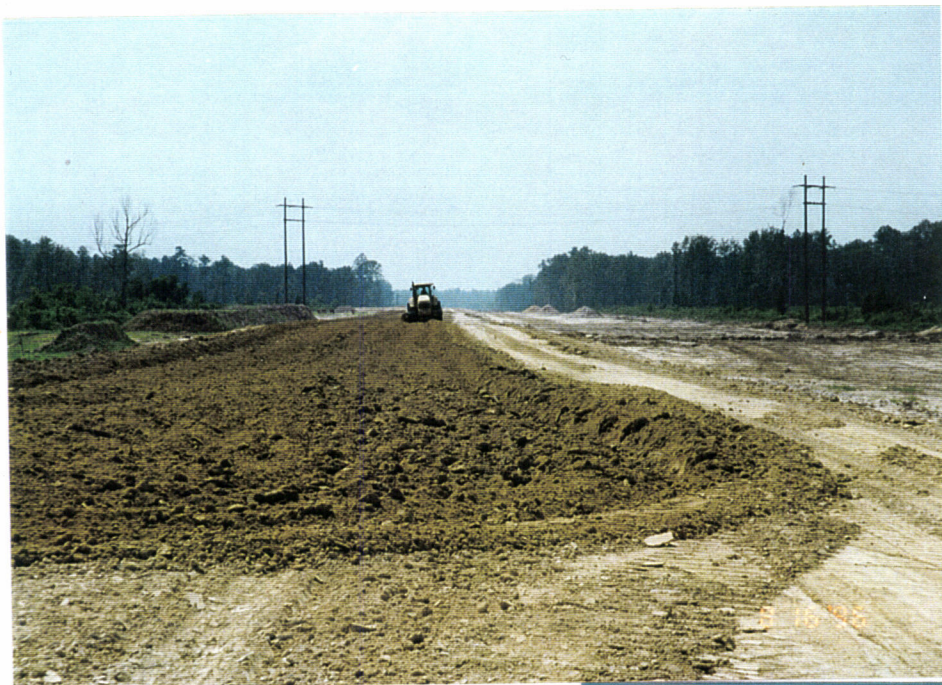
G960167- 13 - O-P

13. Southeast arm at station 56+00 using the Challenger to dry out the berm for compaction.

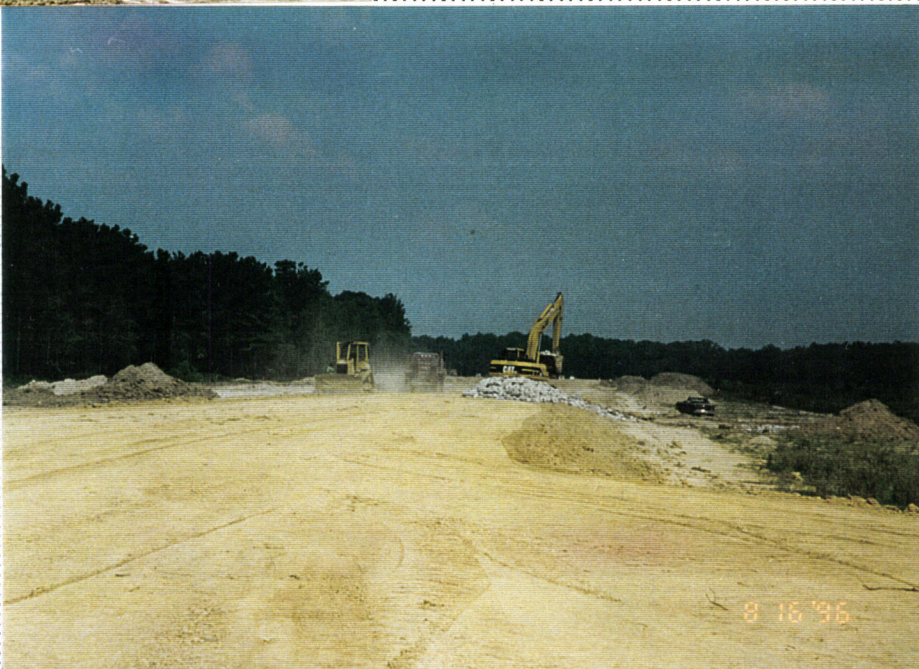
G960167- 14 - O-P

14. Southeast arm at station 33+00 showing the installation of rip rap at culvert crossing 27+00.

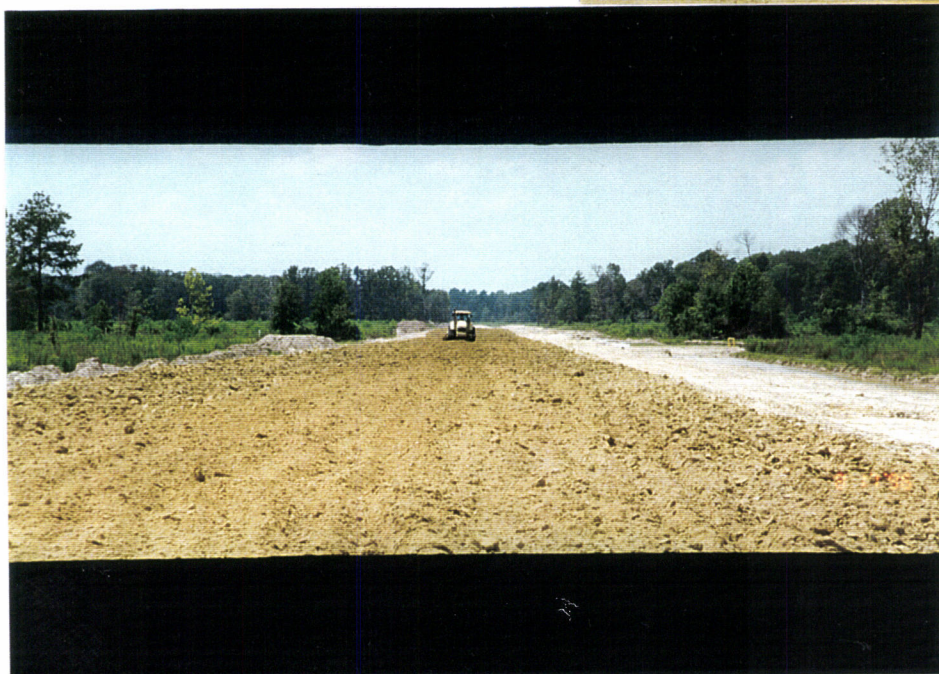
G960167- 15 - O-P

15. Southwest arm at station 109+00 drying out berm for compaction.

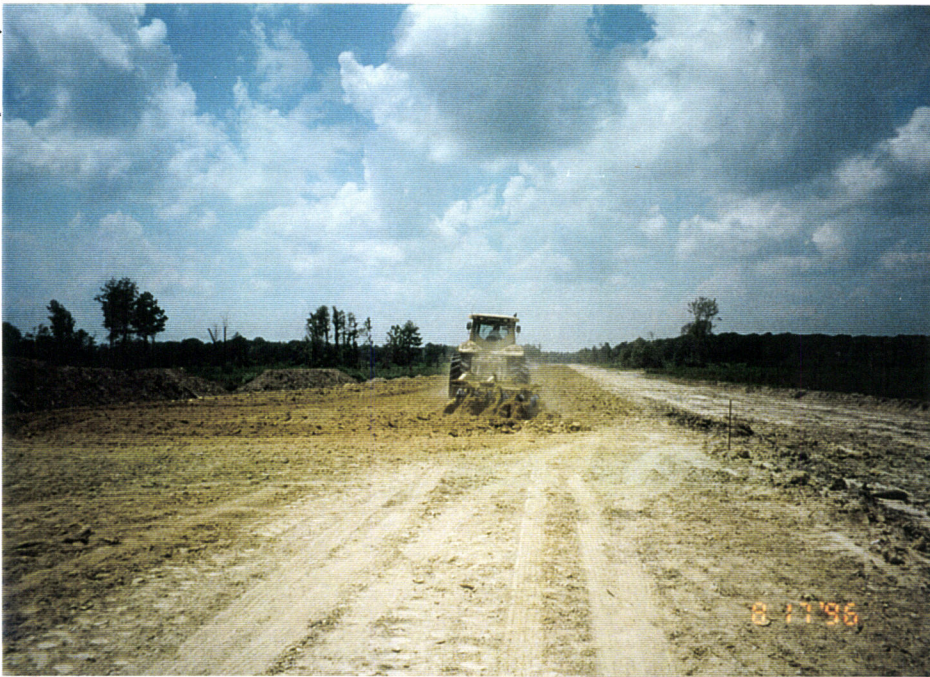
G960167- 16 - O-P

16. Southwest arm at station 86+00 drying berm material for compaction.

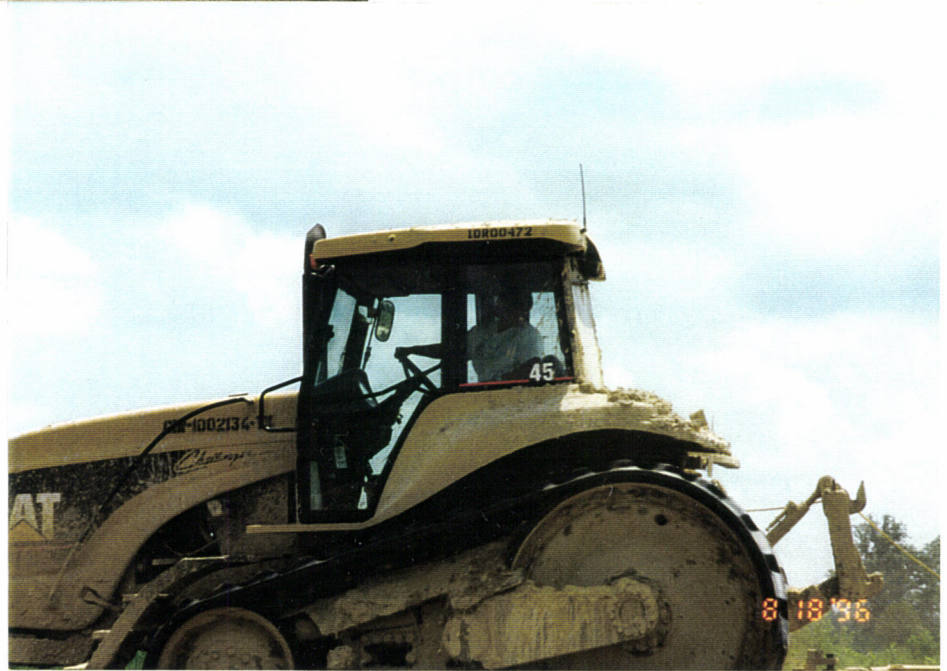
G960167- 17 - O-P

17. Southwest arm showing a close up of the Challenger and Operator.

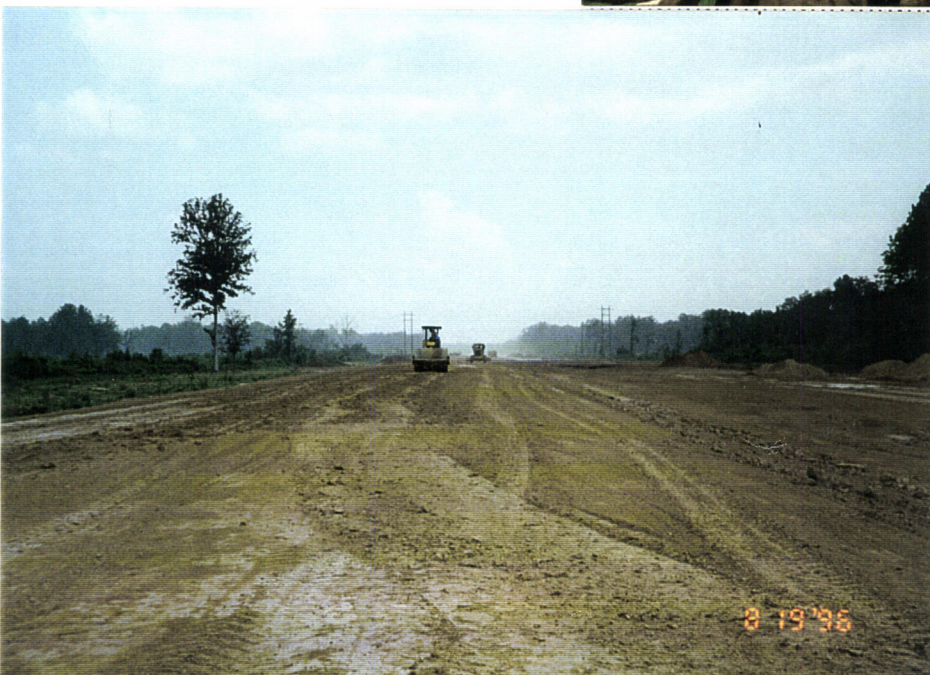
G960167- 18 - O-P

18. Southeast Arm at station 20+00 looking SE at a roller sealing off material in foreground and the rain falling as the sun shines in the back ground.

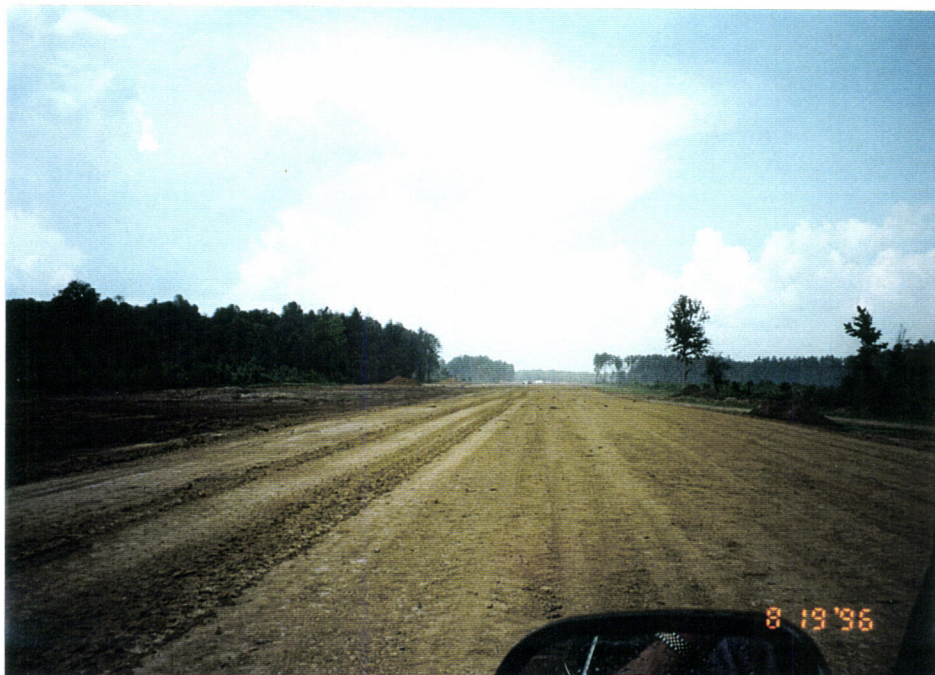
G960167-19 - O-P

19. Southeast Arm showing the berm at station 58+00 looking at the site office in the background.

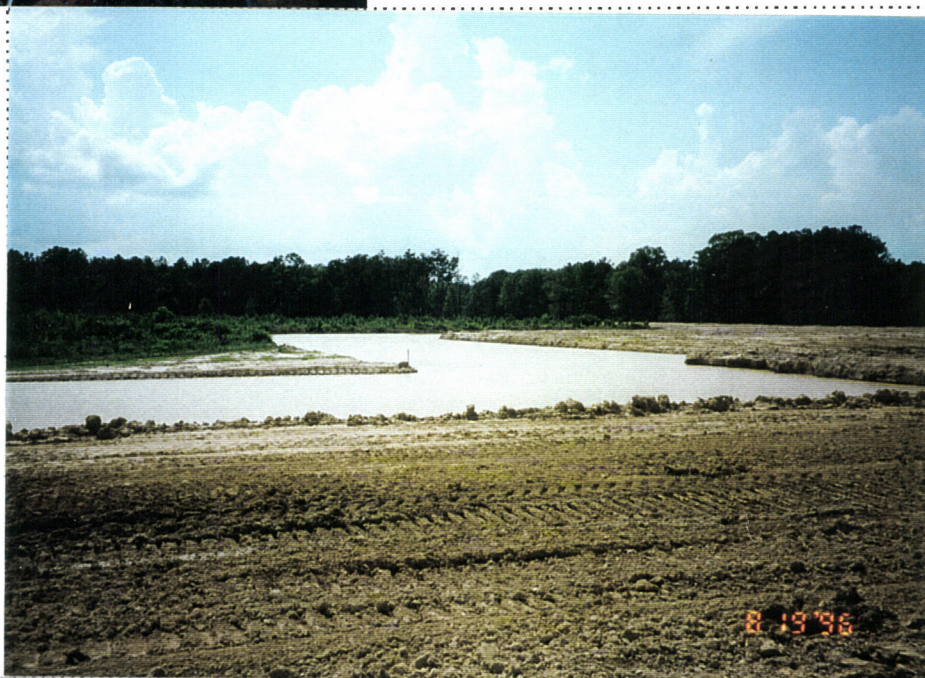
G960167-20 - O-P

20. Southeast arm at station 10+00 looking toward the Southwest arm over the excavated trench.

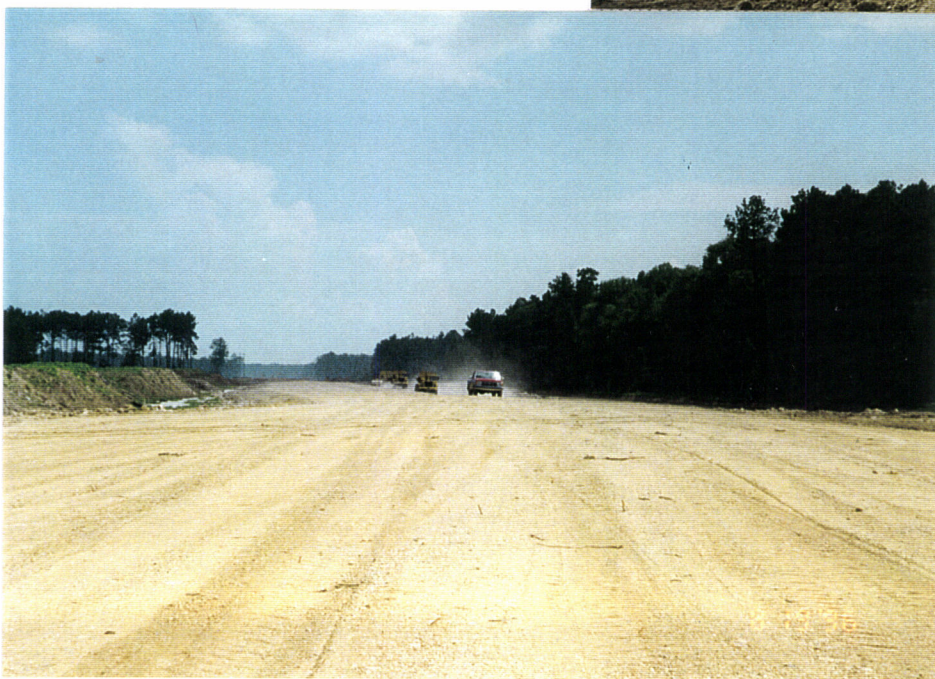
G960167-21 - O-P

21. Standing at the Apex area, looking at the SE berm showing progress in this area.

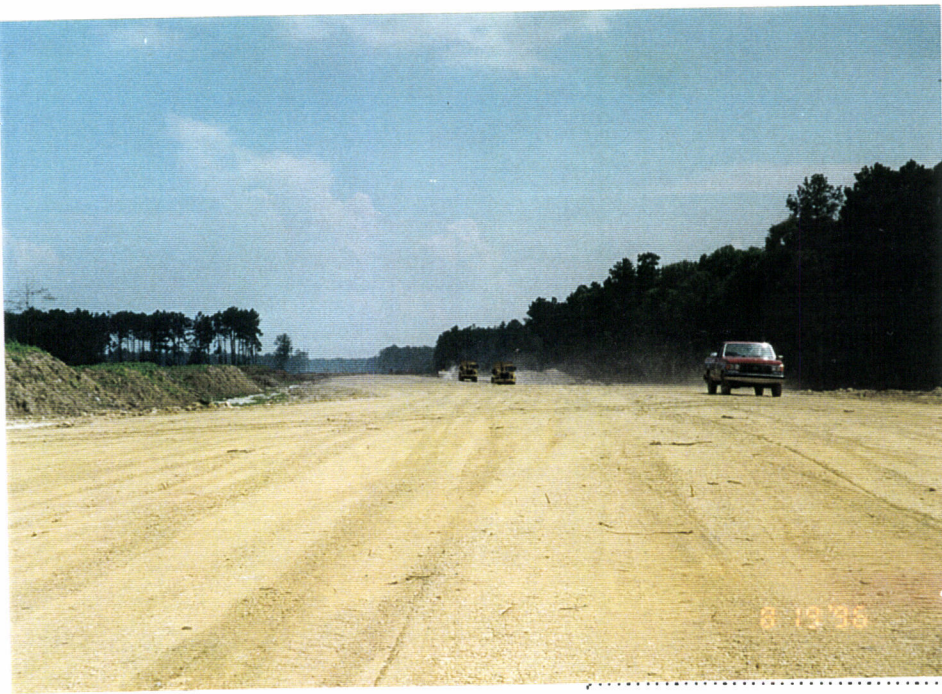
G960167-22-O-P

22. The same photo as in 21 showing haul trucks following the spread foreman to be shown where to start dumping fill.
