G960168-01 - O-P

- 1- Positioning Beam Tube Enclosure lifting device over Type 'A' beam tube enclosure.

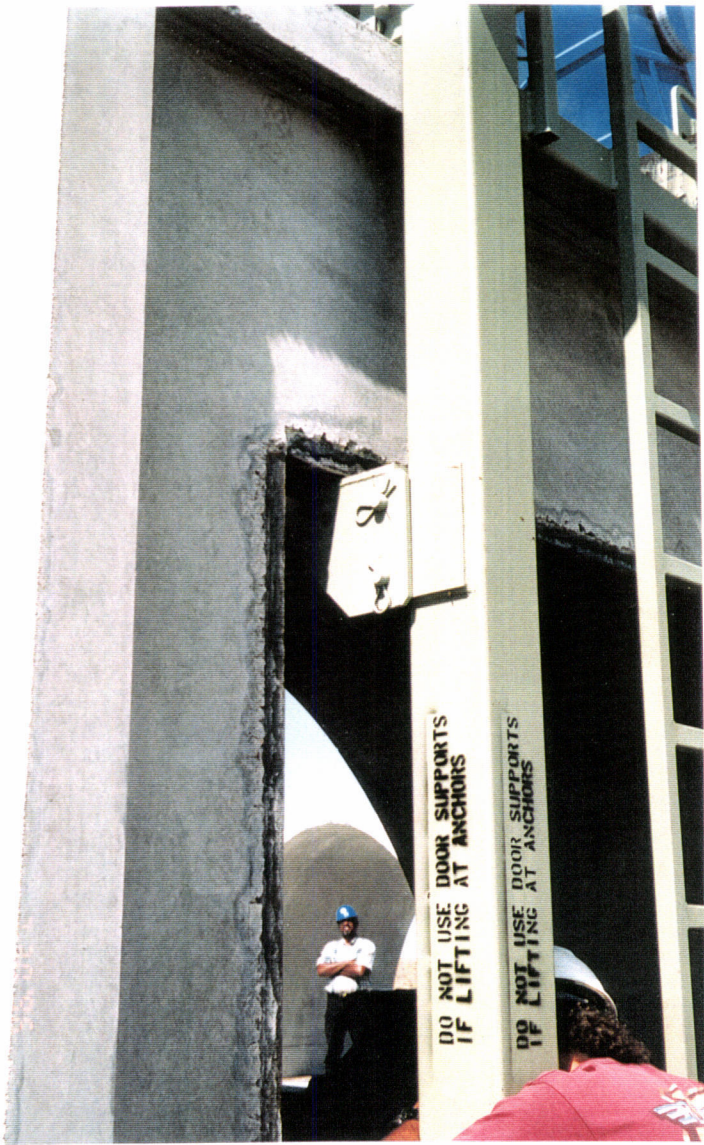
G960168-04 - 0-P

- 4- Type 'A' showing typical cracking in the top of the arch.

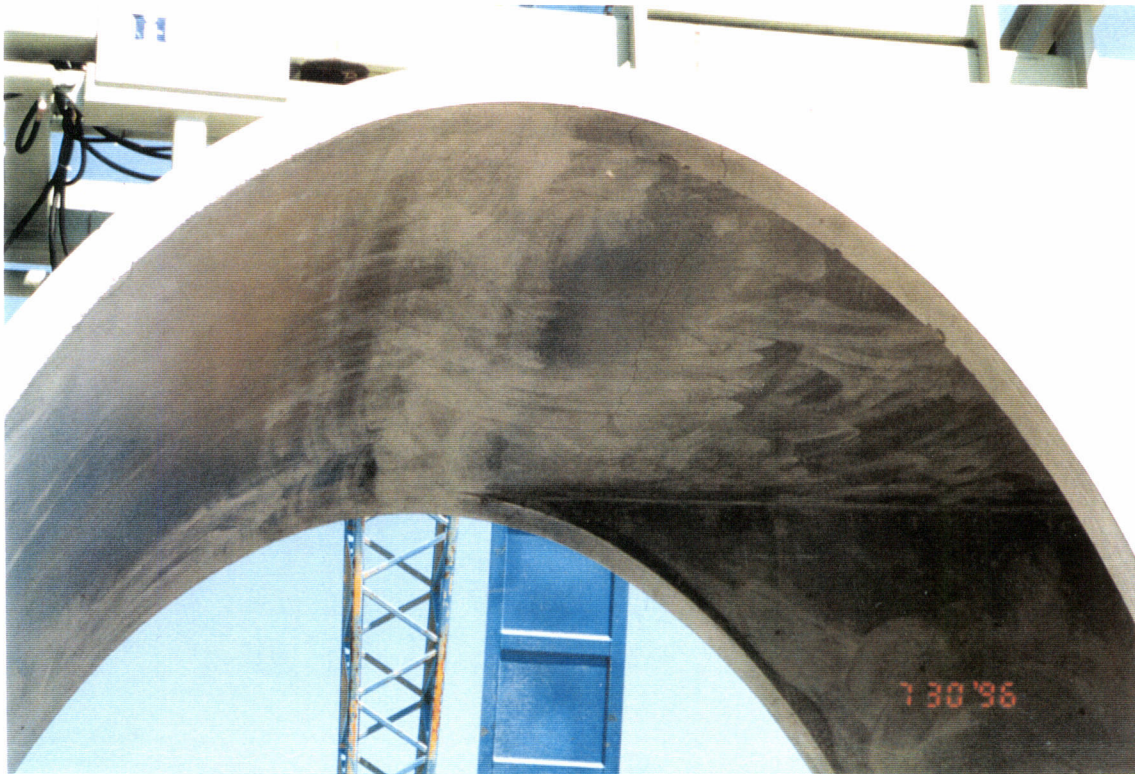
G960168-05 - O-FV

5- Close up of the crack in the Type 'A' enclosure.

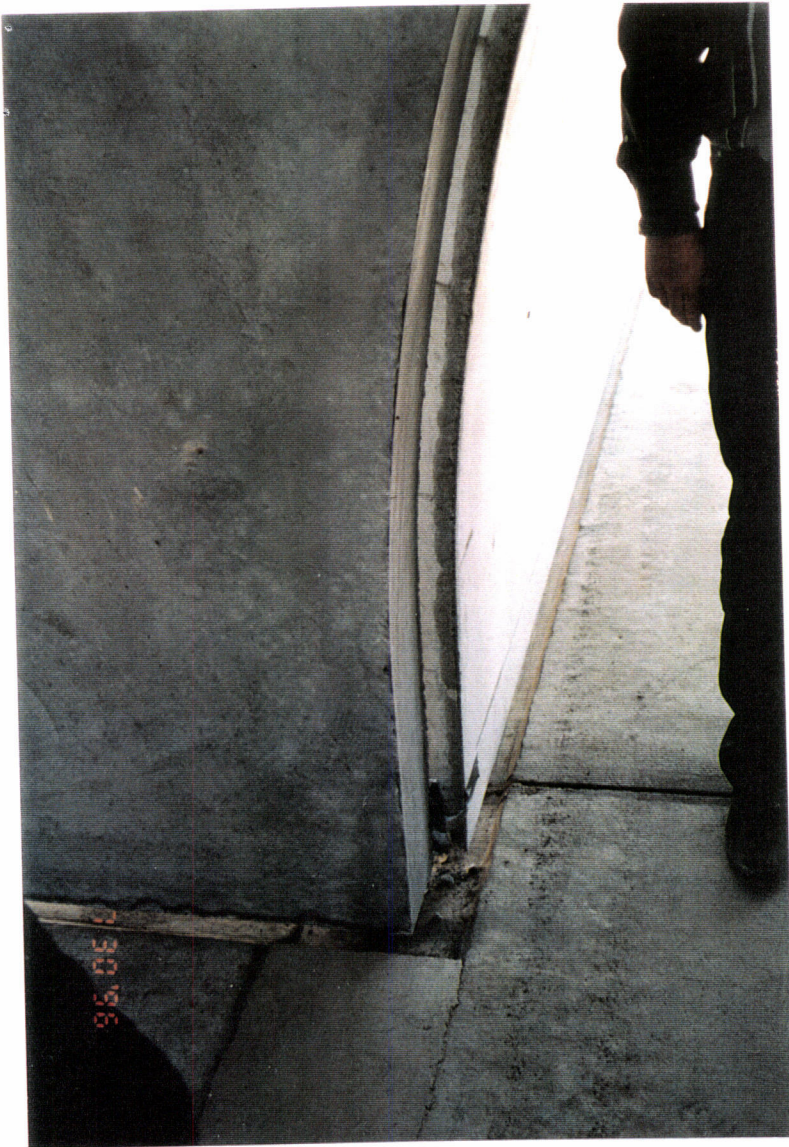
G960168-08 - OP

- 8- Position of Type 'A' enclosure on beam
tube slab, at service entry. Interference between
enclosure and conduit identified.

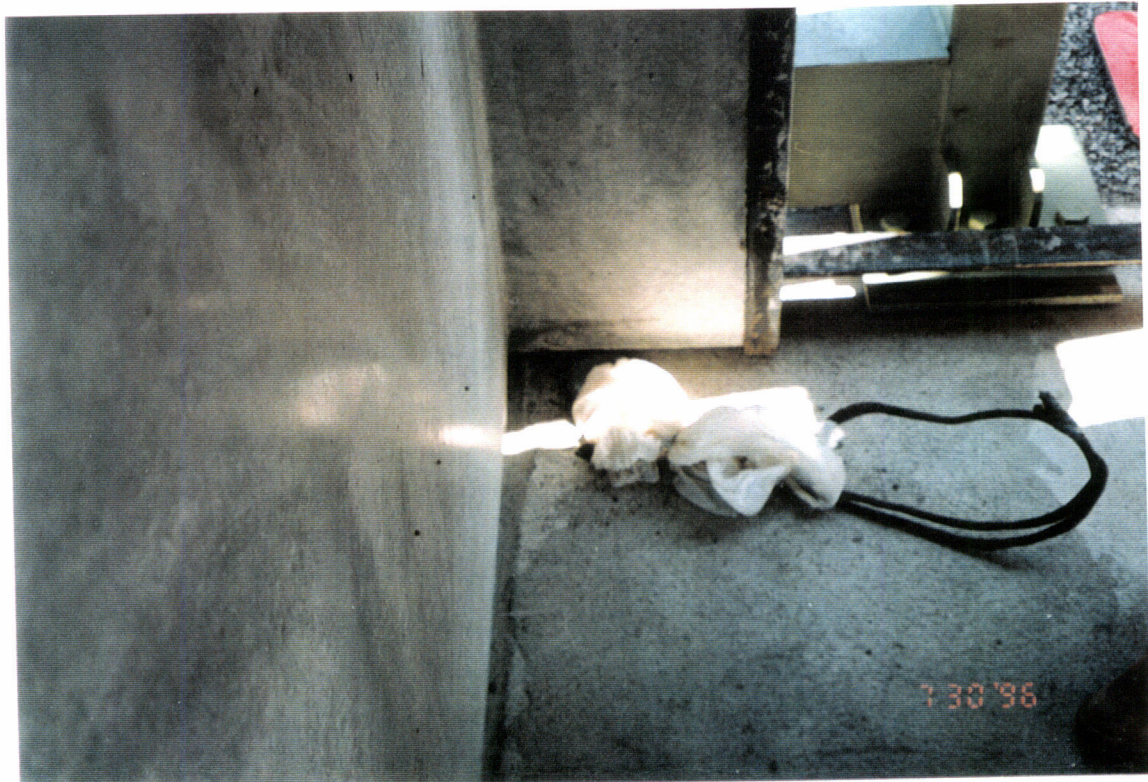
G960168-09 - O-P

9- Another view of the interference.

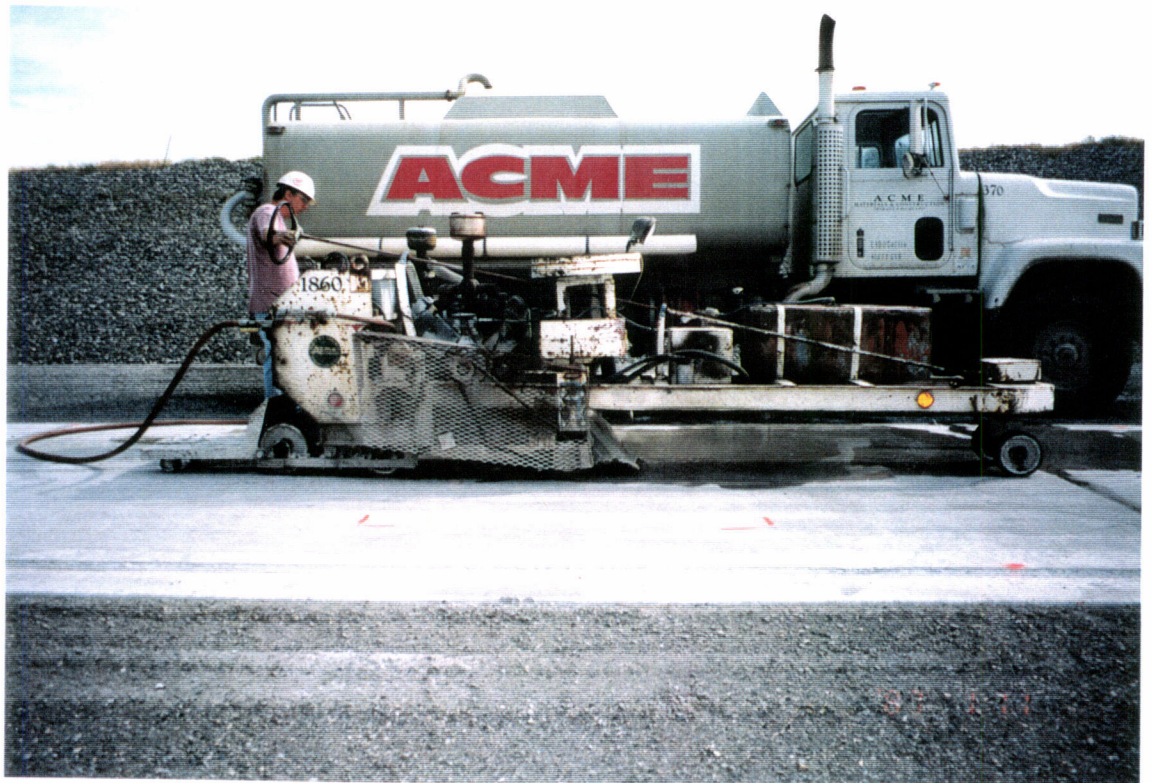
G960168-35 - OP

35- The orange markings are there to indicate where grinding needs to be done.

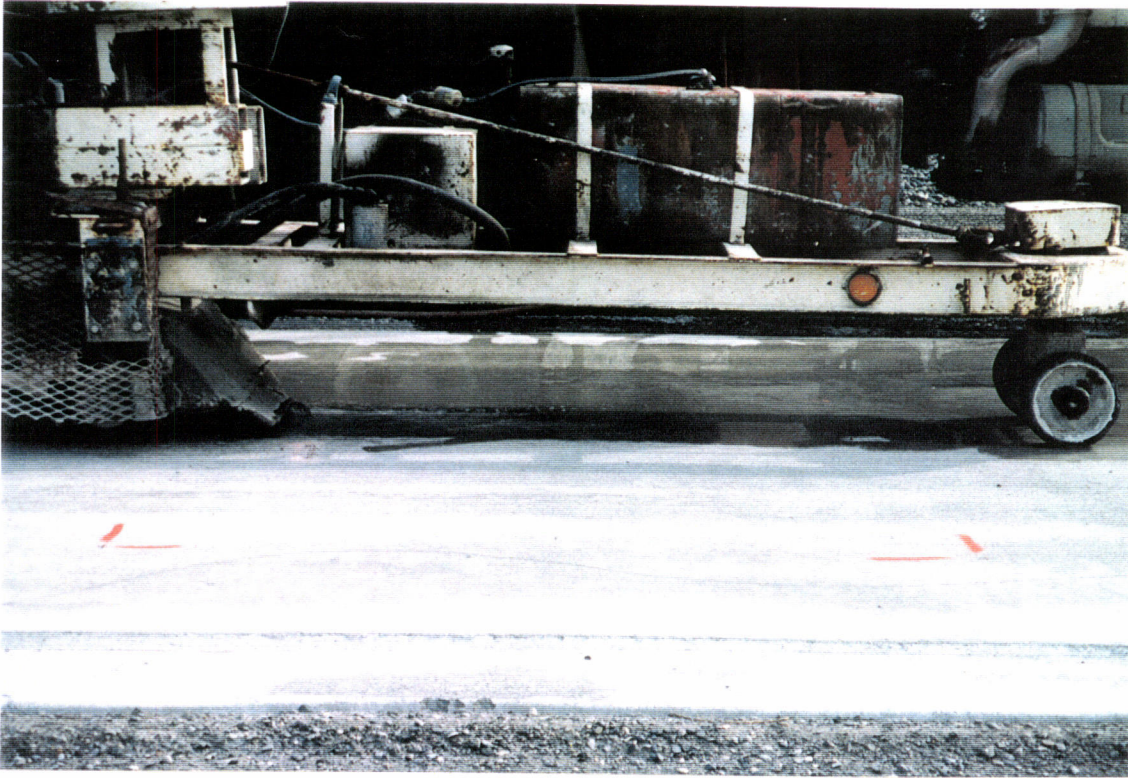
G960168-36 - O-P

36- A closer view of what needs to have grinding done.
