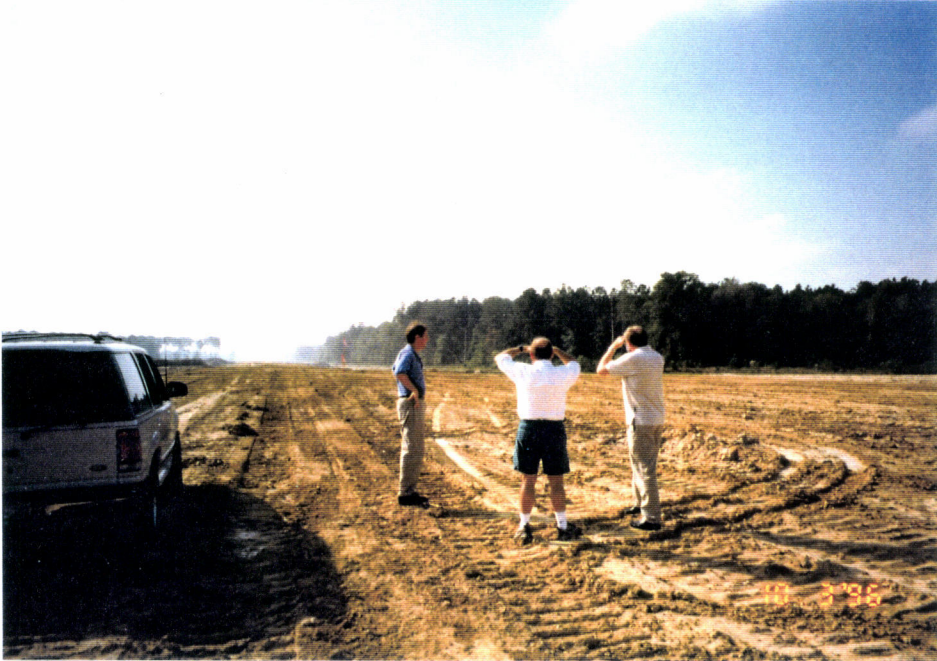
G960186-01-O-

1. Site visit by team members, standing at the point where two arms intersect each other.

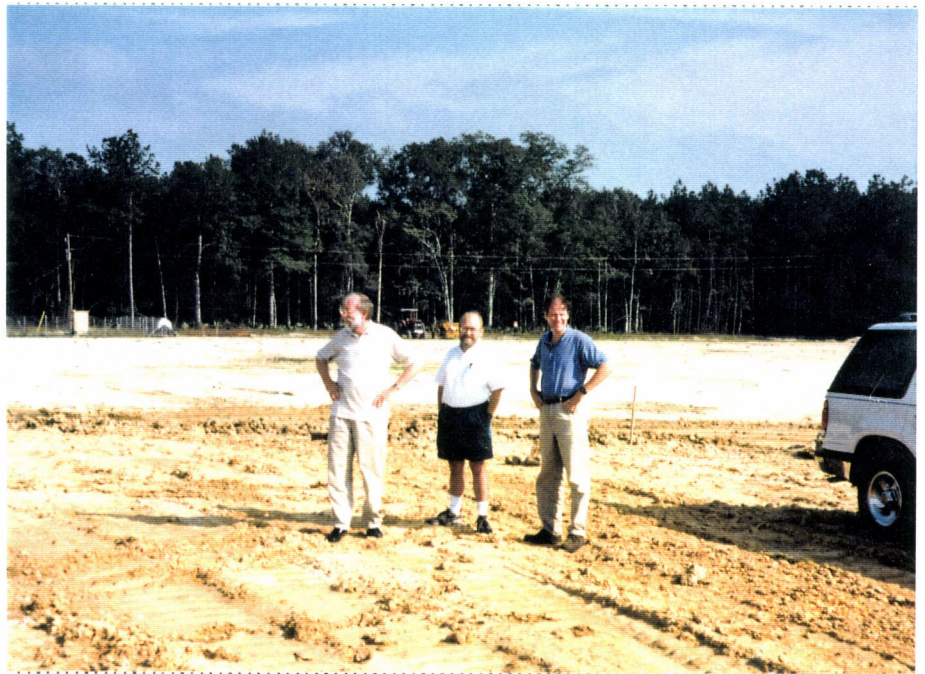
G960186-02-O-

2. Team members left to right: Professor Kip Thorne, Dr. Warren Johnston and Dr. Martin McHugh.

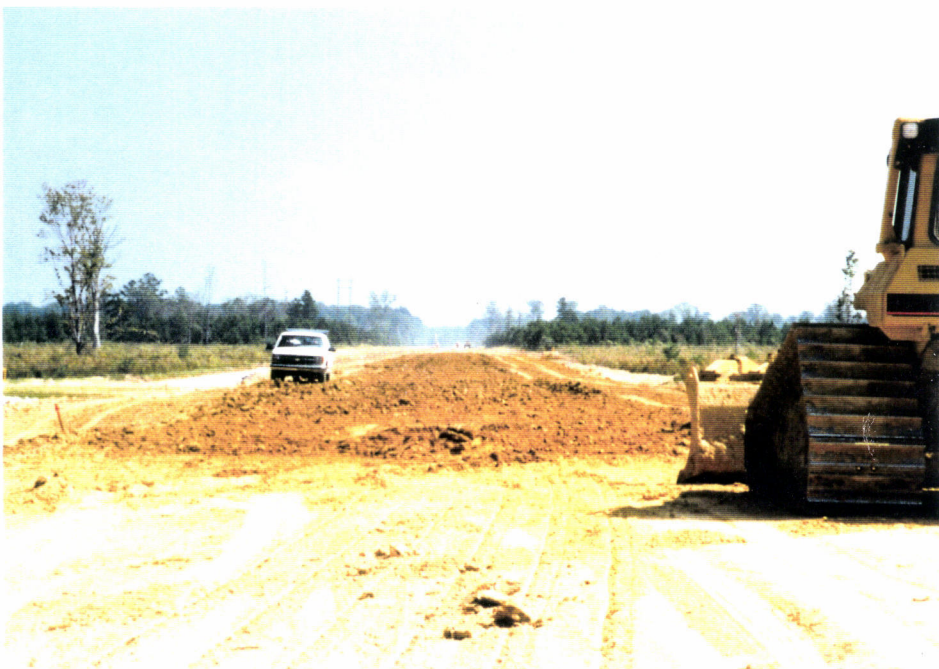
G960186-03-O-

3. Southwest arm at pipeline crossing, adding fill to bring berm up to elevation.

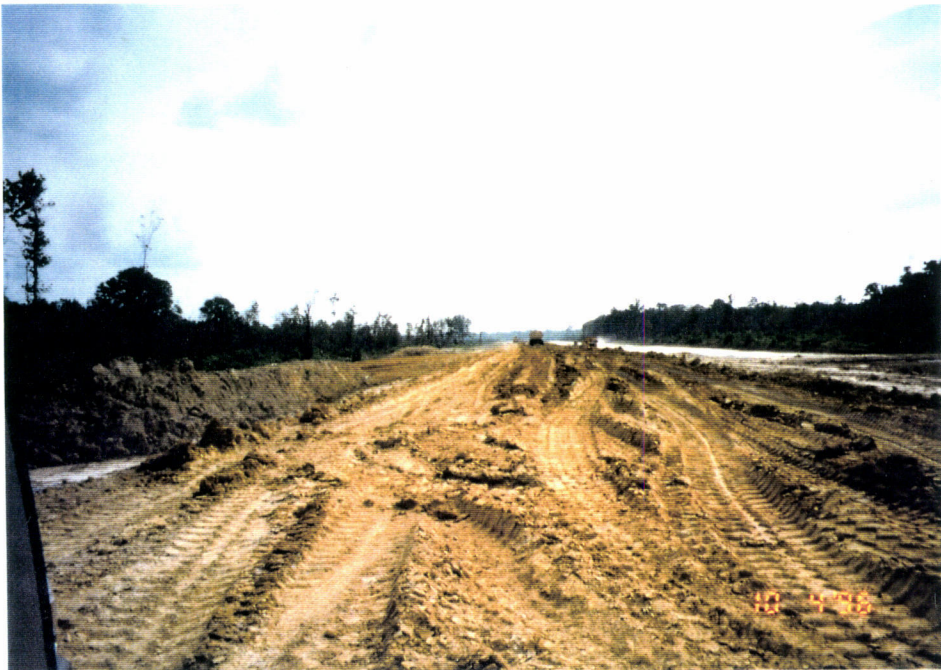
G960186-04-O-

4. Southeast arm at station 36+00 showing a lift of moist material being added. Note truck tire prints assisting in compaction.

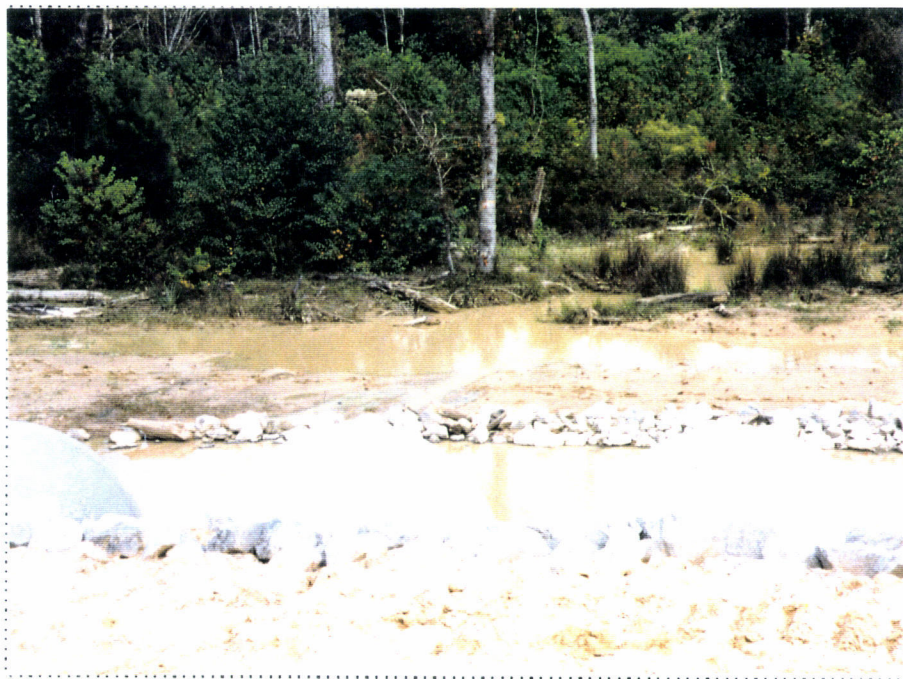
G960186-05-O-

5. Southwest arm at culvert crossing, station 83+00 showing water draining into creek.

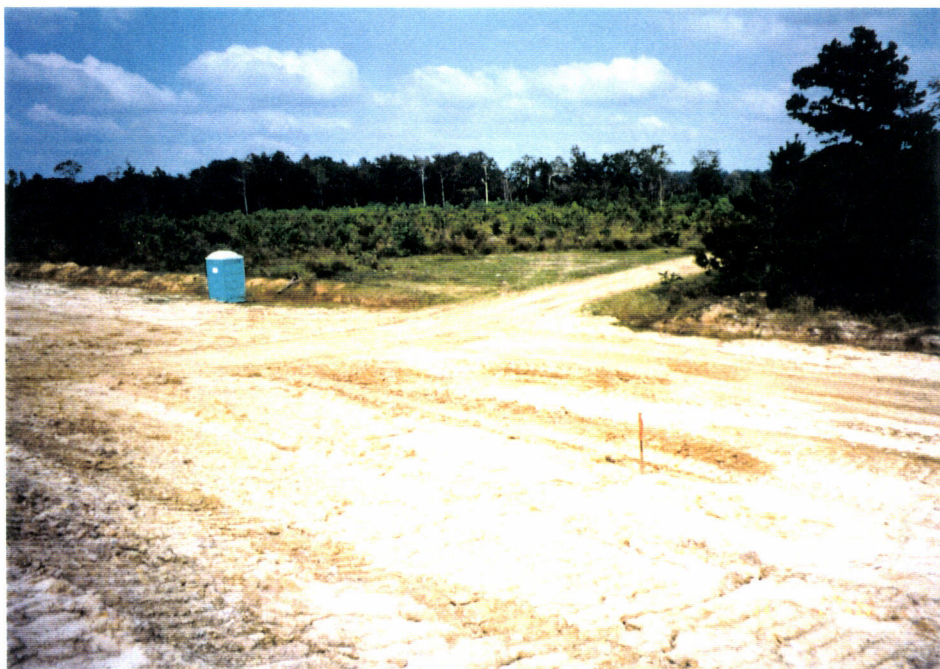
G960186-06-O-

6. Southeast arm at station 113+00 showing the temporary road at berm.

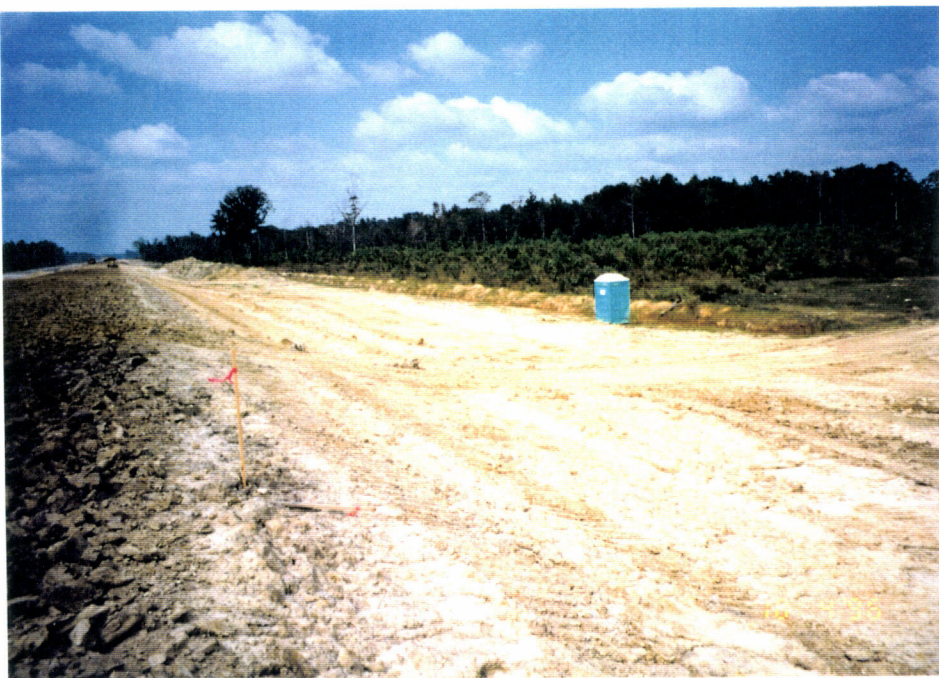
G960186-07-O-

7. Southeast arm at station 113+00 showing berm and temporary road interface.

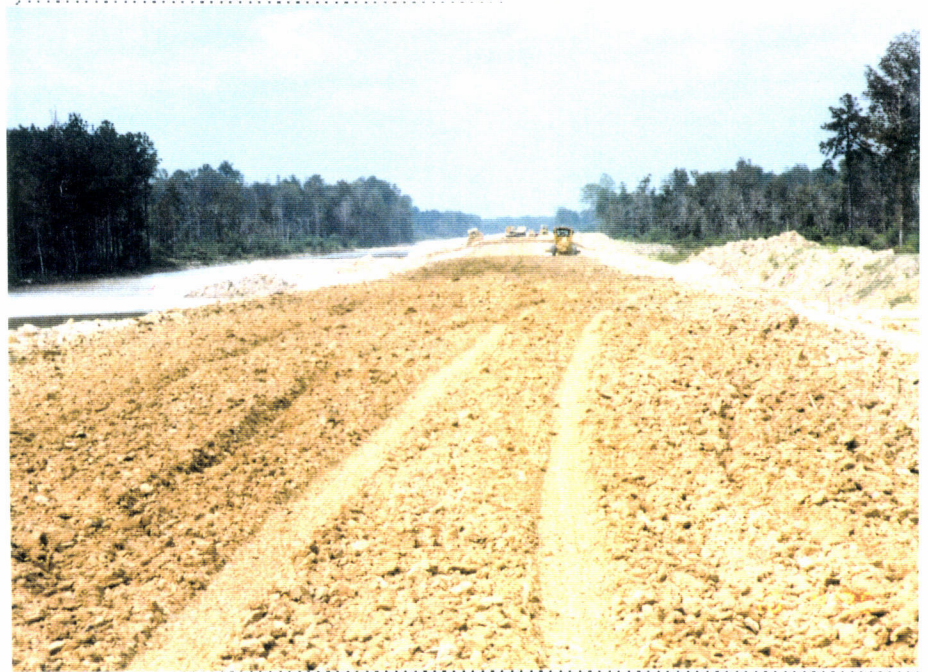
G960186-08-O-

8. Southeast arm at station 113+00 showing last lift being disked.

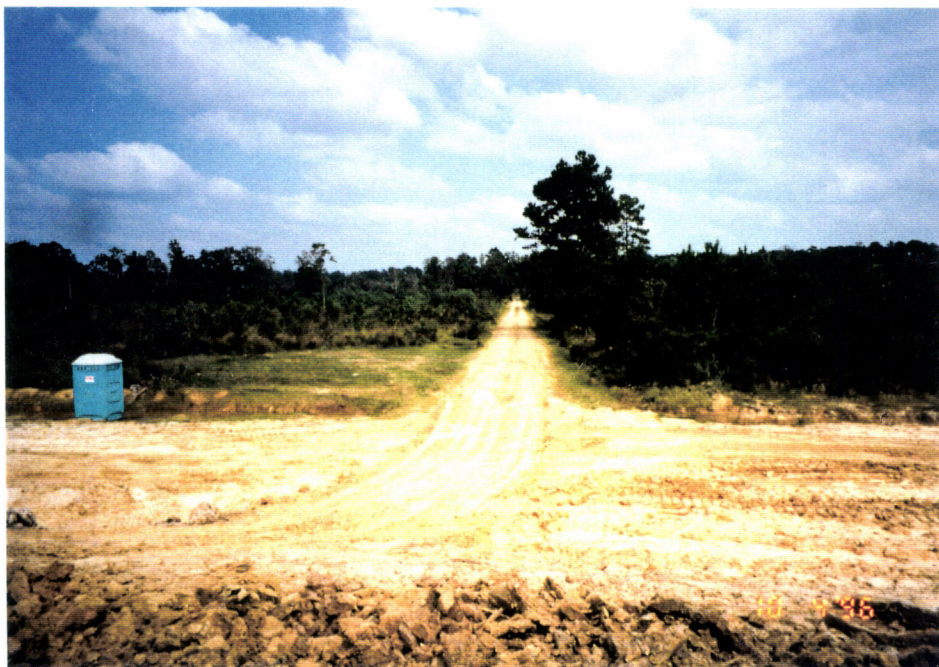
G960186-09-O-

9. Southeast arm at station 113+00 standing on berm looking east at temporary road.

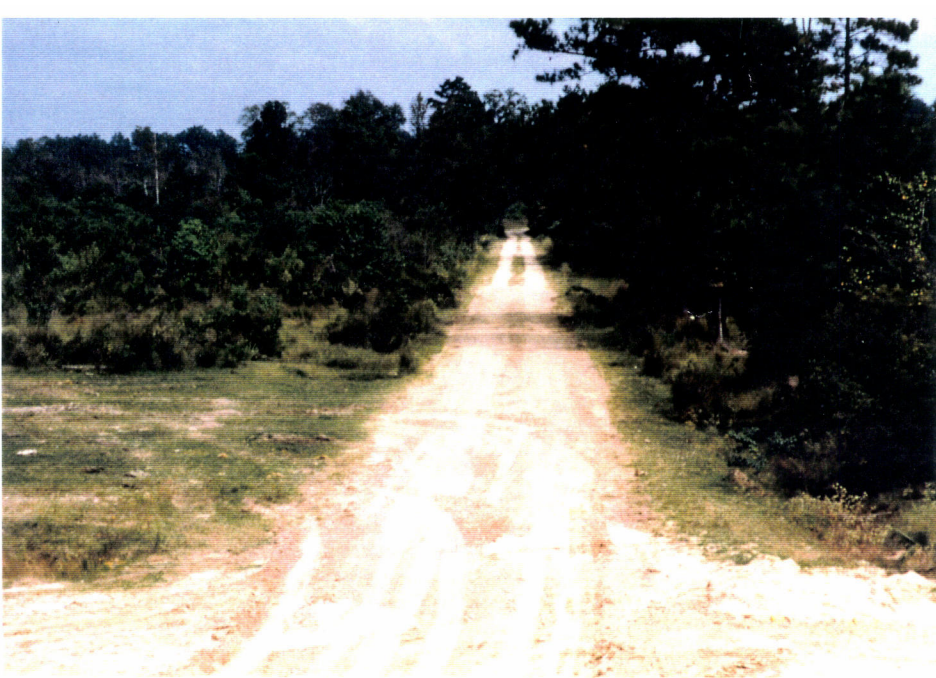
10. Southeast arm at station 113+00 , a closer look at temporary road.
G960186-10-O-

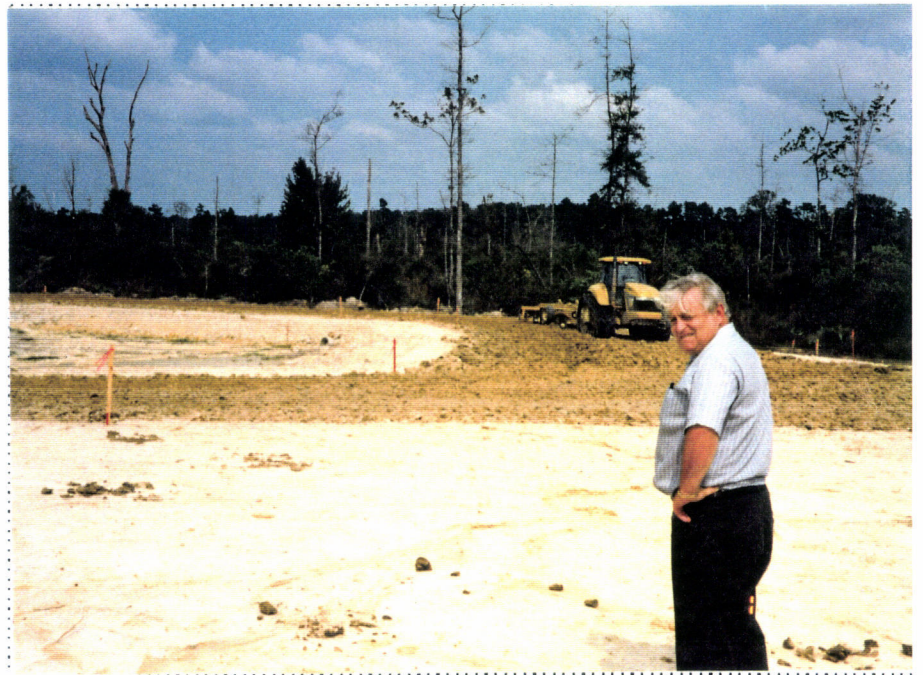
11. Southeast arm at station 132+00.
Mr. Gerry Stapper observing disking process.
G960186-11-O-

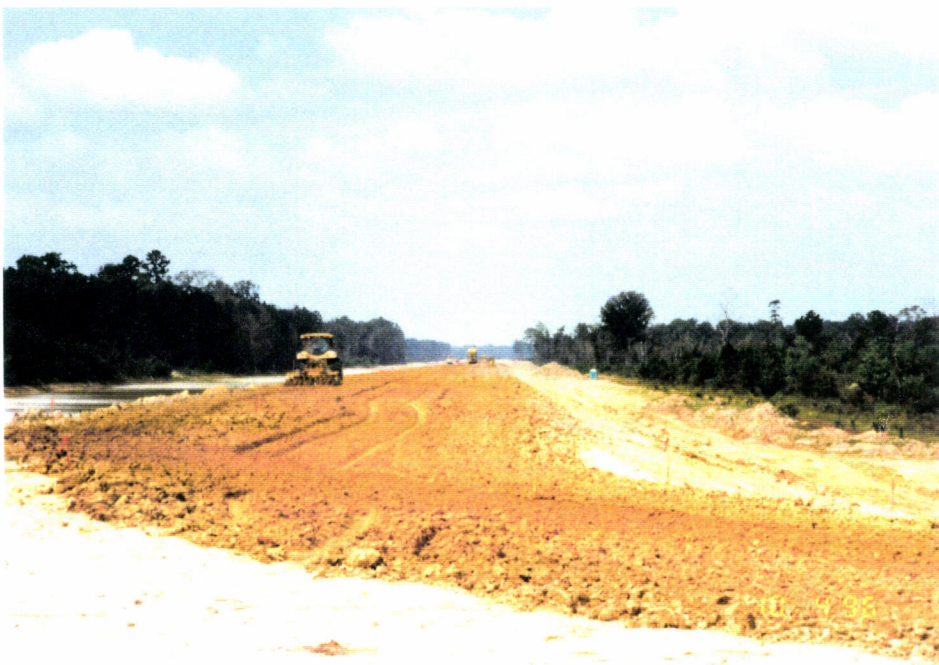
12. Southeast arm at station 132+00 disking a lift of berm.
G960186-12-O-

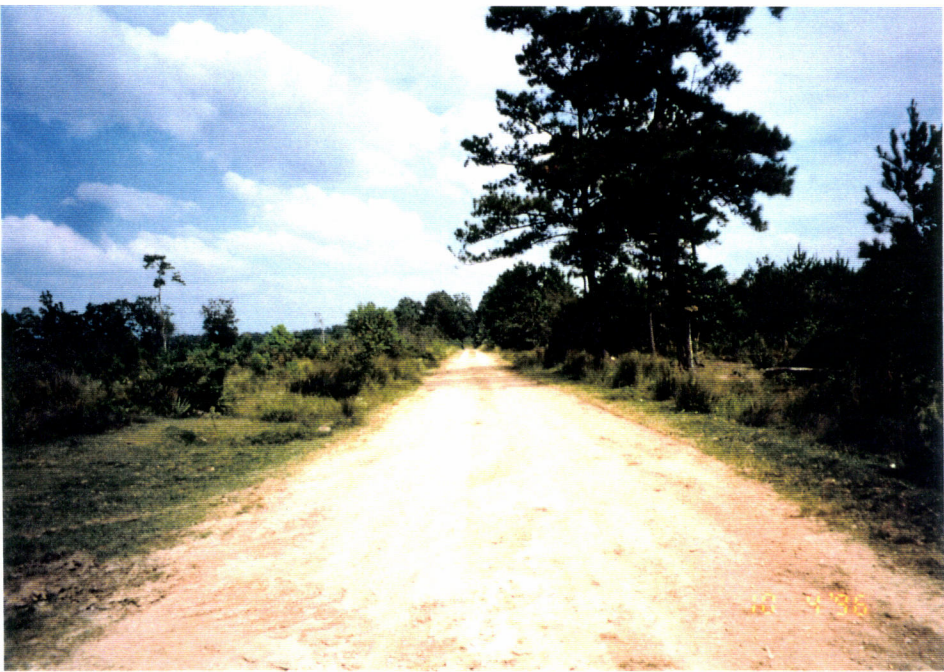
G960186-13-O-

13. Southeast arm looking east from berm at temporary haul road.

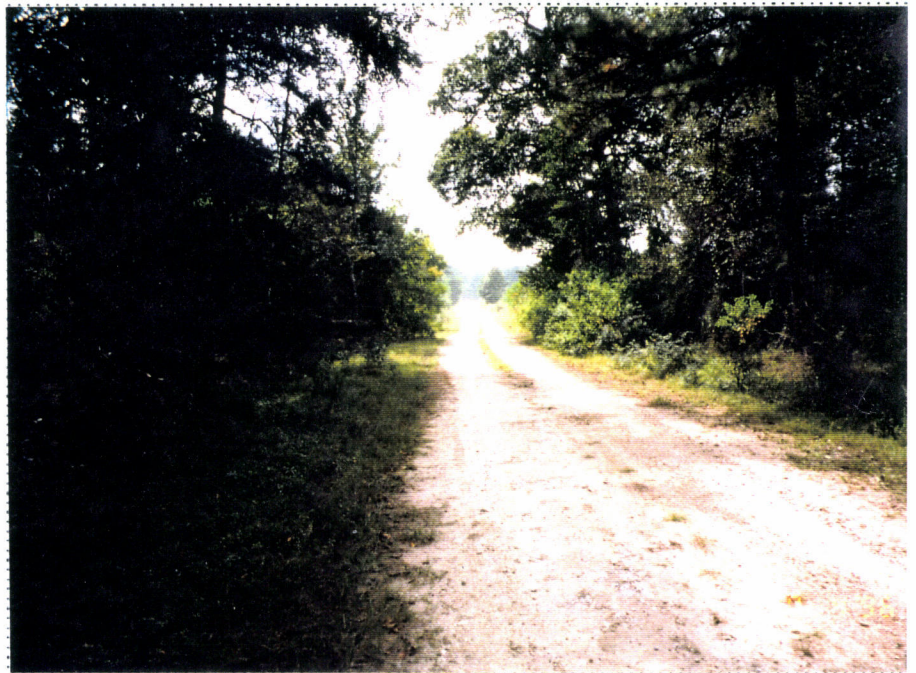
G960186-14-O-

14. Southeast arm standing on temporary haul road looking west at berm in the background.

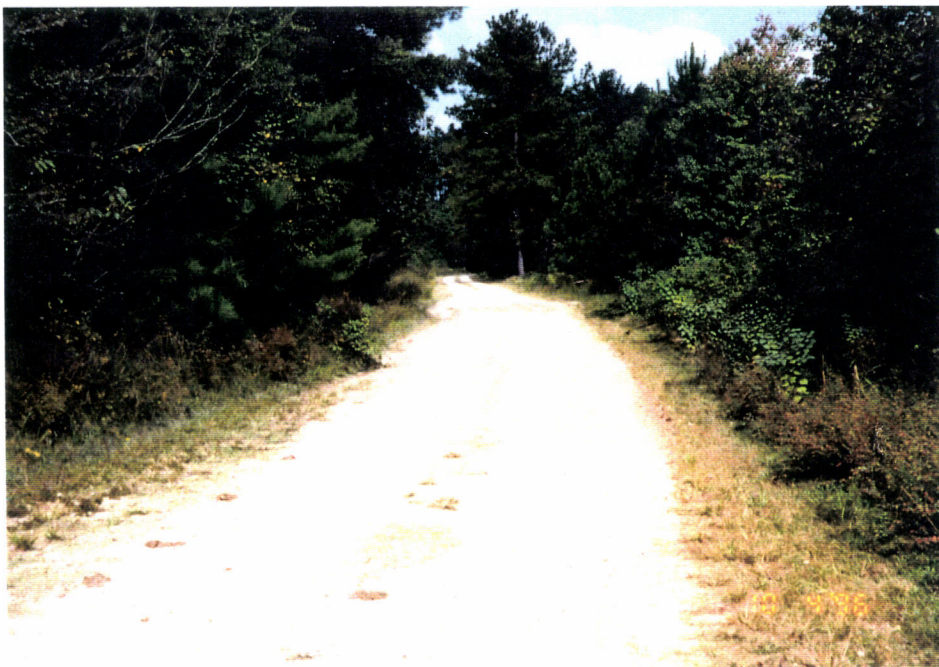
G960186-15-O-

15. Temporary haul road looking east at creek under crossing and low spot requiring some fill.

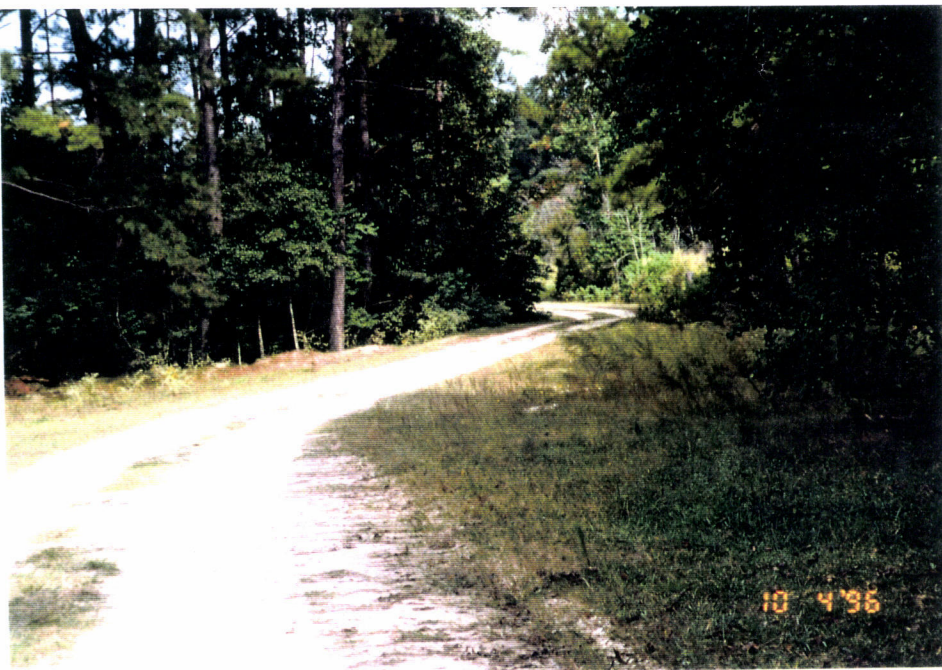
G960186-16-O-

16. Temporary haul road looking east at "S" curve between creeks.

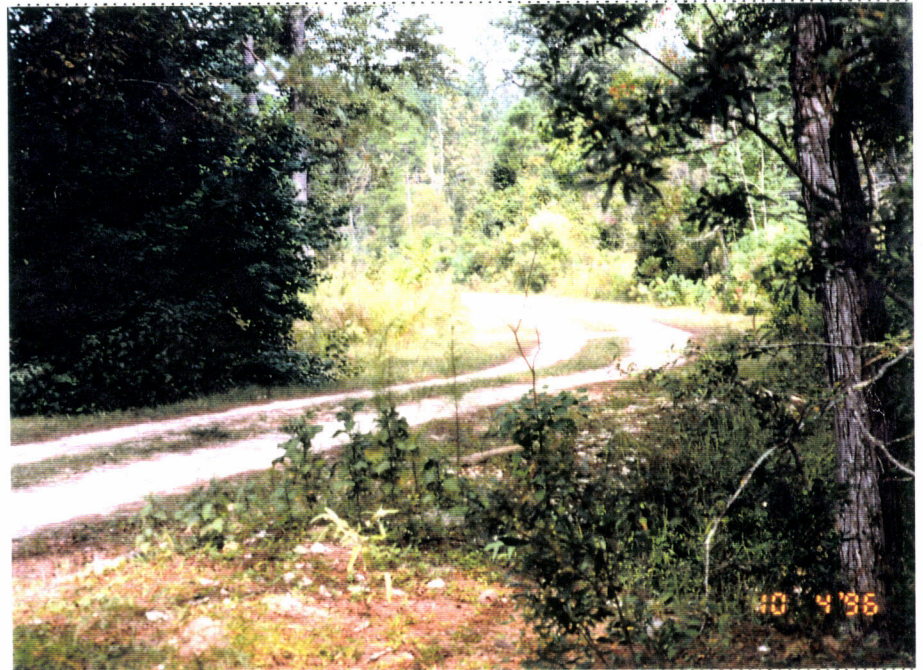
G960186-17-O-

17. Temporary haul road looking northeast at end of "S" curve.

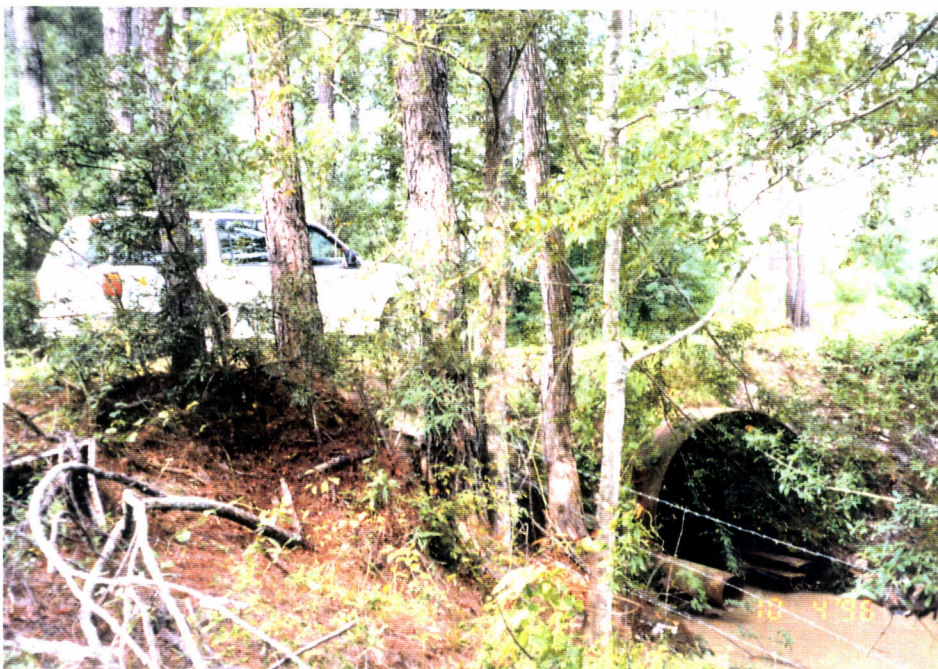
G960186-18-O-

18. Temporary haul road looking at second (larger) creek culvert.

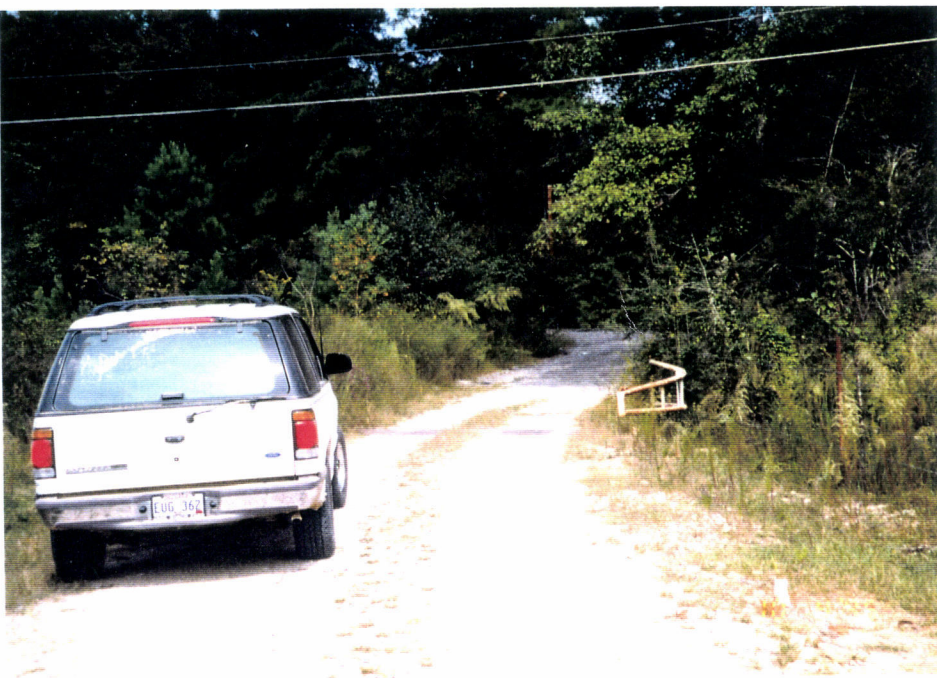
19. Temporary haul road looking east at cattle guard and gate. Highway 63 in the background.
G960186-19 -O-

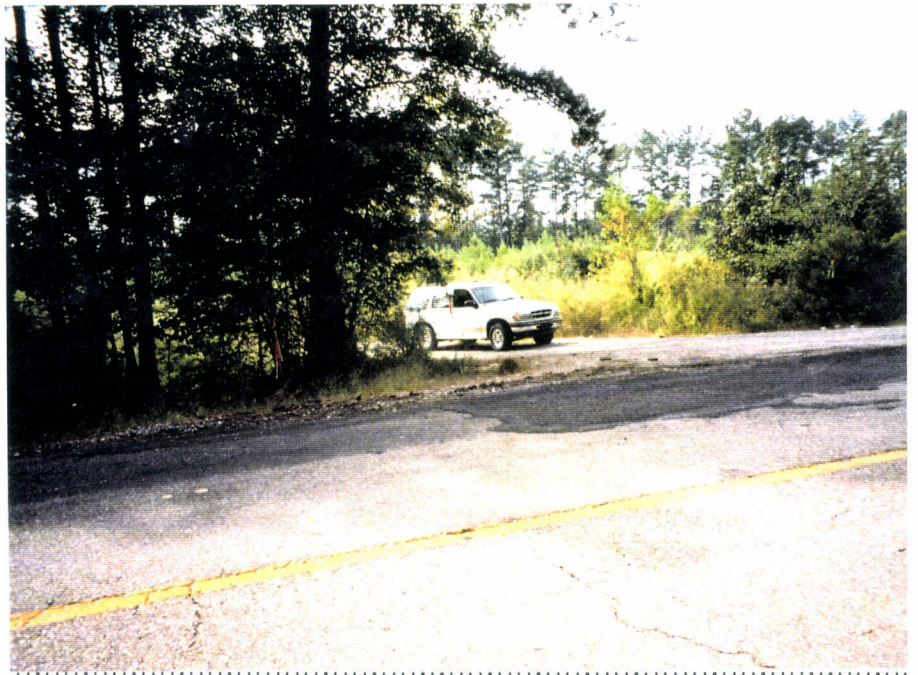
20. Highway 63 looking at temporary haul road entrance.
G960186-20 -O-

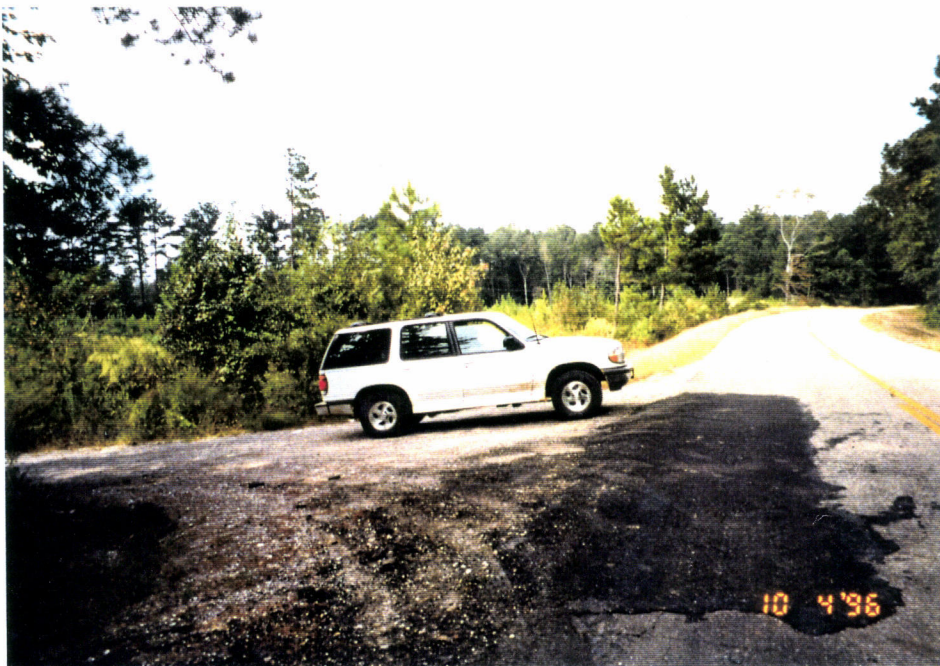
21. Highway 63 looking north at temporary haul road as it connects to the highway.
G960186-21 -O-

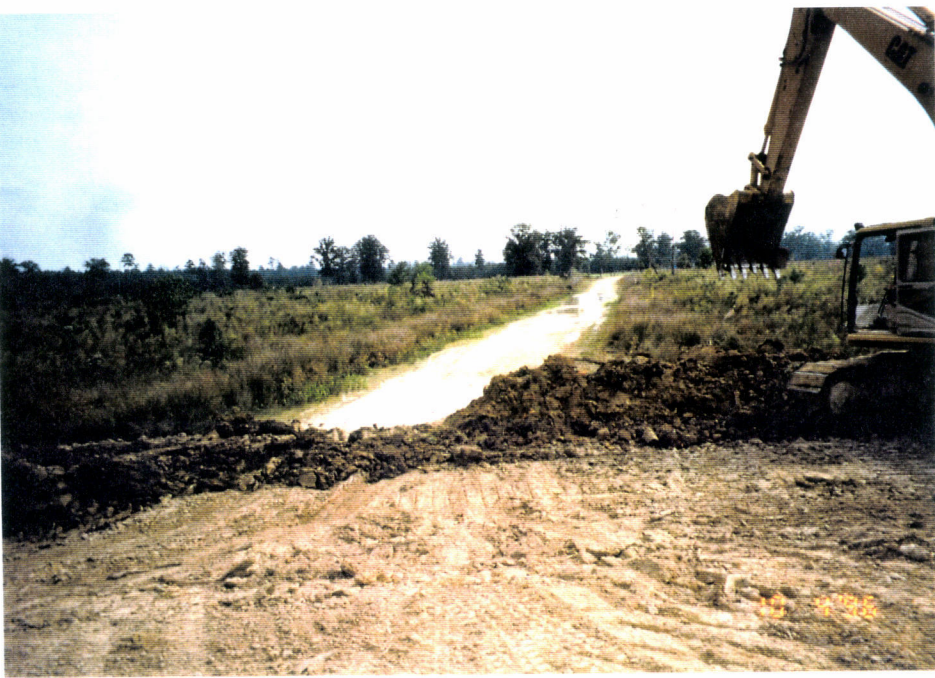
G960186-22-O-

22. Southwest arm at station 98+00. Contractor is building a soil blockade to keep 4x4 activity at a minimum.

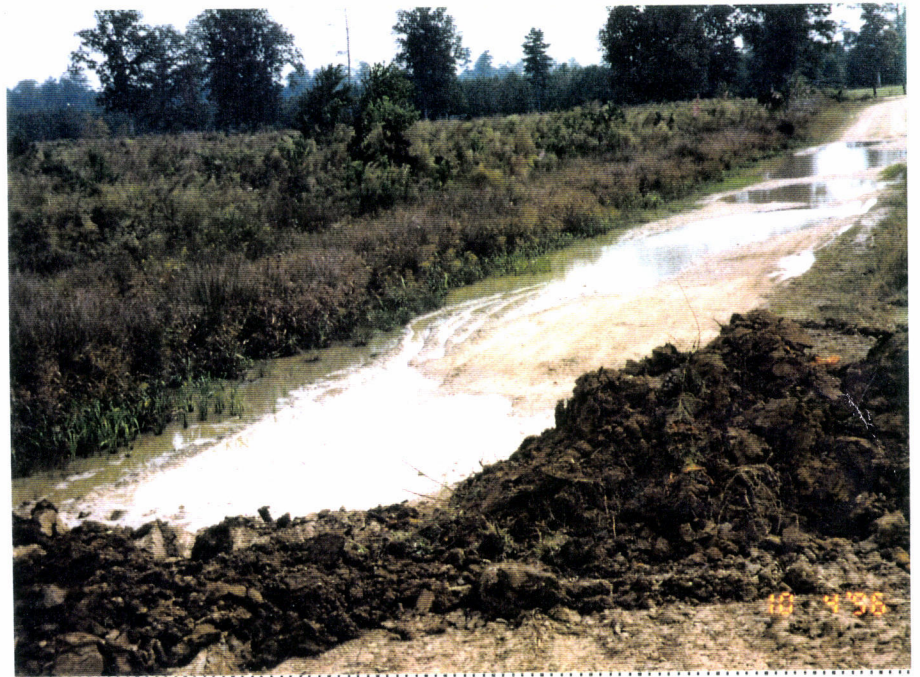
G960186-23-O

23. A closer look at blockade station 98+00, SW arm looking south.

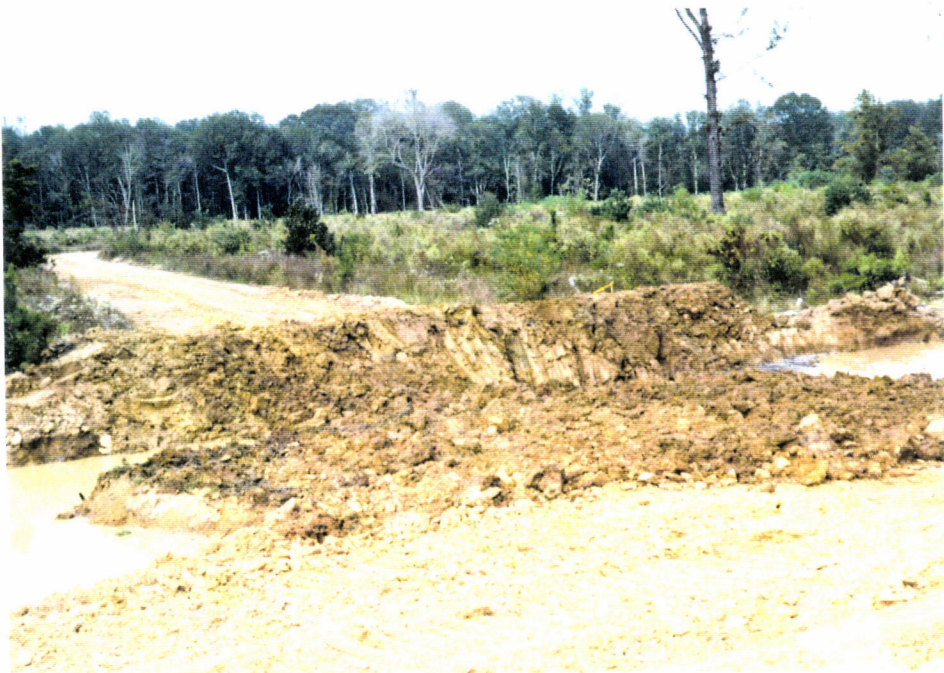
G960186-24-O

24. Southwest arm looking north at station 98+00 showing blockade.
