LIGO- T1200328-v1

Repair to a severely damaged “horn” on E/ITM Ears

A. S. Bell, A. V. Cumming, and L. Cunningham

Institute for Gravitational Research, University of Glasgow

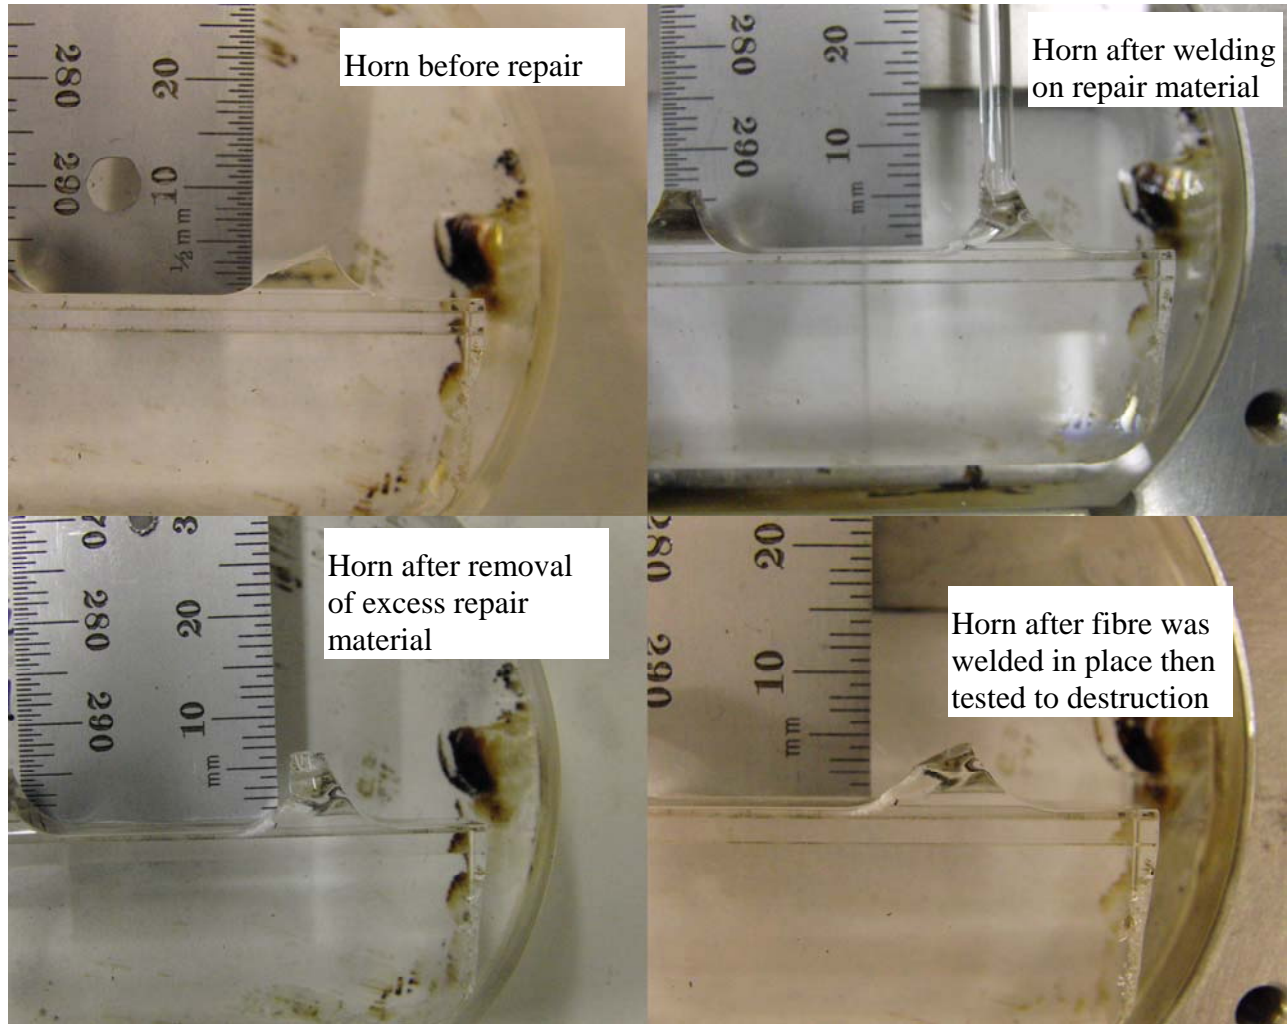
### 2.3.1 Horn #3 at all stages

The process was continued with #3, which had been cut to resemble the damaged horn at LHO. The horn also has a crack across the ground surface and some chipping around the edges. A lot of material was used from the 3 mm stock to build up the horn. The repair was completed by removing the excess stock above 6 mm from the flat of the ear. This horn was tested by welding on a fibre and doing a pull test on the strength testing machine.

The welding of the fibre to the repaired horn was unremarkable and a reasonable looking weld was produced. The assembly was loaded into the testing rig and the load slowly increased until breaking point. The failure came at a 25 kg load, which is 2.5 times nominal load, if perhaps slightly lower than the mean value we have seen for cartridge tests.
