# A Proposed Capacitive Position Sensor Timing Synchronization and Distribution Solution

Ben Abbott

May 9, 2014

**G1400522-v1**

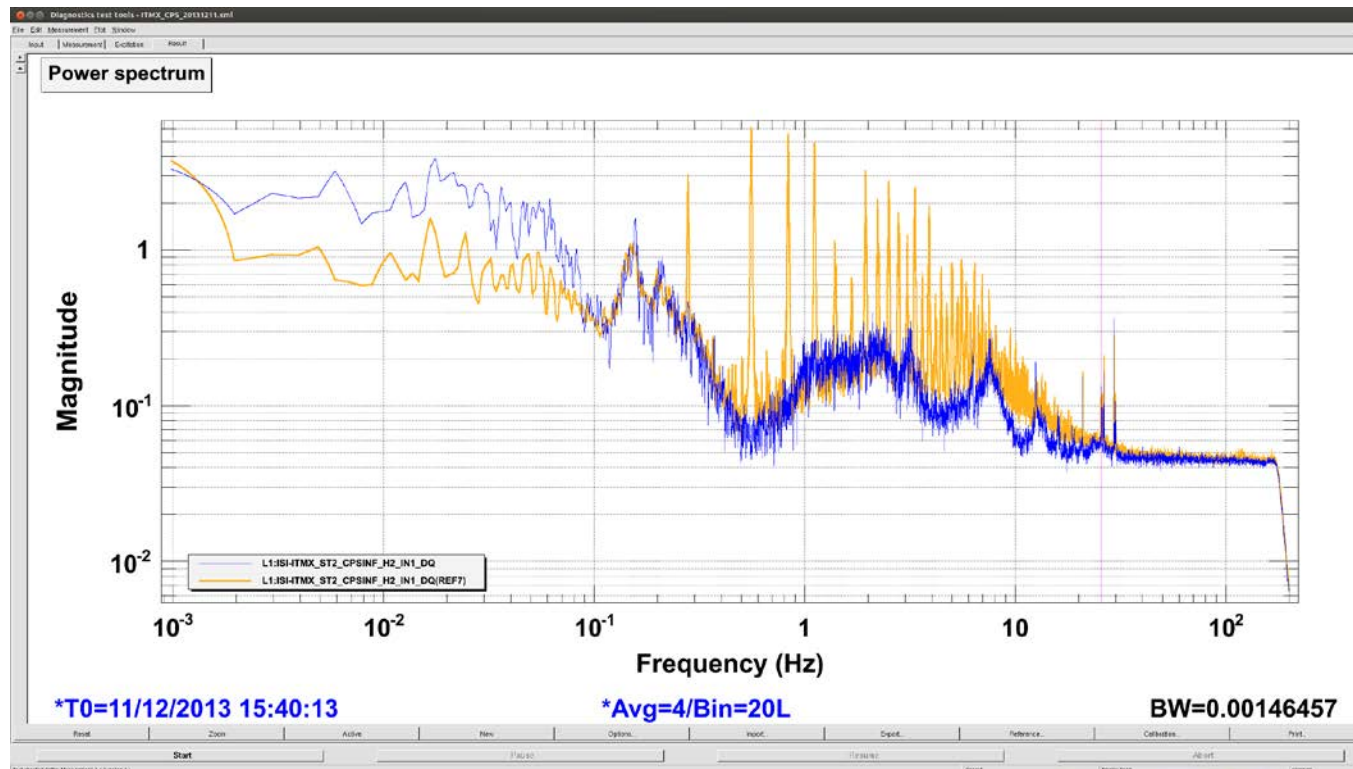
From a LIGO LLO Logbook report 10089. **Orange** trace is ITMX with all 3 chambers' CPSs on, **Blue** trace is ITMX with the other two chambers turned off.

Suspecting interaction between chambers, this morning we shut down all CPSs of ITMY and BS (from 9:40 am to 10:35 am) and compared ITMX St2 CPS spectra with the other chambers CPSs powered on (ref in orange on the attached spectra) and off (in blue). [Shutting down the other chambers CPSs resulted on having ITMX comb disappear from ITMX St2 CPS spectra.](#)

We are now fairly convinced that the problem (a frequency comb in the CPS spectra) is due to having multiple master oscillators in close proximity (what close means is still to be determined).

We measured the frequencies of the sync pulses on the three BSC chambers (~25.733Khz) and found that the differences between the frequencies was about the same as the observed comb frequencies. We then powered down the ITMY ISI and eliminated the master oscillator on the ITMX ISI. We then added a cable to bring the sync signal from the BS chamber to the ITMX ISI. After doing this the ITMX ISI ran well and the CPS spectra showed no signs of a frequency comb. Unfortunately this loaded down the BS sync sufficiently so that it did not run well. the major problem was in the Stage 1 V1 CPS sensor (which is the master). So we restored everything to the way it was before and everything is running as it was previously.

It looks like the solution is going to be running neighbouring chambers off of the same master and installing a buffer amplifier so that more slaves can be driven then we currently can

Rich A. has suggested that we replace all of the local master/sync signals with a gps generated signal, then all of the chambers would be running at the same frequency

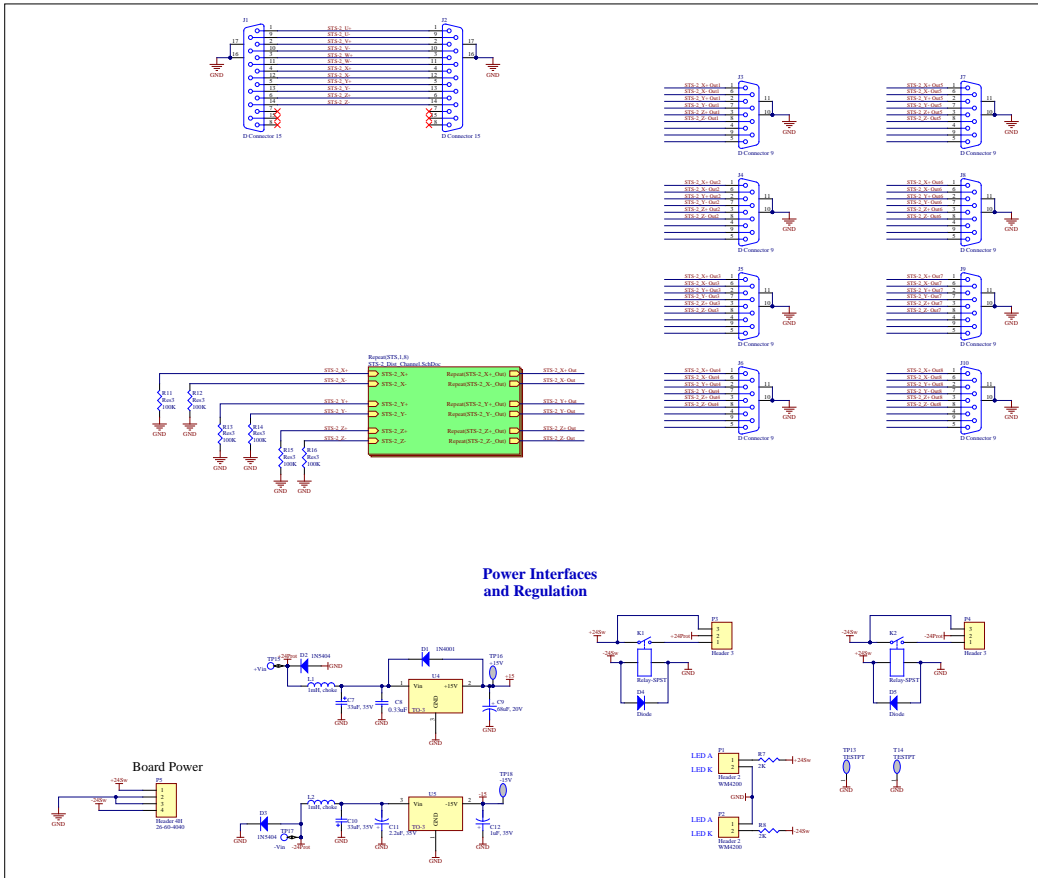
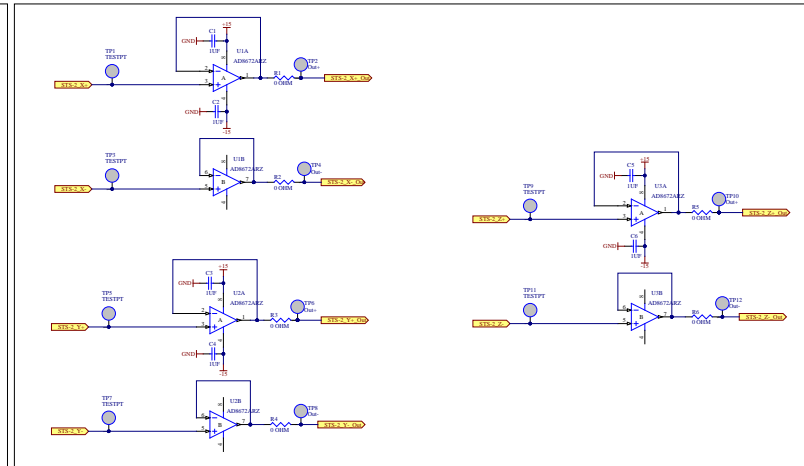
- AD8672s are analog OpAmps, and are not fast enough to recreate there high-frequency square pulses.
- The waveforms produced are ugly, sine-ish lumps, and are easily perturbed by people touching the system in any way.
- There is no synchronization to the site clock.
- We're going to need that STS-2 Distribution Chassis back.

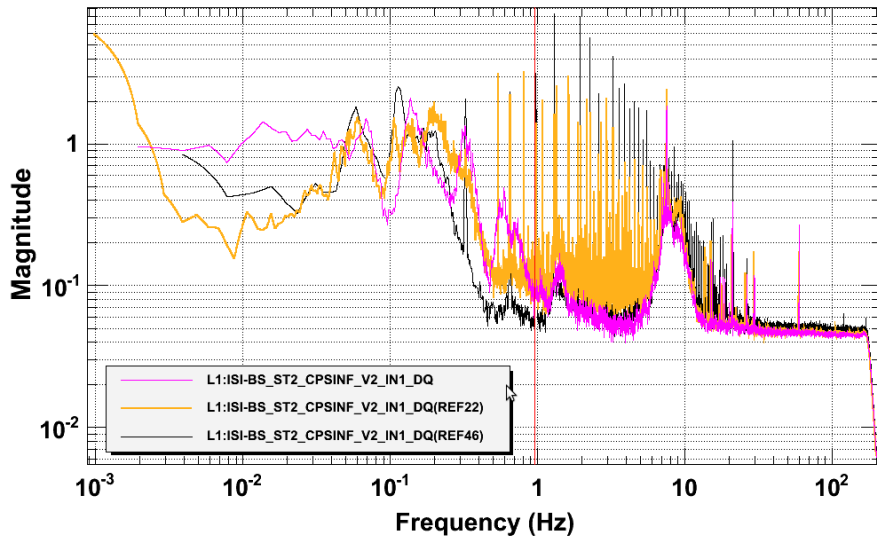
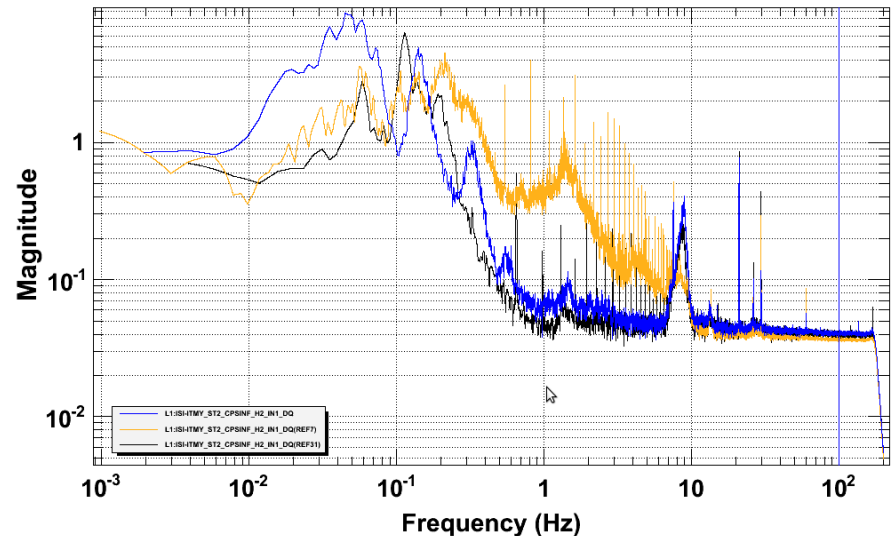
You can find attached sample spectra for the CPS sensors of all 3 BSC ISIs. In **orange** are the measurements from last Wednesday night when all 3 ISIs had different masters ("*comb reference*"), in **black** are the measurements from Sunday night with *both ITMY and BS on the same master and ITMX still running*, and in any **other colors** are the measurements from last night. In all cases, those measurements were taken with St1 ISI isolated, St 2 only damped. One can see that **there is no more comb visible on those spectra!**

You can find attached sample spectra for the CPS sensors of all 3 BSC ISIs. In **orange** are the measurements from last Wednesday night when all 3 ISIs had different masters ("*comb reference*"), in **black** are the measurements from Sunday night with *both ITMY and BS on the same master and ITMX still running*, and in any other colors are the measurements from last night. In all cases, those measurements were taken with St1 ISI isolated, St 2 only damped. One can see that **there is no more comb visible on those spectra** (all other variations are likely due to variations in ground motion when those measurements were taken). Also, it is to be noted that high frequency noise (>30 Hz) has not gotten any worse with all those changes (we were worried about our grounding configuration).

Note that despite this success, this is only a temporary setup. We believe that the filtering in the STS distribution slows down the sync signal sent to the slave CPSs, and we're not sure how this might affect the ISI performances. Also, I have noticed that the system is very sensitive to any new connection made to that interface box, and that the BS sync signals need to be connected last and carefully to avoid issues. We believe that this is linked to some grounding problem. However, since it does not seem to affect ISI performances at this point, we haven't done (yet) any further investigation.
