# LHAM2

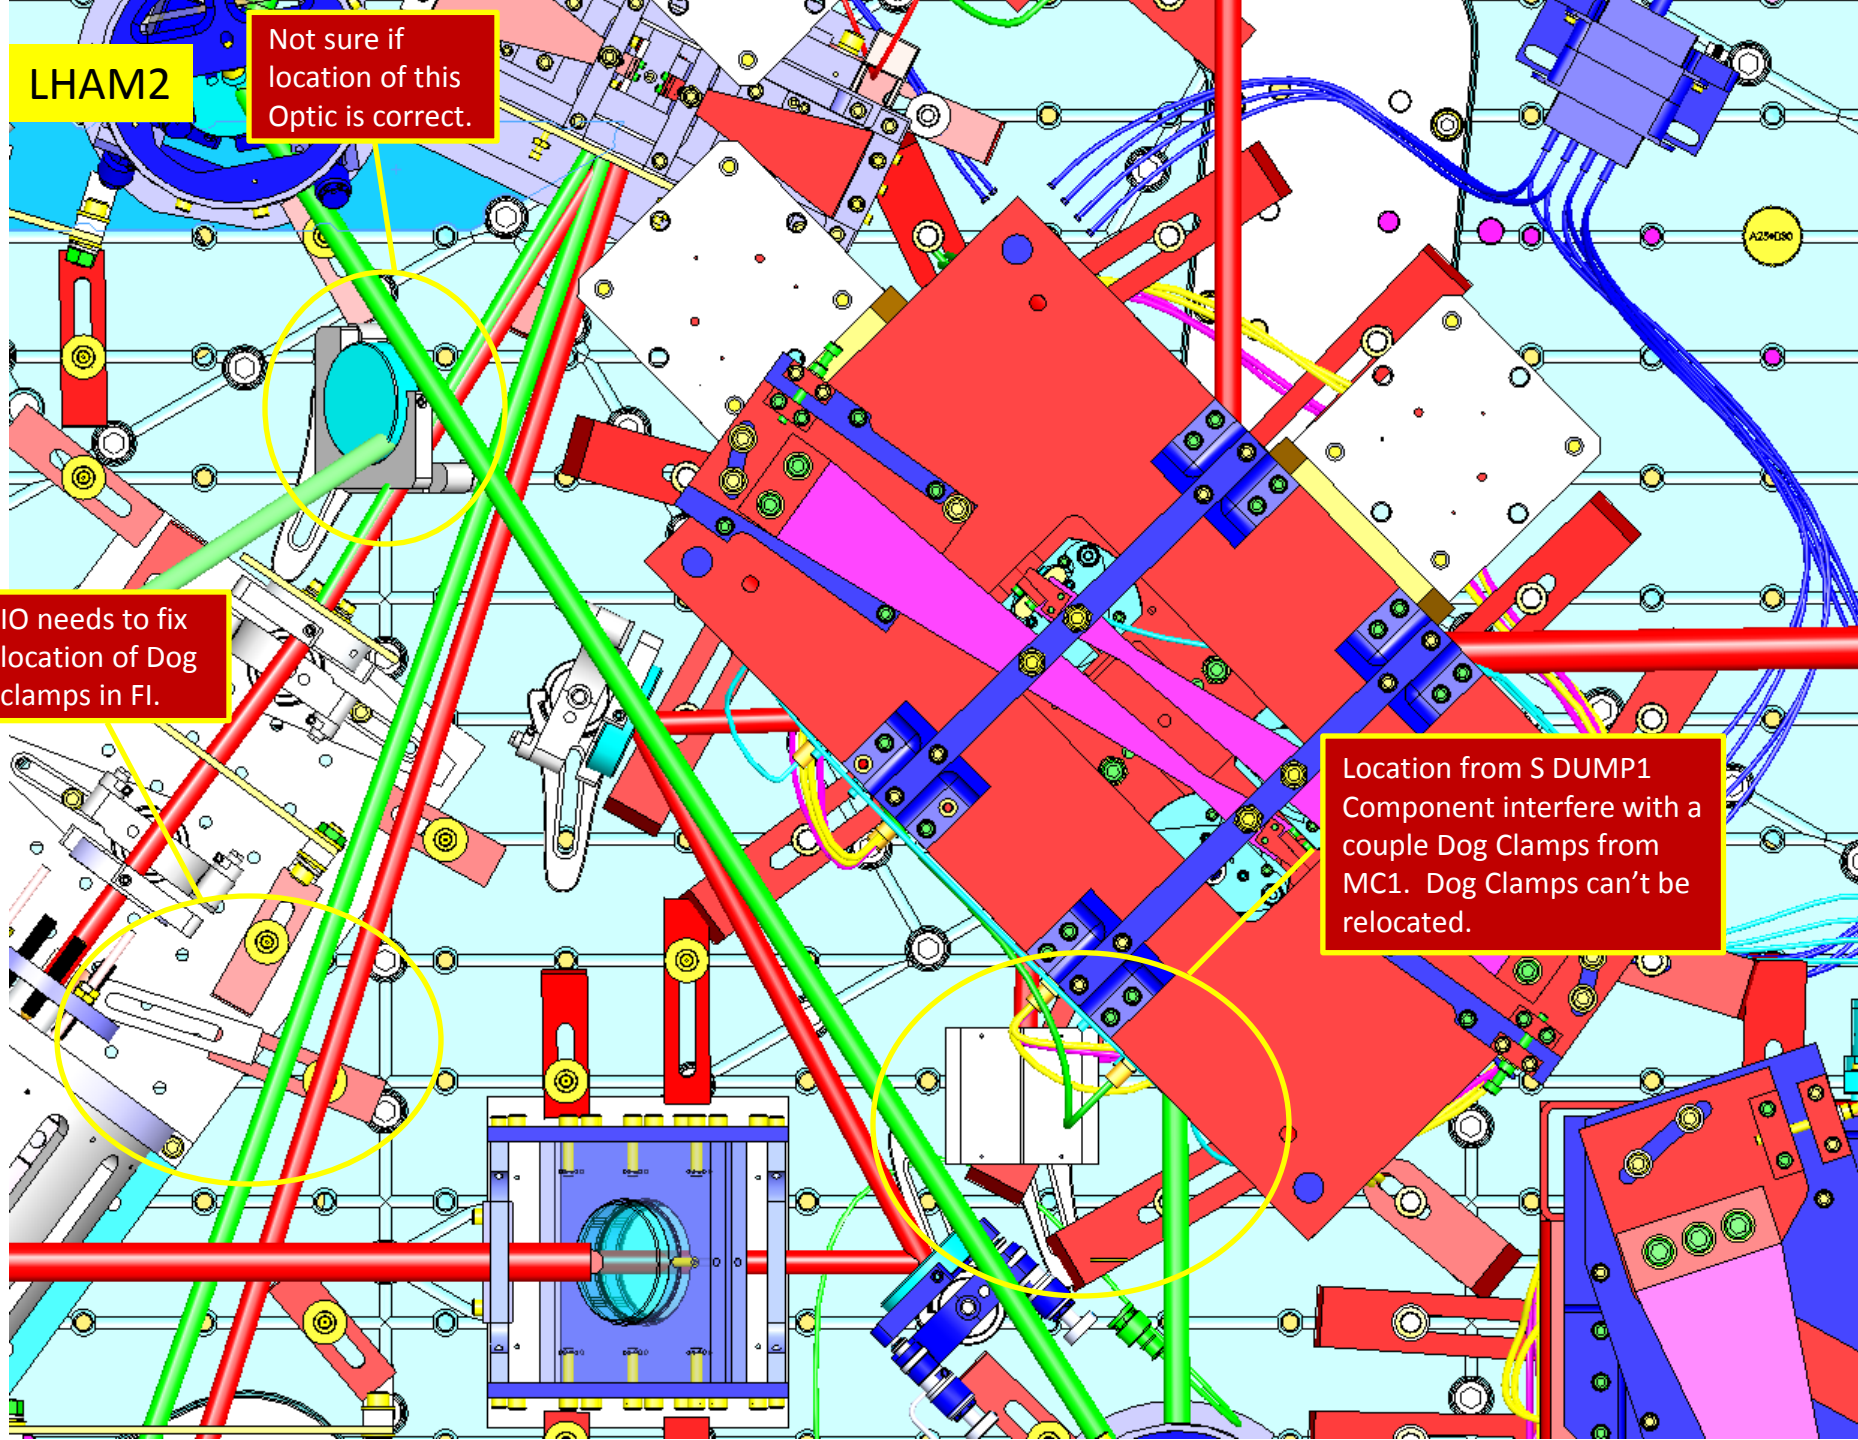
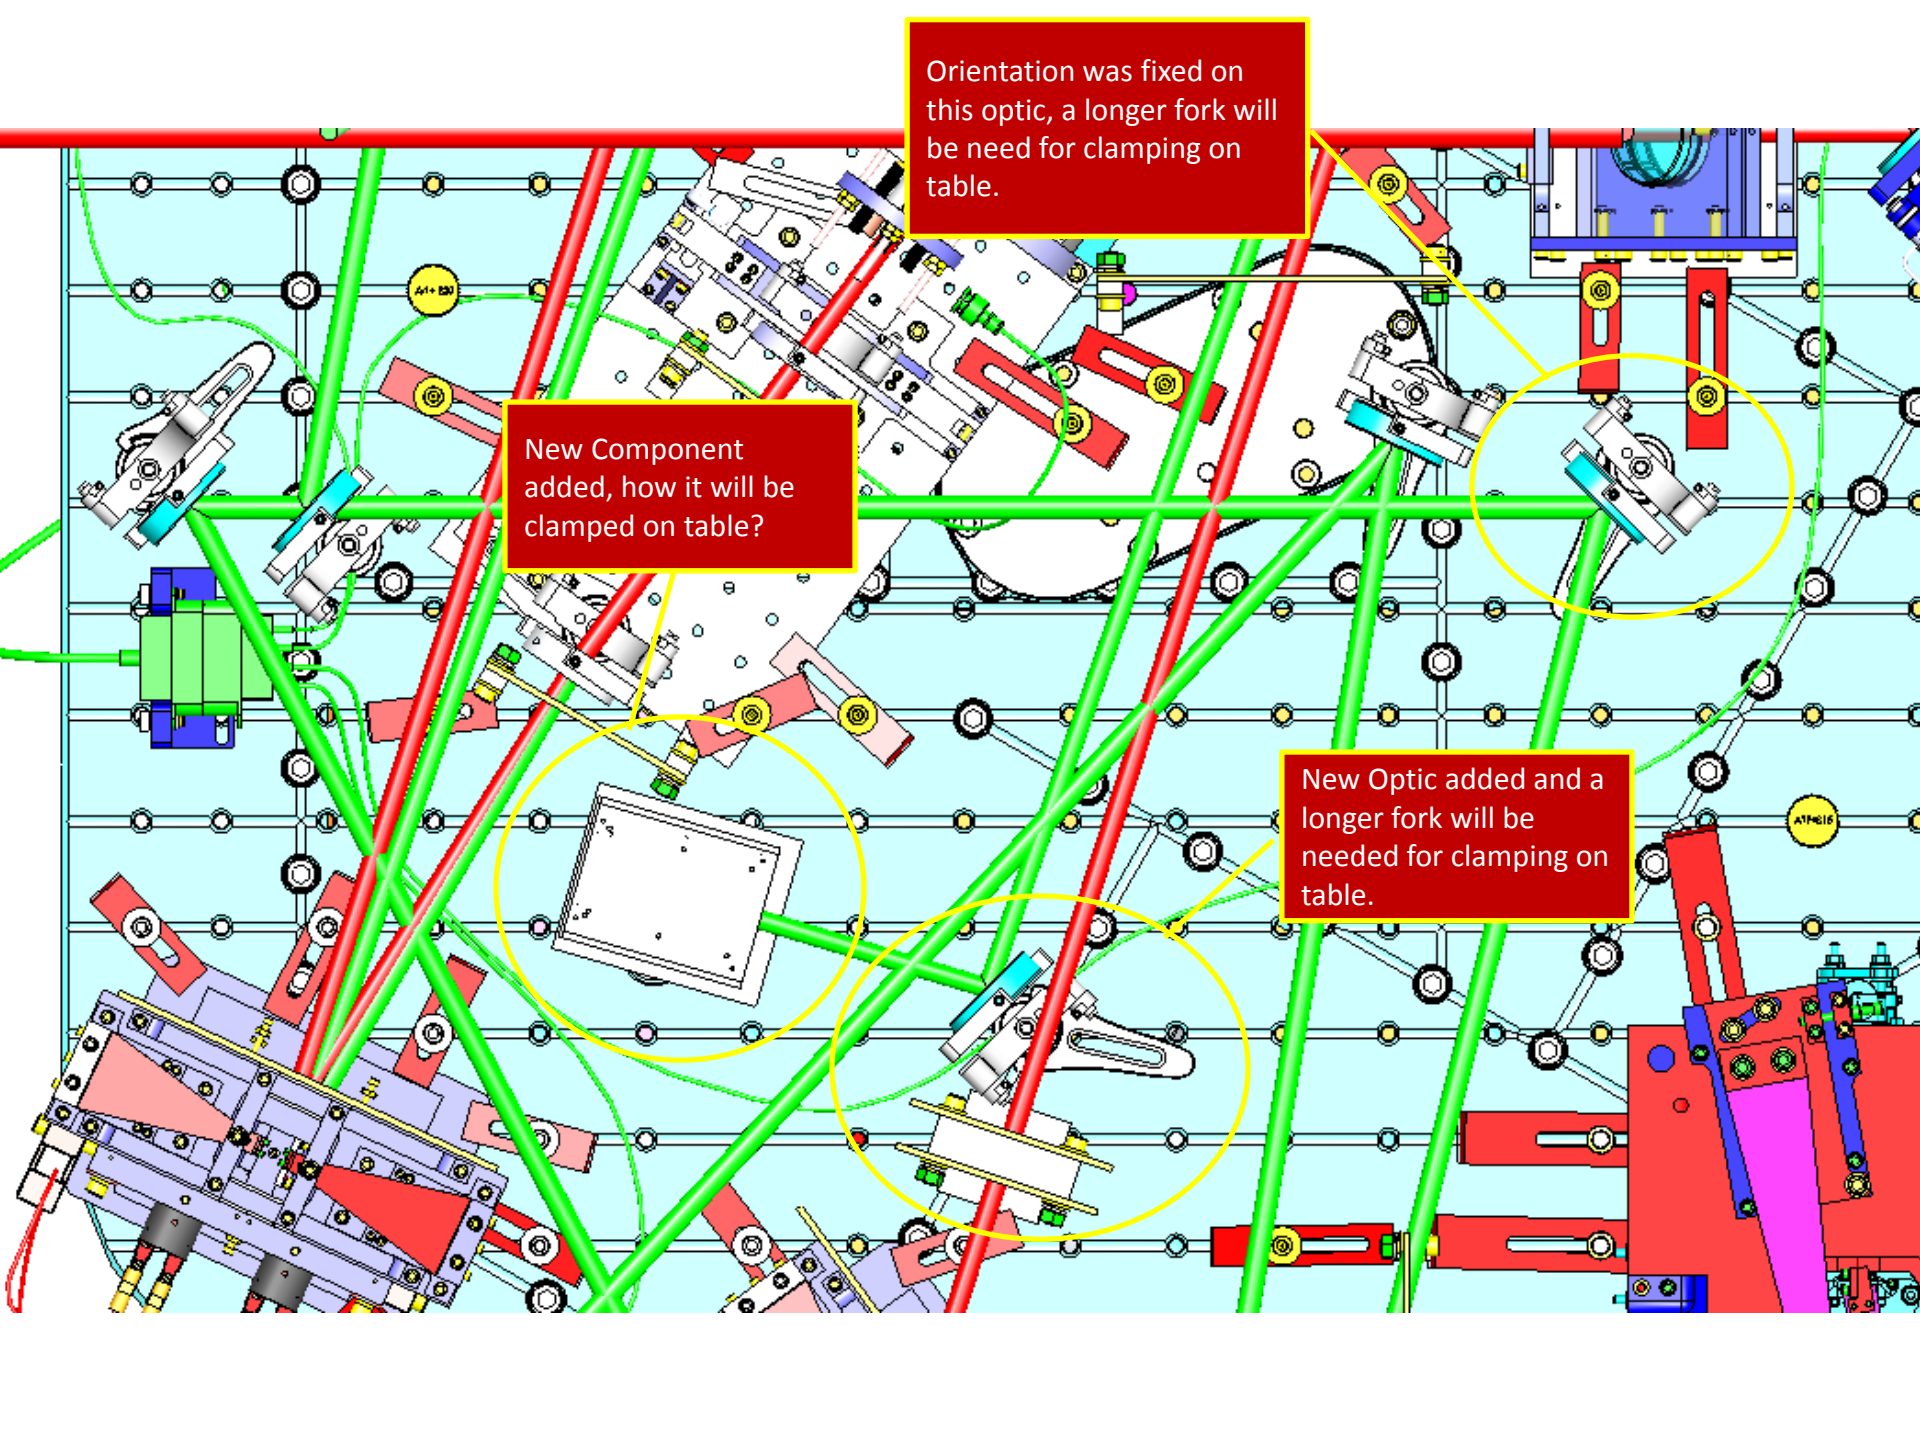
Orientation was fixed on this optic, a longer fork will be need for clamping on table.

New Component added, how it will be clamped on table?

New Optic added and a longer fork will be needed for clamping on table.

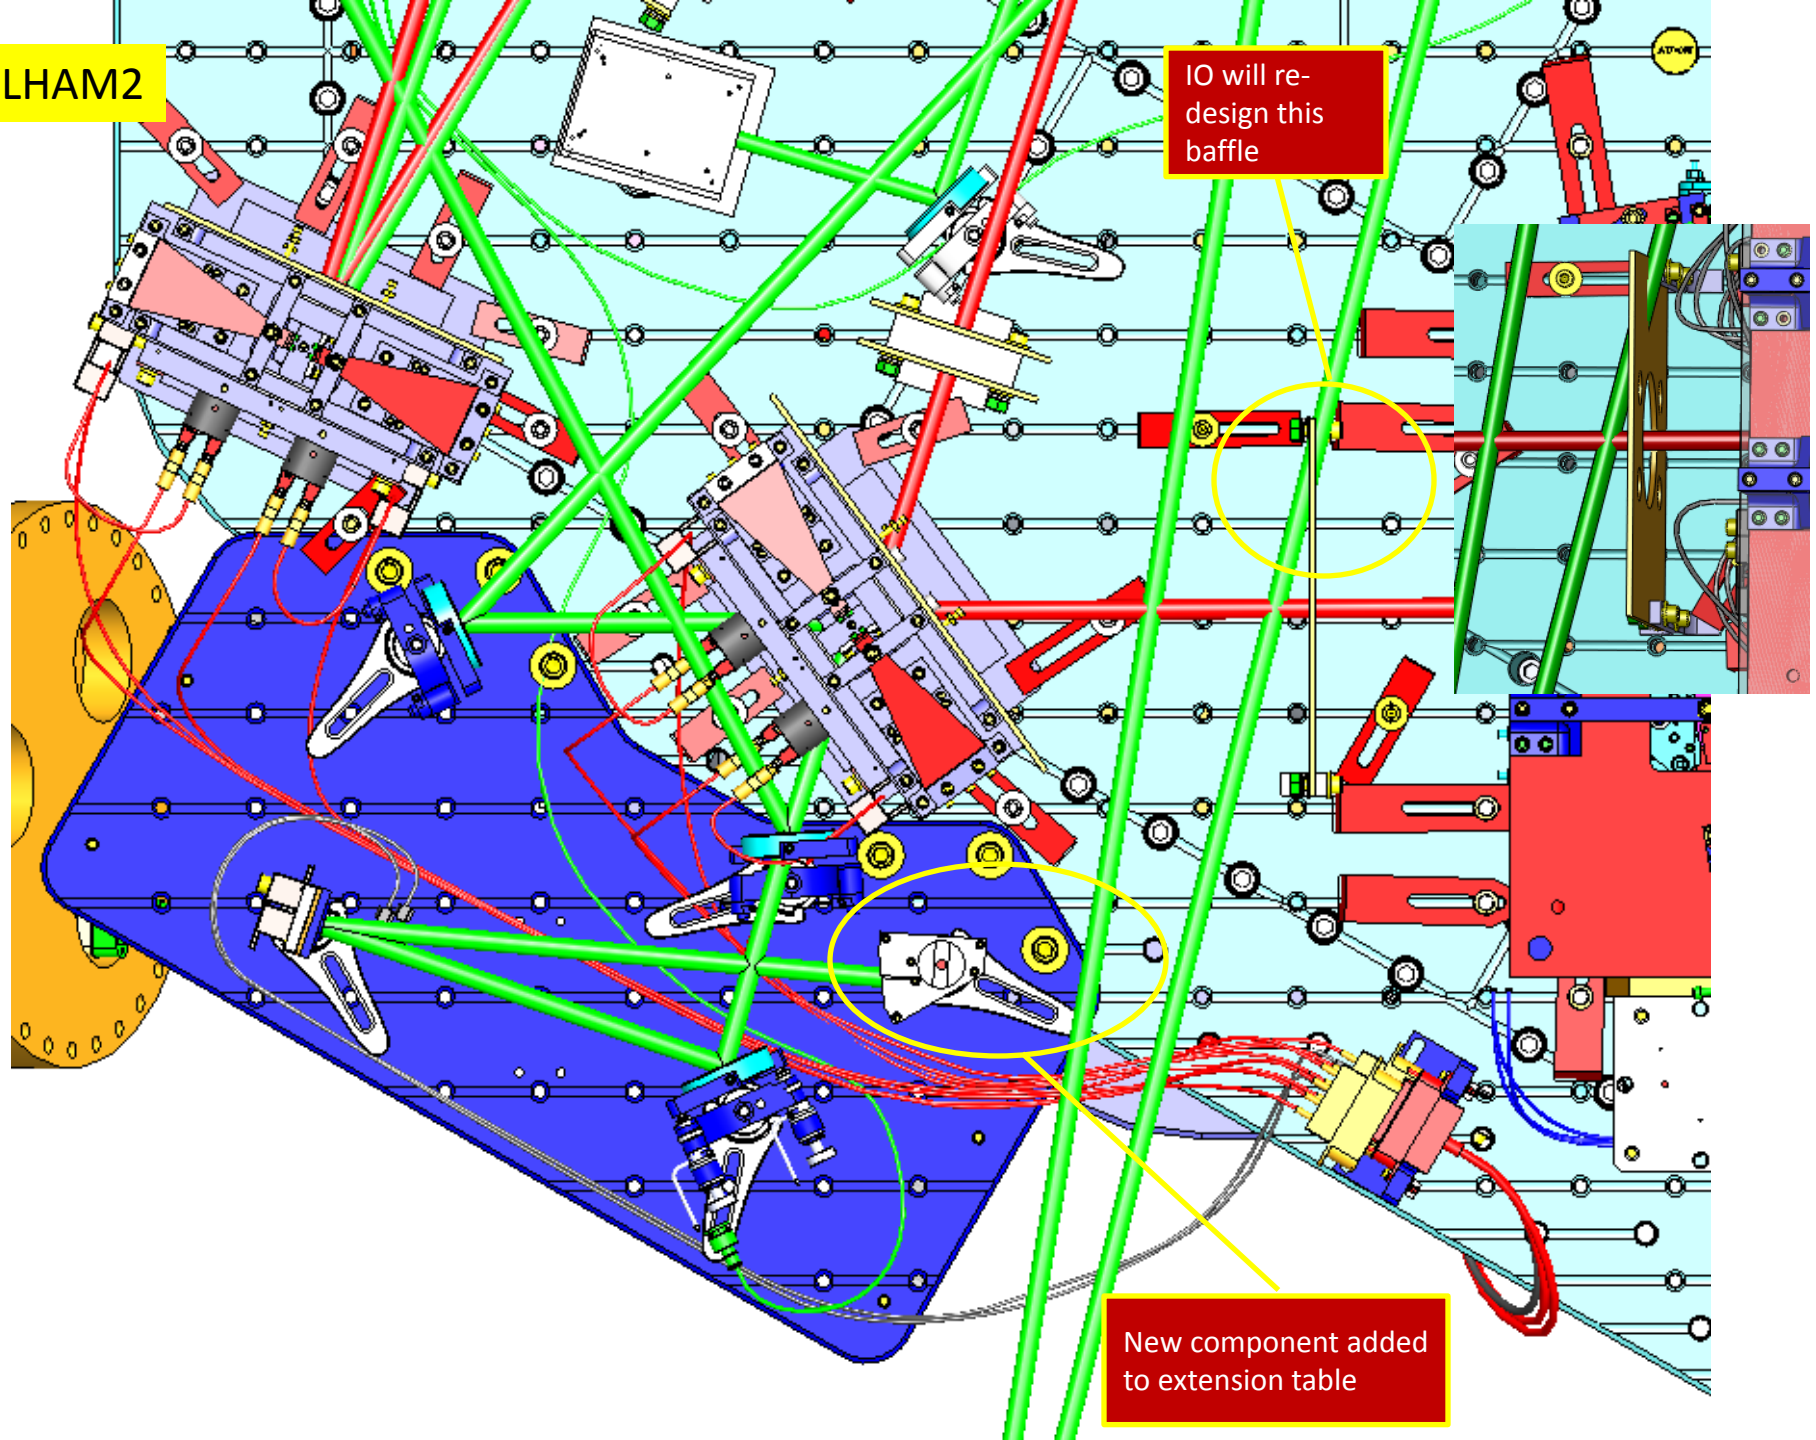
IO will re-design this baffle

New component added to extension table
