HAM2-H1

HAM8-H2

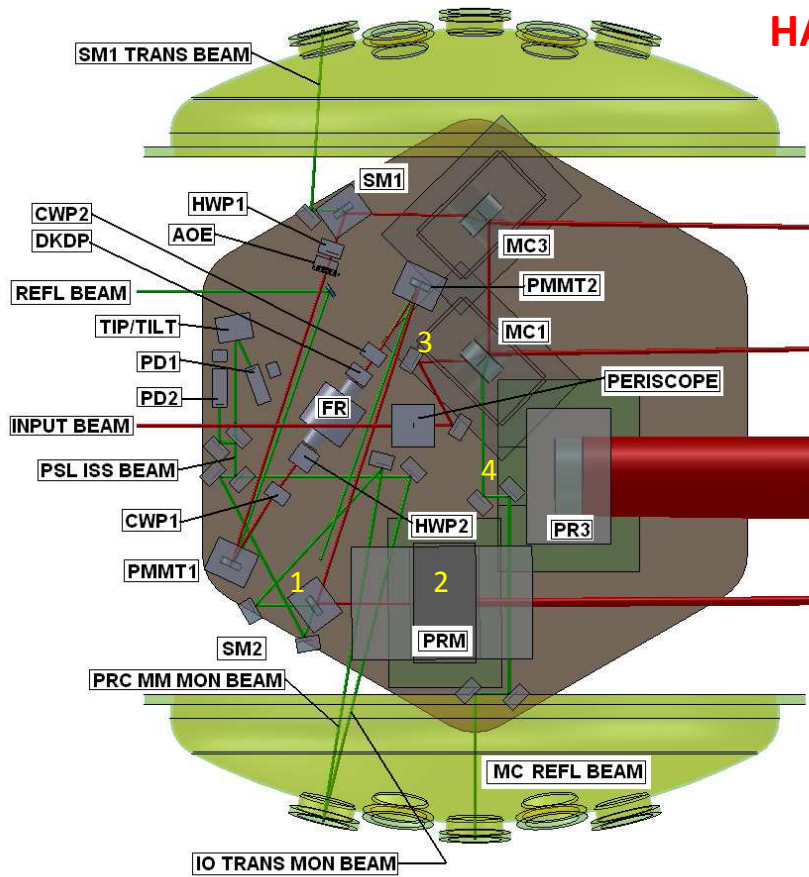
Luke's Layout

Most of the Laser Beams are pretty much on target (on X & Y Axis) except for the following components:

- 1- SM2: $X = -559.5$; $Y = 630.9$; $Z = 100$; $Yaw = 143.531^\circ$
- 2- PRM: $X = -69.9$; $Y = -628.0$; $Z = -96.8$; $Yaw = 179.574^\circ$
3. Missing Component ID and Coord's. Laser Beam path is Different from Actual layout
4. Laser Beam path is lower than in actual layout.

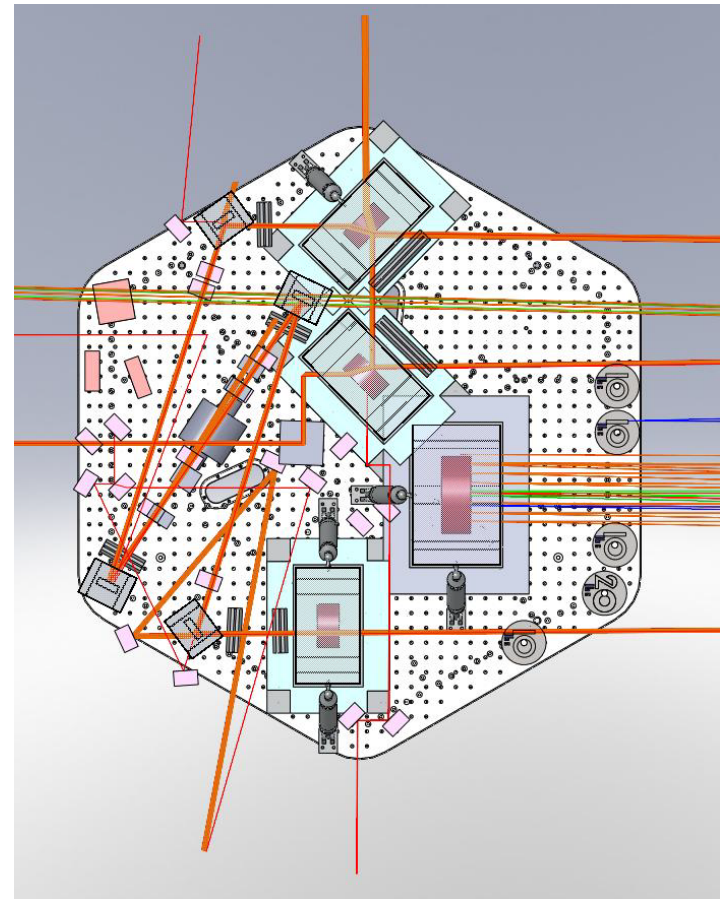
Actual Layout

(Includes the latest Laser Beam File D0901920-v4)

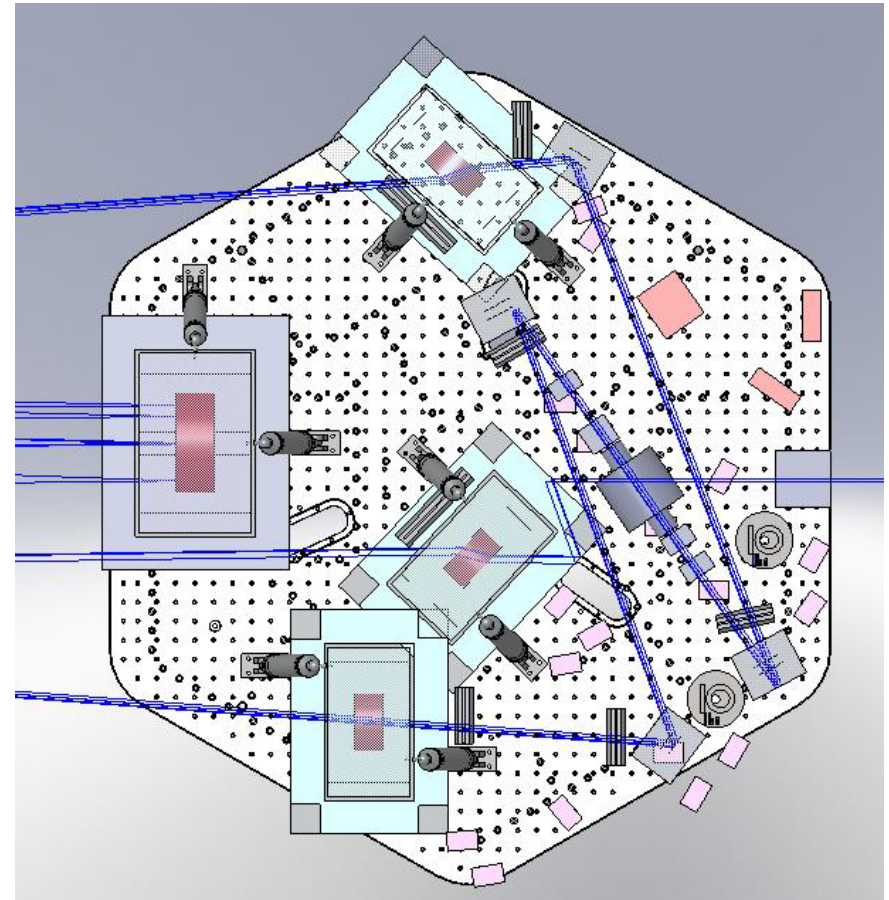
Actual Layout

(Includes Laser Beam file d0902345-v2)

1, 2 & 3 are missing components in actual layout.
I need ID and coords.

4 & 5 look out of position on actual layout. Maybe with latest
Zemax file, they are OK
