LIG0-T1000032-v1

<u>Summary on the surface absorption study of a 1x0.25" FS substrate one surface of which</u> was treated by Ion-Beam Figuring (IBF) technique

01/20/2010.

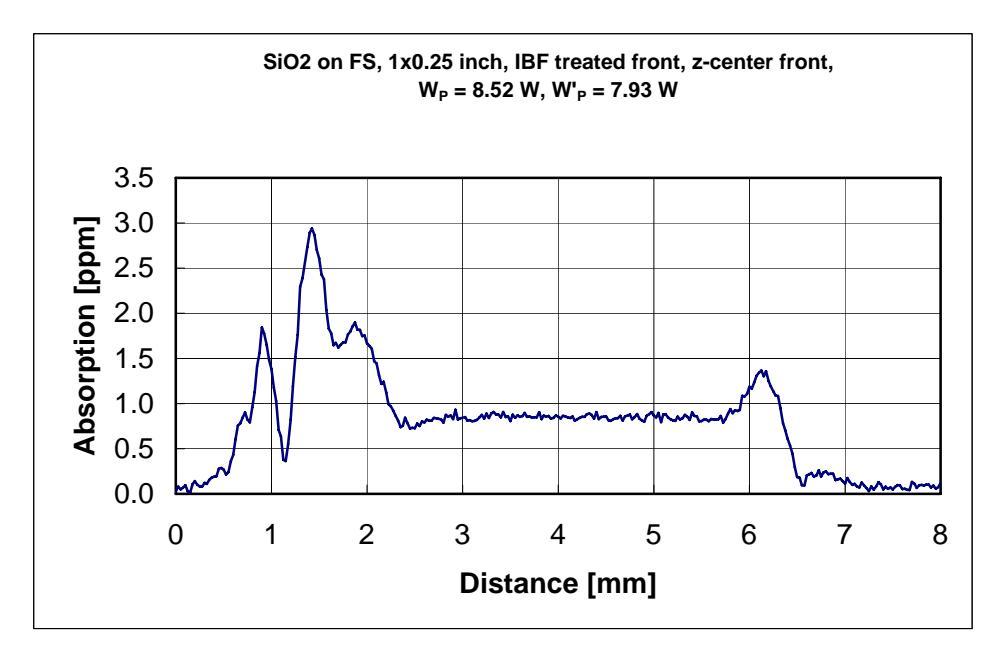
Fig.1. A z-scan through the sample. Front surface, central point. The front surface at this point has an obvious defect, while the rear surface shows a regular behavior.

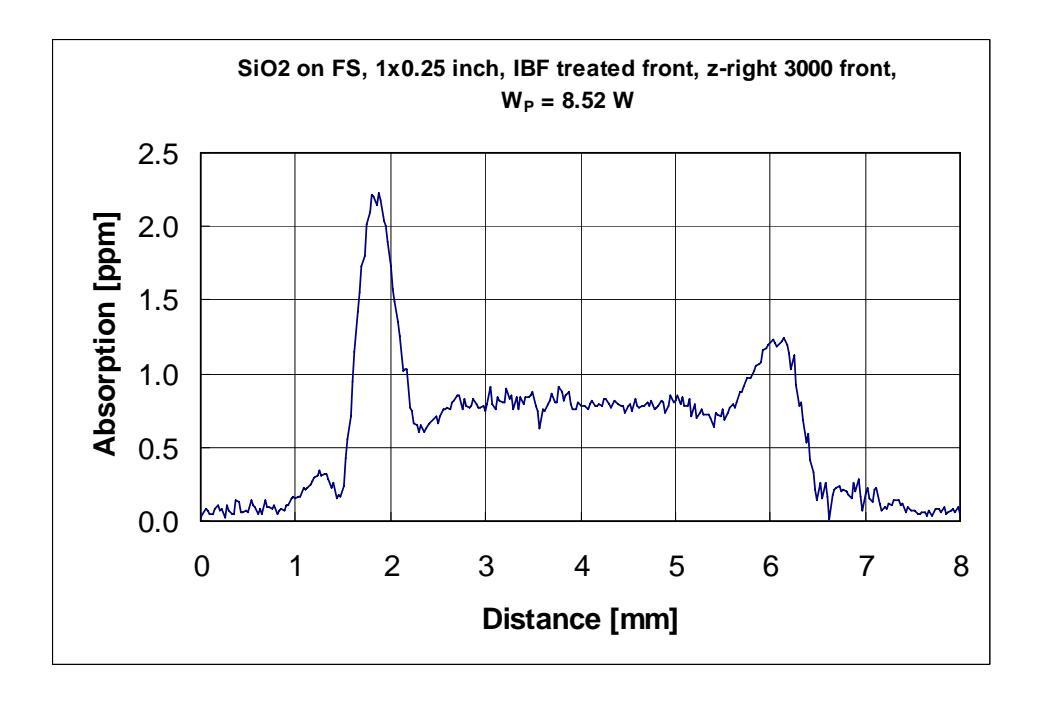
Fig.2. A z-scan through the sample. Front surface, 3 mm to the right from the central point. Both surfaces show regular behavior.

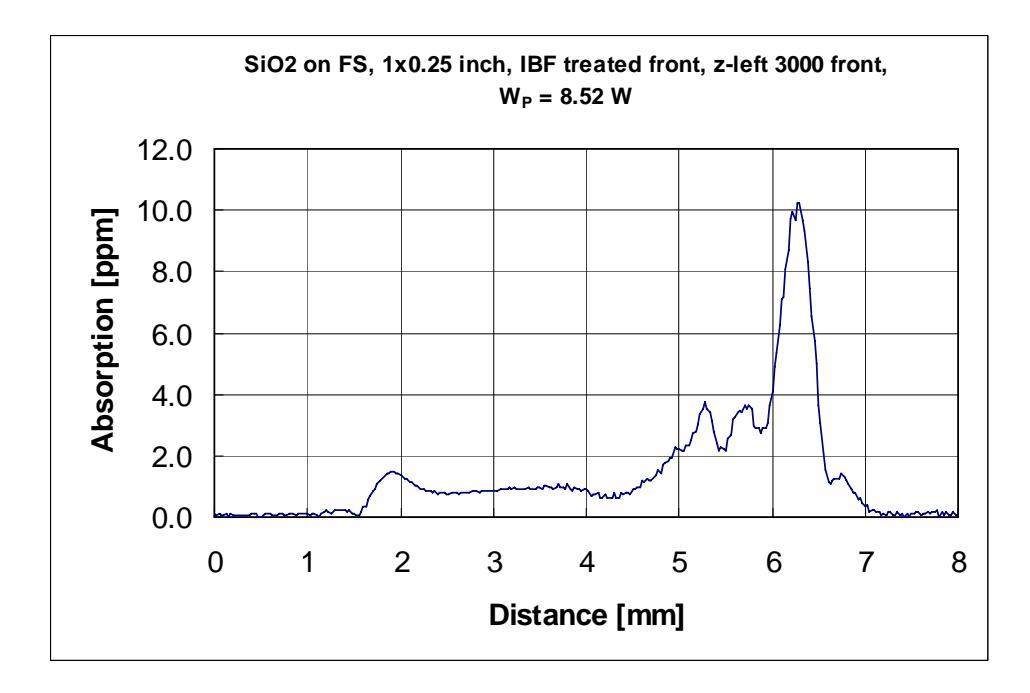
Fig.3. A z-scan through the sample. Front surface, 3 mm to the left from the central point. The signal from the rear surface shows a deviated behavior.

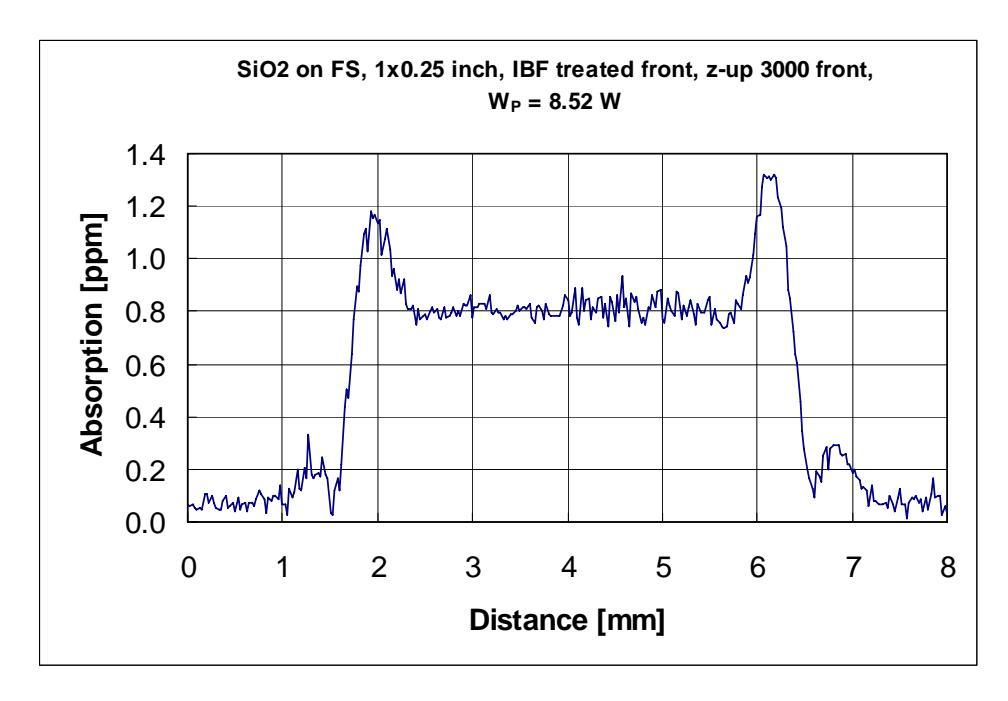
Fig.4. A z-scan through the sample. Front surface, 3 mm above the central point. Both surfaces show regular behavior.

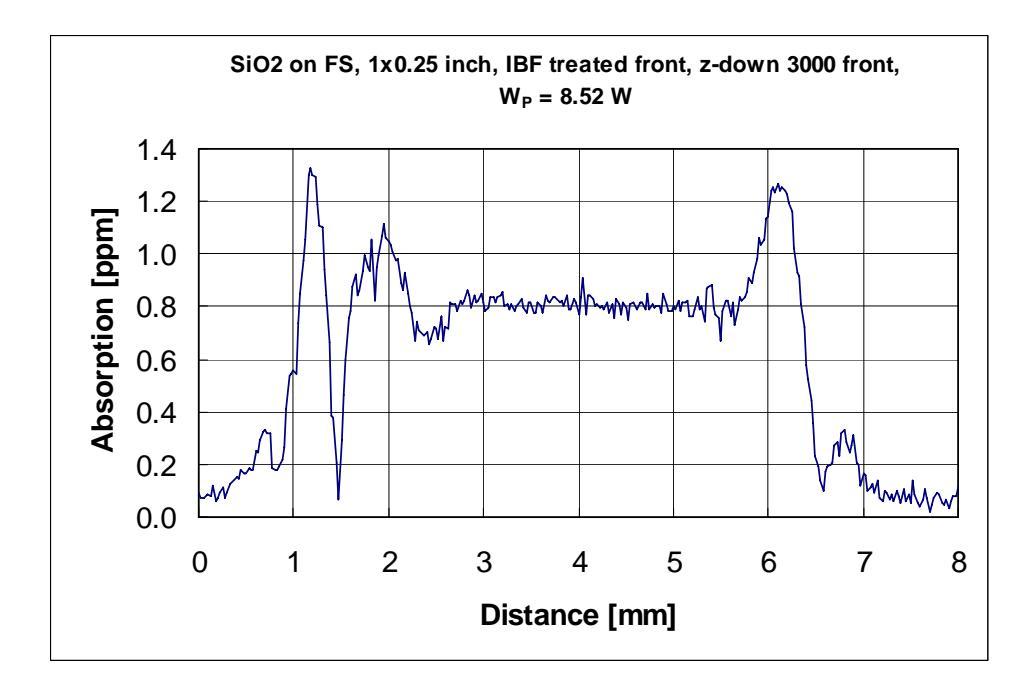
Fig.5. A z-scan through the sample. Front surface, 3 mm below the central point. The front surface at this point has an obvious defect, while the rear surface shows a regular behavior.

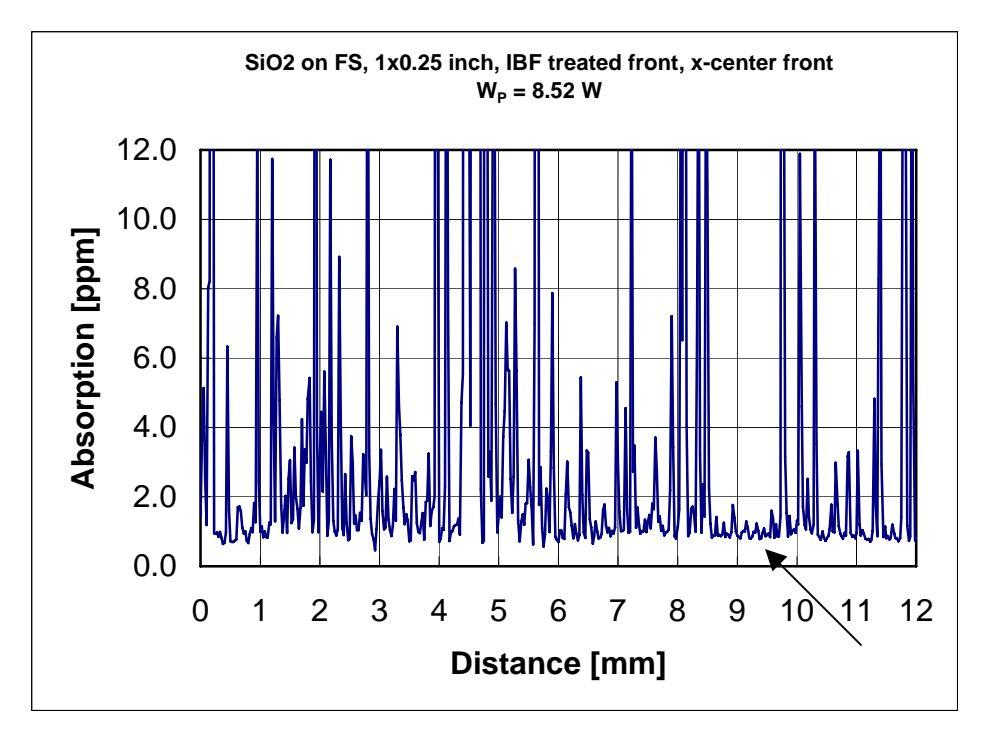
Fig.11. An in-plane x-scan along the central line of the front surface (IBF treated). The surface contains a lot of "defective" spikes, which are due to dust particles sticked to it electrostatically. A repeated on-site cleaning removes some of them but new spots arise then. Looking at a relatively perfect segment, one can see that the signal is c.a. 1 ppm. This value is equal to the signal from the bulk substrate. Therefore it can be concluded that the really clean surface is not absorptive and all the losses, when illuminating a big area, arise from dust particles and/or surface defects.

In conclusion. IBF treatment does not increase the surface absorption in general. However, the surface seems to become more receptive to sticking foreign particles on it.

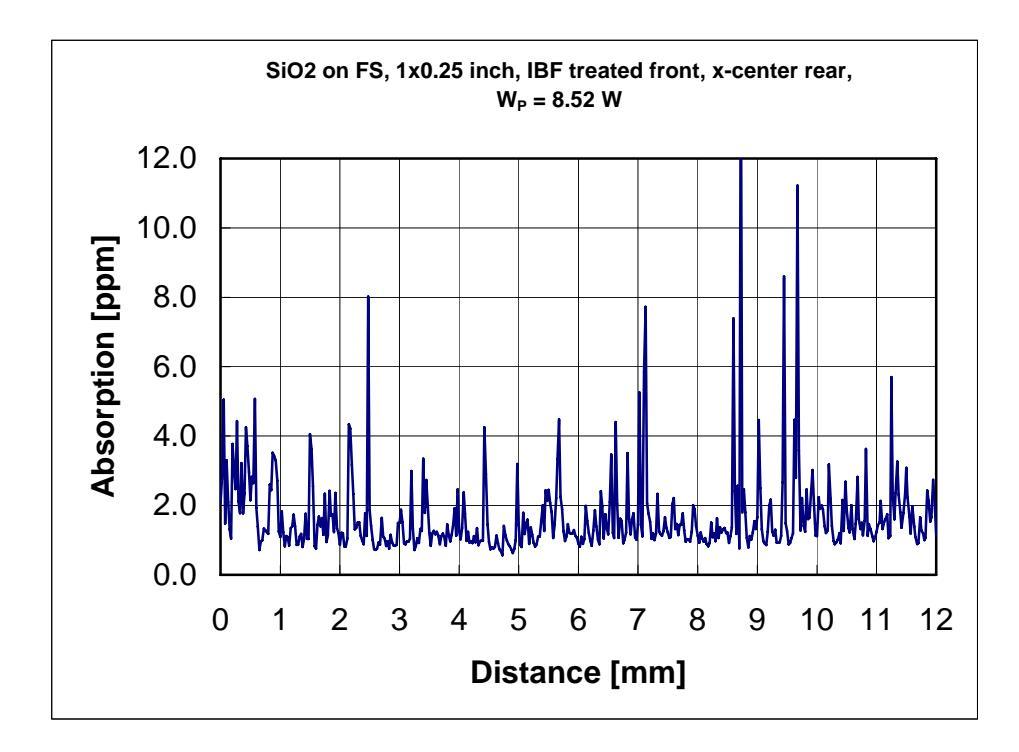
Fig.12. An in-plane x-scan along the central line of the rear surface (untreated). The surface contains substantially less "defective" spikes, which are supposed to have the same origin as those shown on fig. 11. A repeated on-site cleaning removes some of them but new spots arise then. Looking at a relatively perfect segment, one can see that the signal is c.a. 1 ppm. This value is equal to the signal from the bulk substrate. Therefore it can be concluded that a really clean surface is not absorptive and all the losses, when illuminating a big area, arise from dust particles and/or surface defects.
