OMC Structure Frequencies –Results and Interpretation

LIGO DCC #: T070207-00-R

1. Introduction

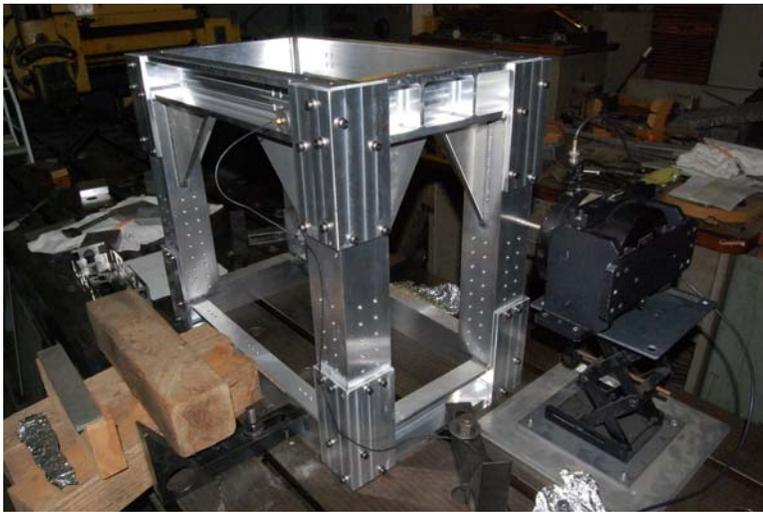
Figure 1: set-up for first set of measurements. Note that the scissors table under the driver was replaced by heavy steel blocks in later measurements.

These measurements were made using a loudspeaker style driver with amplifier to drive the structure, and a B and K accelerometer type 4378 and SR560 amplifier for sensing, using a swept sine signal from the SR785 spectrum analyzer to measure a frequency response over a frequency band of 70 Hz to 400 Hz. We did a check that there were no resonances below 70 Hz. See figure 1 for a typical early setup.

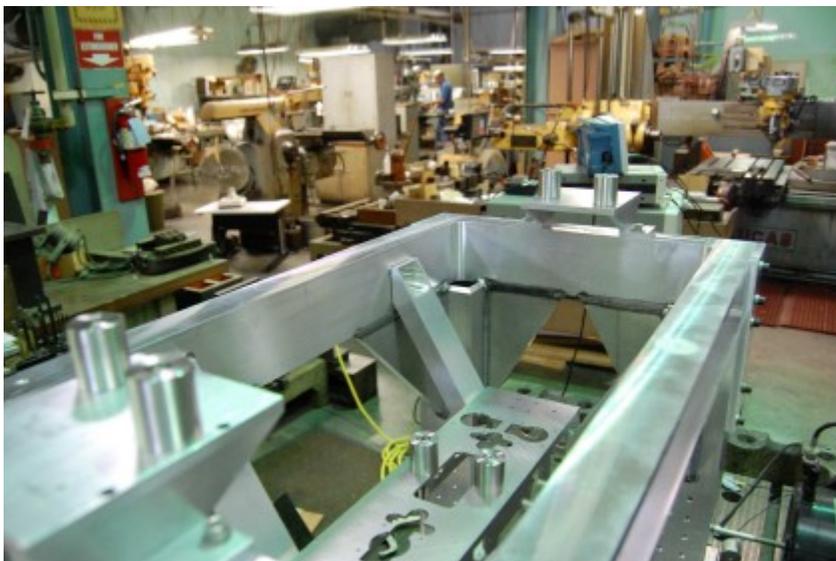
Figure 2 Structure with added mass = 4.1 kg (9 lb)

3.3 Driving and sensing longitudinal with added mass (tablecloth, blade supports and additional mass of 6 steel cylinders, total 9 lbs = 4.1 kg)

Figure 2 shows what the structure with its added mass for these measurements.
