LASER INTERFEROMETER GRAVITATIONAL WAVE OBSERVATORY

Document Type	LIGO-T960117-00 - D	10/13/96
Drop Test - COC Carrier and Shipping Case		
Craig Conley

1 ABSTRACT

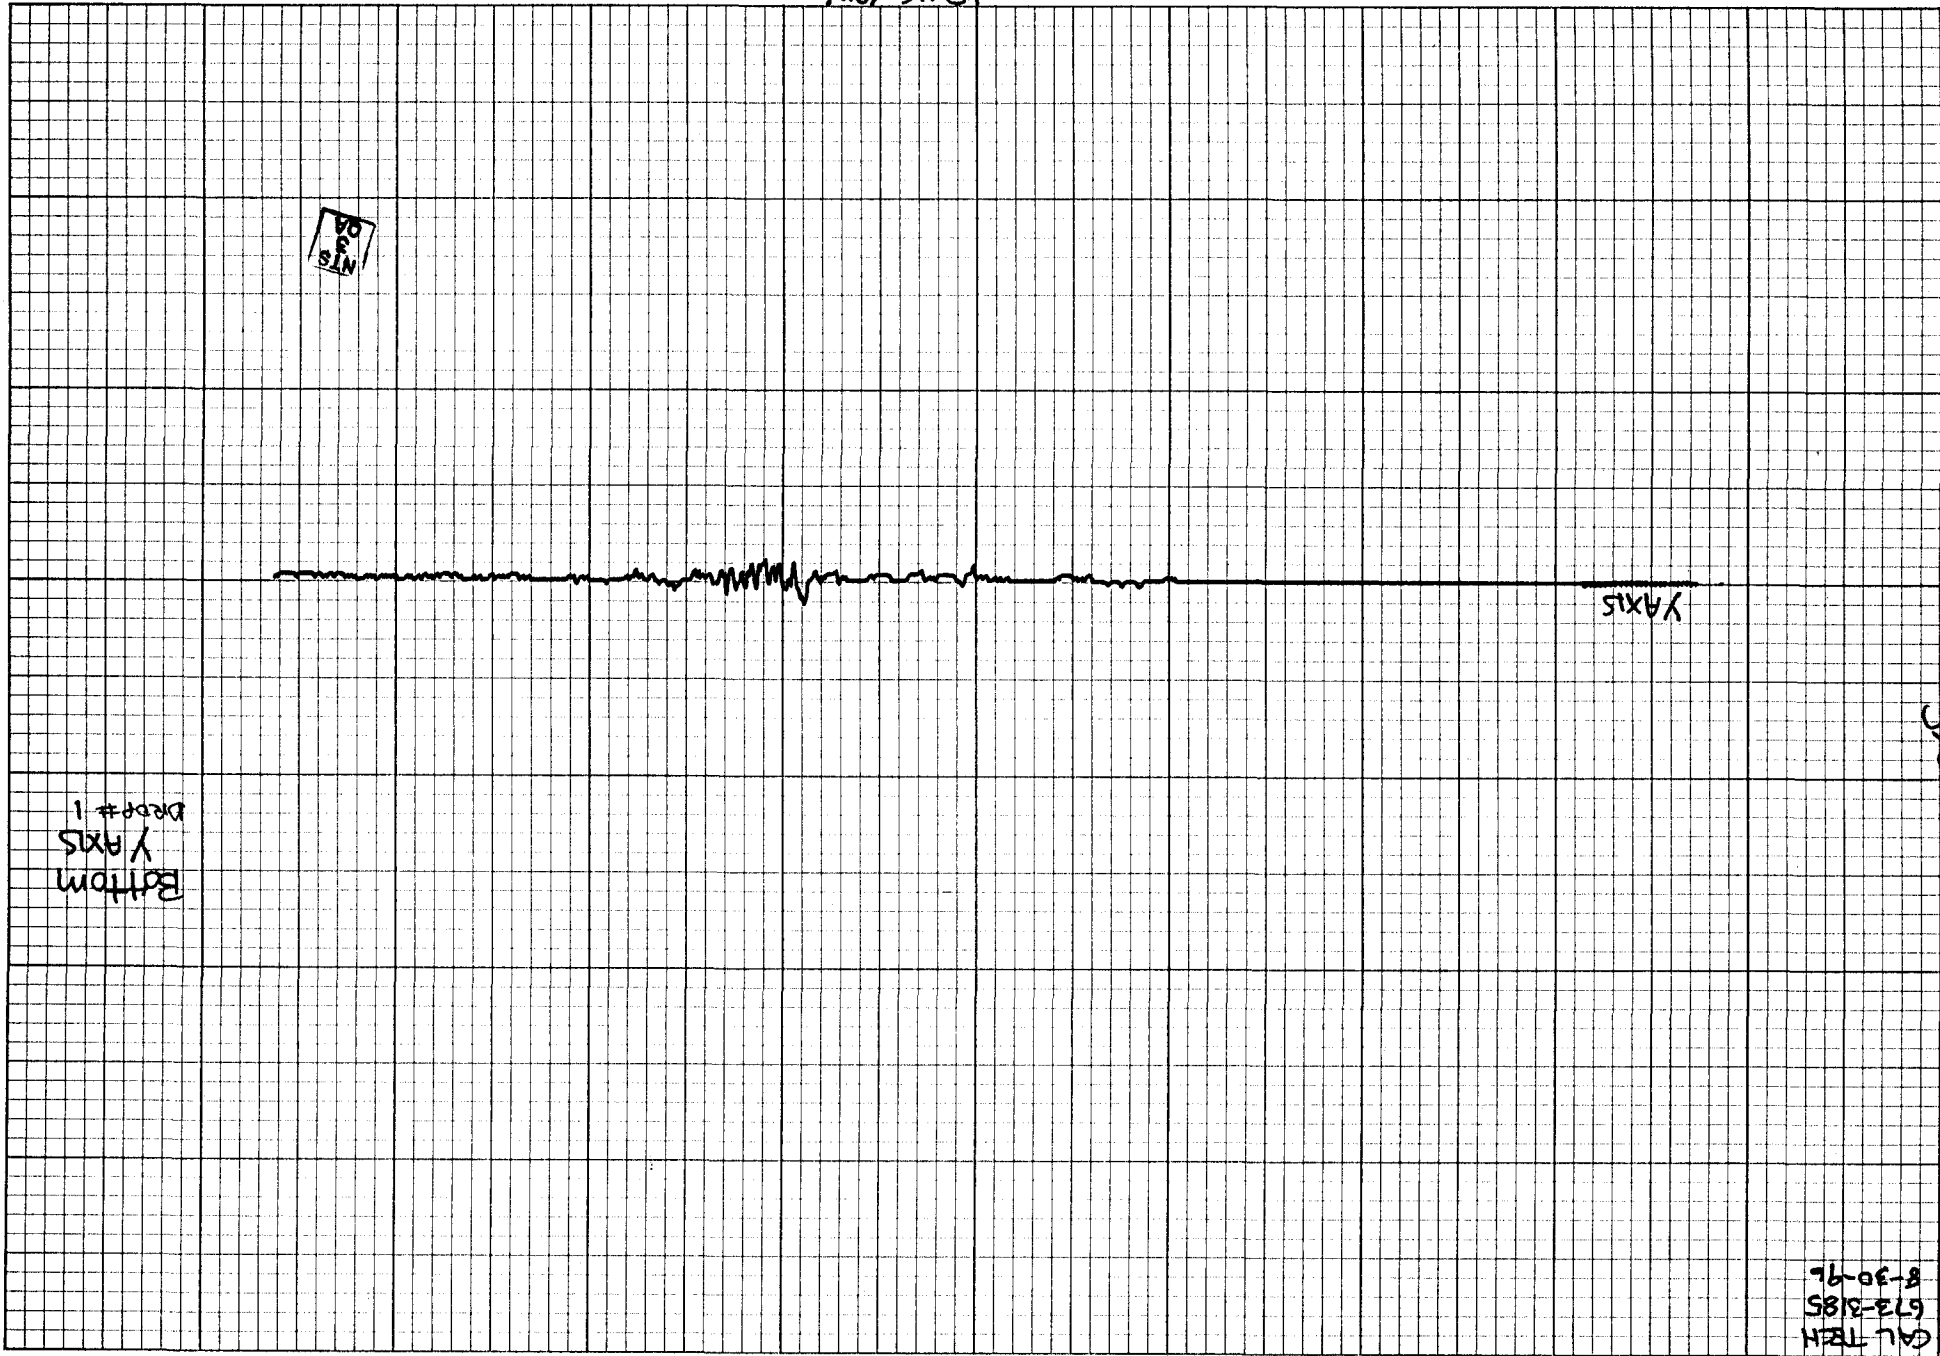
Bottom
Y AXIS
Trace # 1

Y AXIS

20g/div

1 ms/div

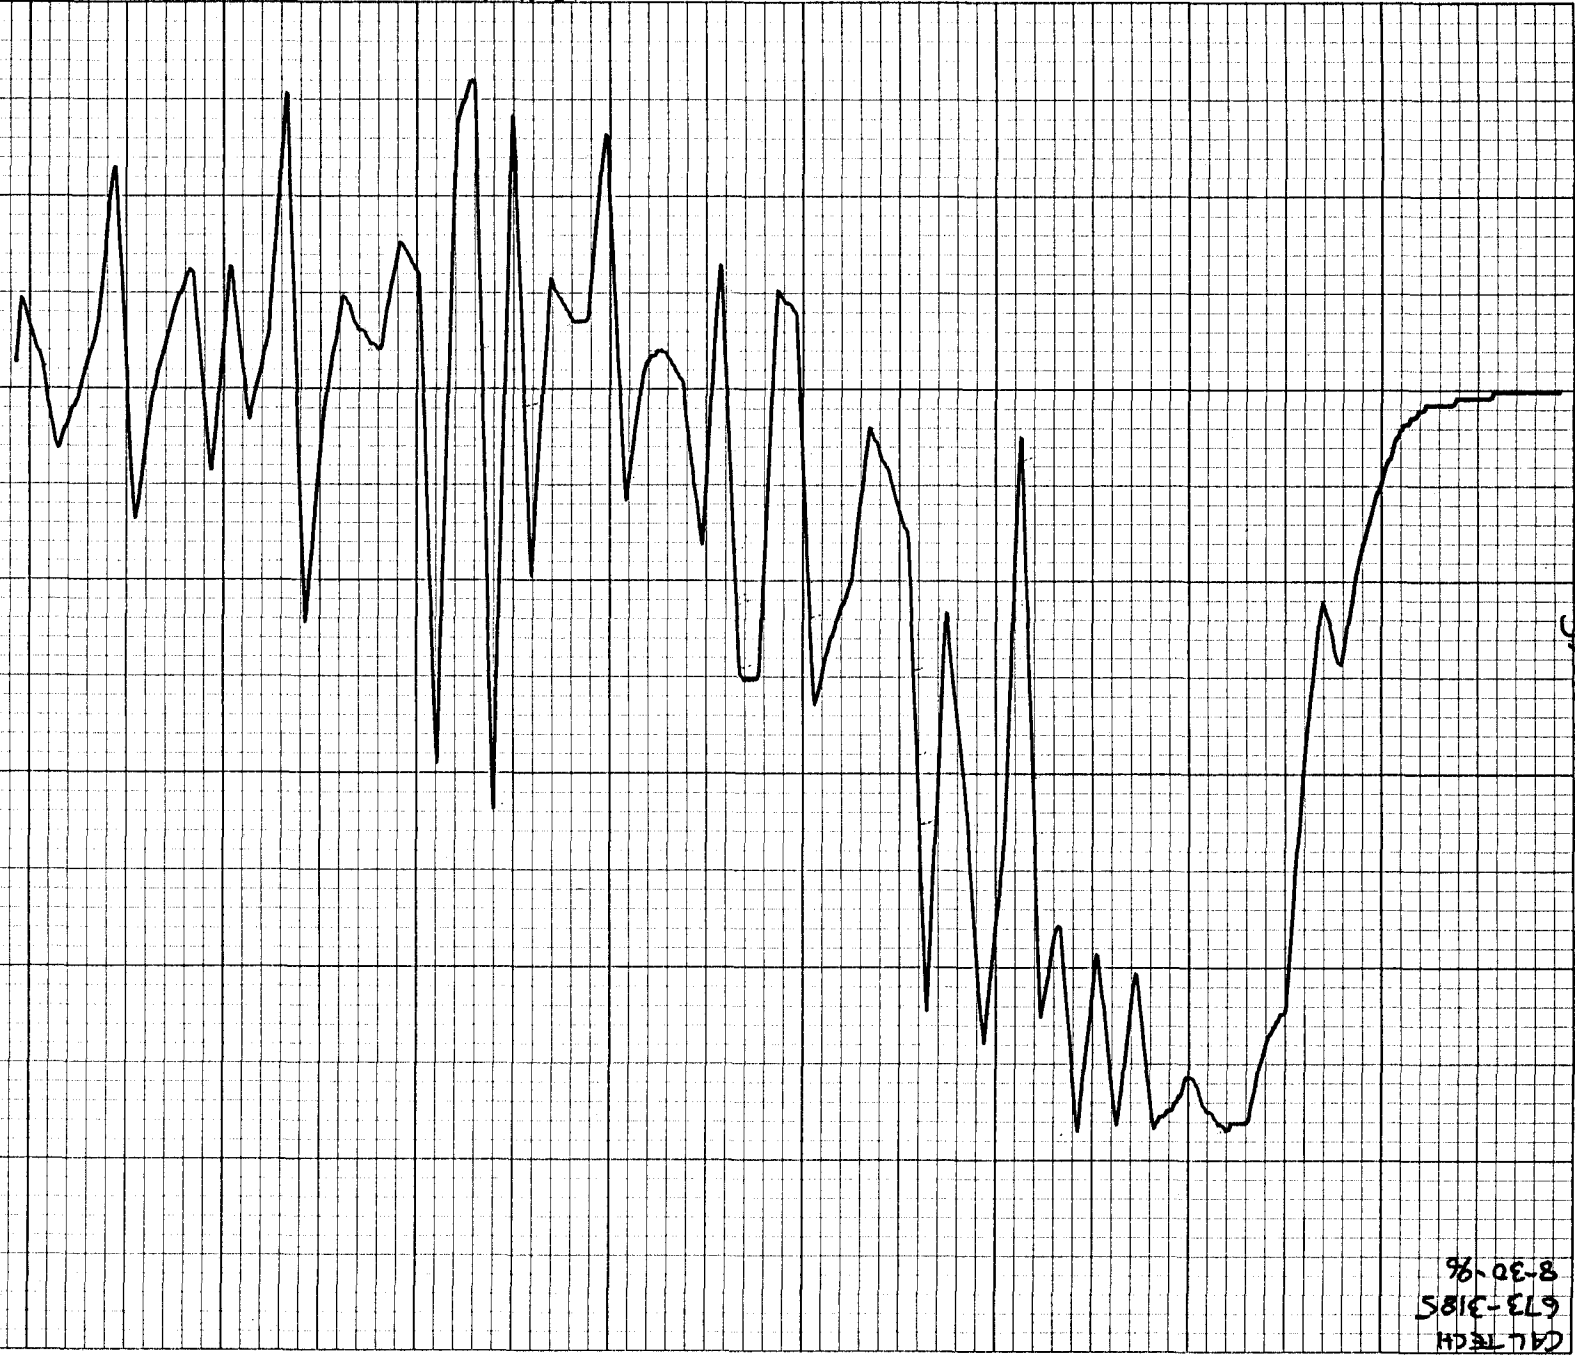
SIDE (INCH)
Y-axis
DROP # 2

50g/div
4
