Coating Core Optics for O4

[LIGO-G2200124-v1](#)

Point Absorbers In Situ

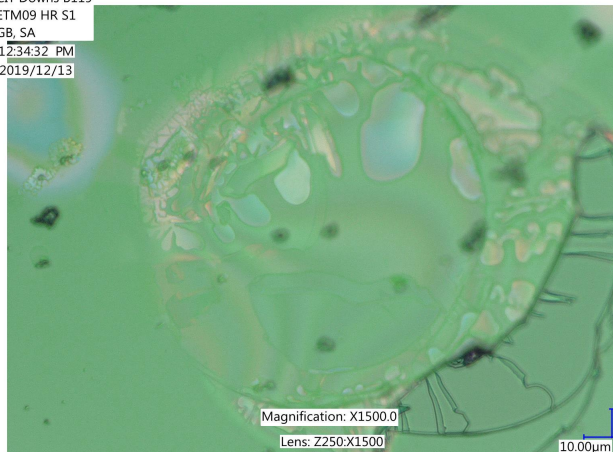
CIT Downs B119
ETM09 HR S1
GB, SA
12:34:32 PM
2019/12/13

another type of point/bubble, not absorbing

(photographed in lab)

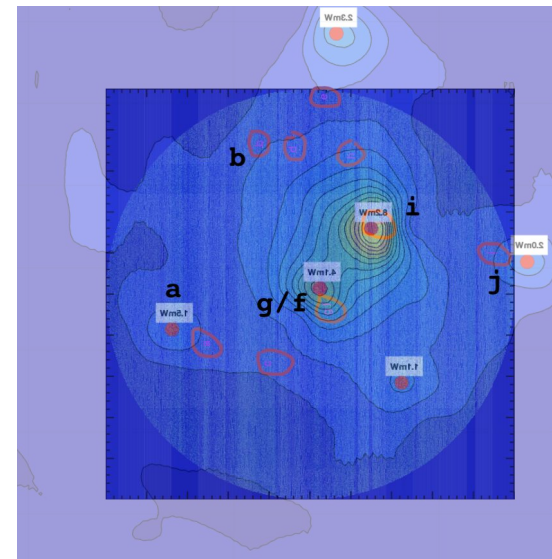
Equivalent point diameters: RTS vs in-situ vs HPAD LHO O3 ITMY

Possible confounding factors:

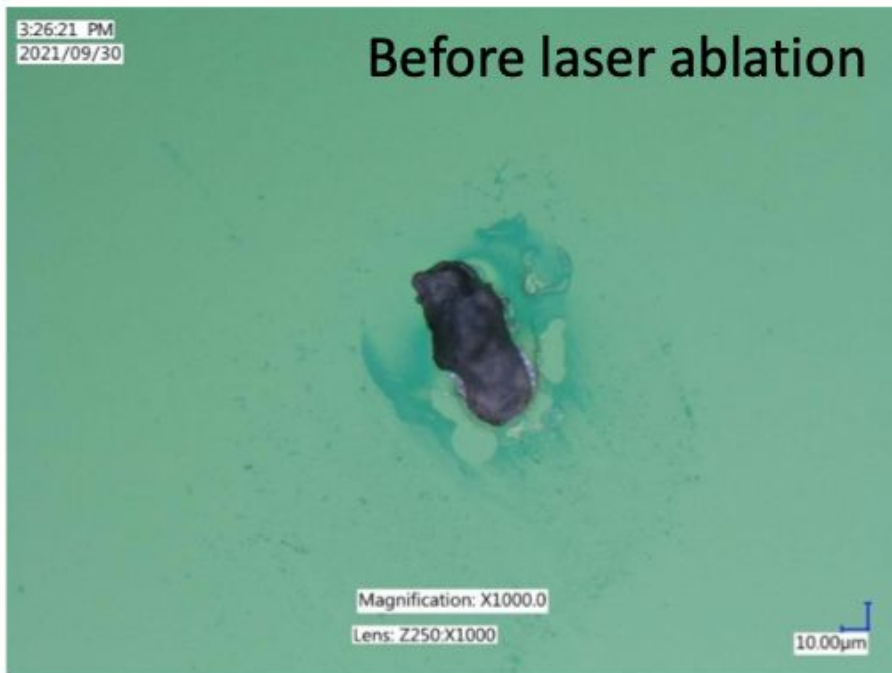
SN1009

Feature c partial removal -
some metal found in SEM.

Feature i no residual metal
found in SEM but possibly
some buried under apparent
coating blob?

All ablated areas seem to
still have features left.

SN1009, Laser Ablation and Annealing Test

Note that per [T2100216 slide 21](#), we are looking for a
factor of 4 to 6 reduction
from anneal.
