DOCUMENT CHANGE NOTICE (DCN)

DOCUMENT No. (DOC-REV-GP. ID)	TITLE	NEW REV.
D961416-A	Large Core Optic Component Carrier Cover	B
D961449-A	Core Optic Component Carrier Top Plate	B
D961467-A	Core Optic Component Carrier Metrology Interface Top Plate	B

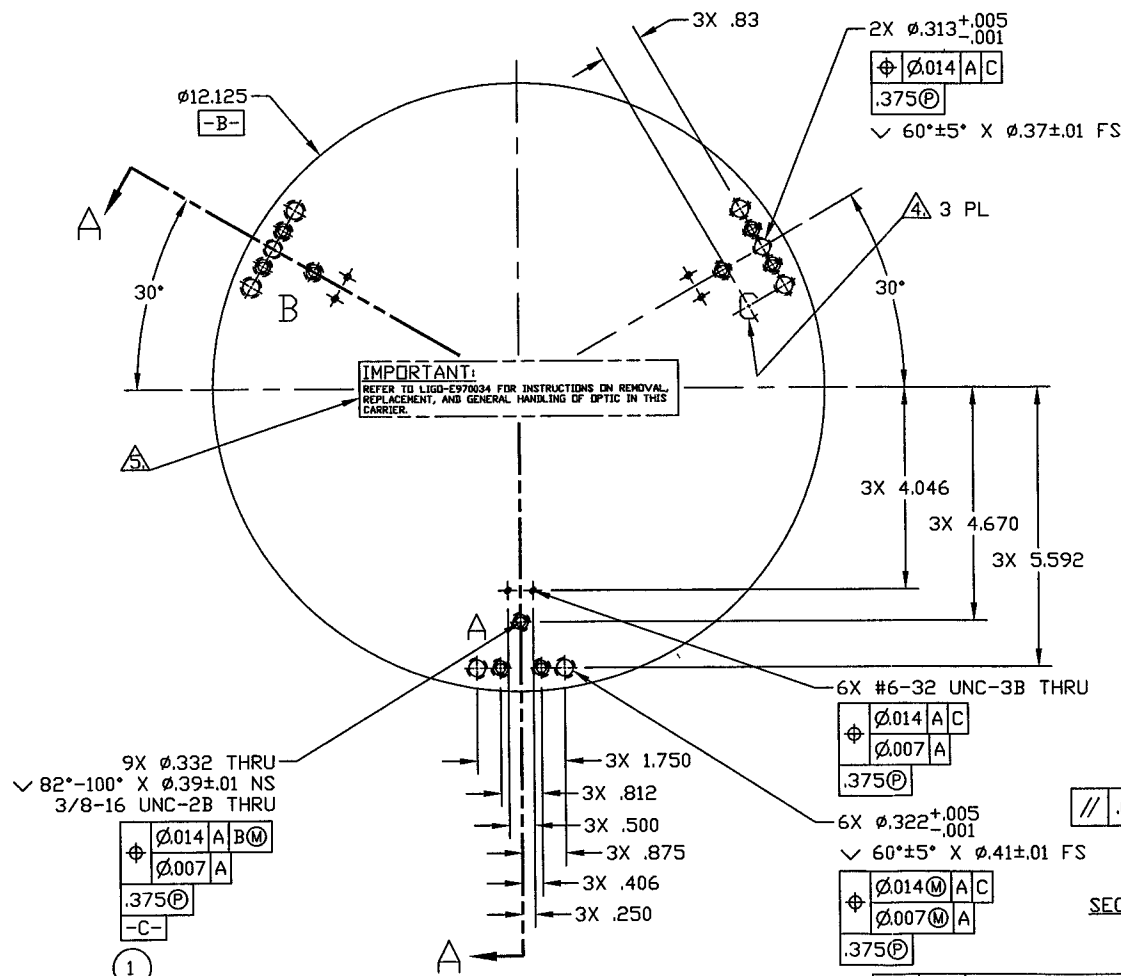
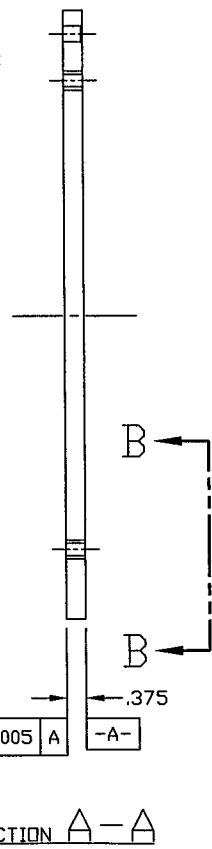
REASON FOR CHANGE: Alleviate “wedging” of captive screw retaining rings D970001, between top of standoffs and bottom side of top plate D961467 on top assemblies D961460 & D961461. This problem caused the retaining rings to ride down the captive screw threads when backing out the captive screws to remove the top plate.
